Randy Dutton

The 9th Asia-Oceania Symposium on Fire Science and Technology

Mechanism of tsunami fires after the Great East Japan Earthquake 2011 and evacuation from the tsunami fires

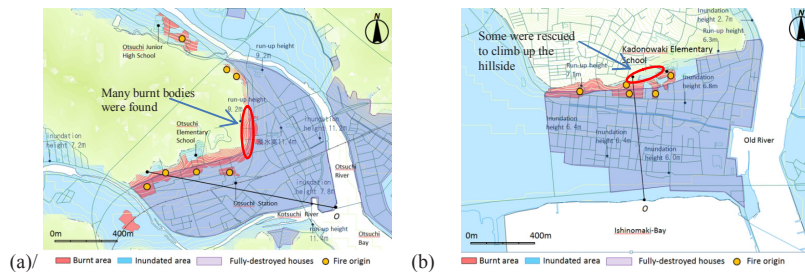
Fig. 1. Fire occurrence points (estimated fires origins) in merged tsunami fire areain (a) Otsuchi townland (b) Ishinomaki city. The fire occurrence ratio is about one per 200 meters in burnt area along hillside where combustible materials from broken houses and floated houses were accumulated.

Figures 1, 12 and 13 show fire sites where multiple fires occurred in combustible material beds along a hillslope in the tsunami flooded areas. This means that there is high probability of fire occurrence in this kind of beds and fires tend to spread widely at these beds.

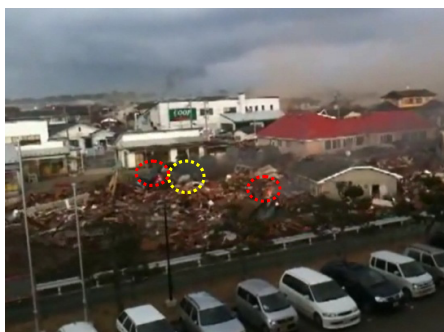
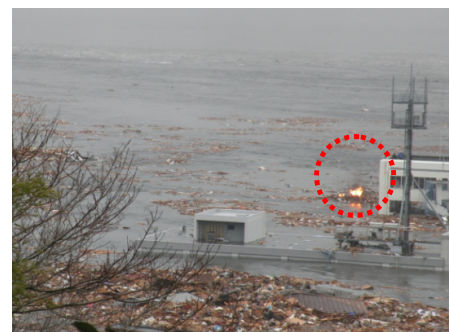
Besides these enlarged tsunami fires there were many small fires as shown in Fig. 2 which were not officially recorded because the evidences of these small fires were swept away by tsunami waves. In order to estimate the tsunami fire occurrences and to consider countermeasure against these fires, it is necessary to collect data of these fire occurrences.

Fig. 2. Small fires circled with red dotted lines (a) at front line of tsunami waves in front of Yuriage Junior High School in Natori city and (b) beside Rikuzentakada city hall where were flooded by tsunami waves. (a) combustible gas ejected from gas-cylinder or tanks is shown with a yellow dotted circle.

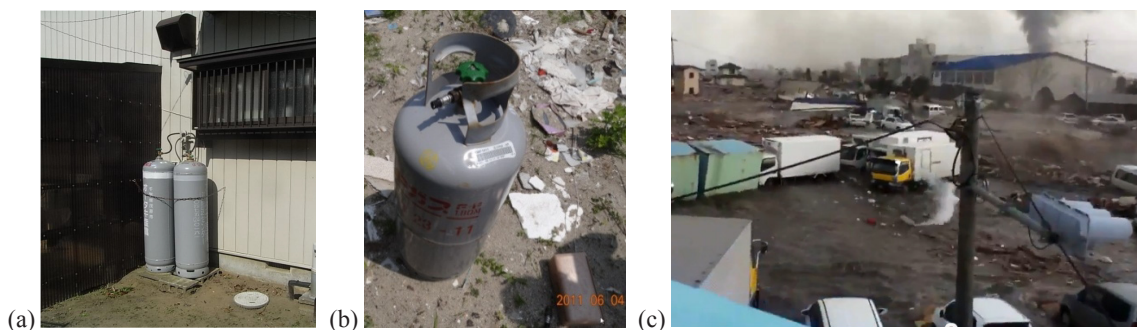
When tsunami hit a house with cylinders as shown in Fig. 3(a), cylinders were disconnected and floated into tsunami waves. Some valves and gas-pressure regulator of cylinders were destroyed when the houses were hit by tsunami as shown in Fig. 3(b). Then propane gas leaked and caused fires inside of the floating houses. Sometimes propane cylinders rolled and floated on the water with the flame jet which ignited the fire on buildings or materials of collapsed wooden houses when they come close. There were also some cases where the rolling propane cylinders drifted on the water ejecting white smoke of flammable gas with no flame as shown in Fig. 3(c). Kitamura estimated that causes of ignition were sparks from metals which collided each other by tsunami [4].

Fig. 3. Liquefied propane gas cylinders at usual situation (a) and tsunami affected situation (b), (c).

(a) Liquefied propane gas cylinders in front of a house at usual situation [8]; (b) Disconnected liquefied propane gas cylinder and buckled at the top by tsunami, Iwate; (c) Combustible gas ejected from a liquefied propane gas cylinder floating on the tsunami waves at a cross street near Yuriage Junior High School around 15:50, 11 March 2011, Natori, Miyagi [9].

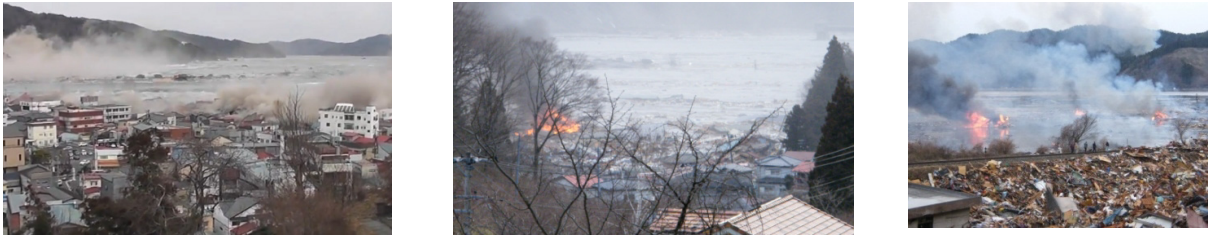
(a) around 15:20, 11 March 2011, Otsuchi, Iwate [10] (b) 15:26, 11 March 2011, Ando, Otsuchi, Iwate [11] (c) 16:00, 11 March 2011, Ando [11]

Figure 4 shows one case of this LP gas cylinder pattern fire without a direct eyewitness. Mr. Toru Suzuki, a volunteer fire fighter of Otsuchi Town volunteer fire company, took this photograph of Fig. 4(b) at 15:26, 11th March 2011 in Ando District in Otsuchi Town in Iwate Prefecture. This was six minutes after the hit of the tsunami at 15:20 here as shown in Fig. 4(a). The district was covered with sand smoke at 15:20, which means the impact of the tsunami was devastating. The location of Ando District is at the left hand of opposite shore in Fig. 4(a).

When he passed through this point before the hit of tsunami, he did not notice a fire around here. He heard a sound of propane gas cylinder explosion after the hit of tsunami. Then when he again reached this viewpoint, he noticed that the materials of collapsed buildings were burning. There are some possibilities that the fires were caused by gasoline leaked from automobiles or fish boats, but it would have taken some more time for propagation of gasoline fire to building materials. So the cause of this fire may have been leaking propane gas from cylinders. The cylinders may have been pushed into a house and caused explosion inside of the house. This estimation meets the size of the fire in Fig.4(b). The situation of this fire at 16:00 is shown in Fig. 4(c).

Fig. 4. Fire occurrence process, (a) situation at the time of tsunami arrival with sand smoke, (b) a small fire occurred after the tsunami arrival on the tsunami waves, (c) continuously occurred small fires on the flooded area by tsunami.

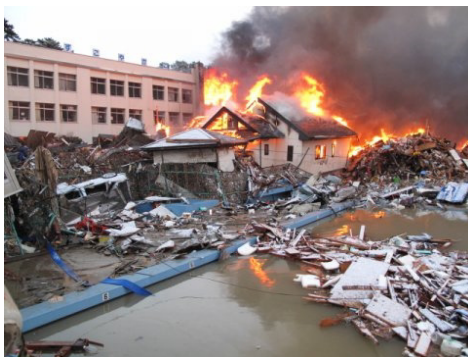
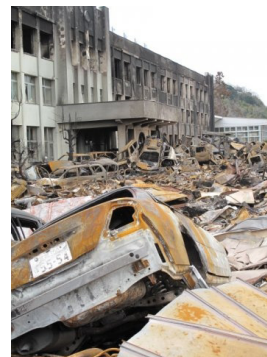
Figure 5 shows a typical case burning in front of Kadonowaki Elementary School in Ishinomaki City in Miyagi Prefecture. About one hundred automobiles with which local people evacuated to the ground of this elementary school were hit by tsunami at around 15:40 11 March 2011. Because the tsunami waves contained floating houses and materials from broken houses, automobiles were pushed and squeezed between these substances in tsunami waves and the reinforced concrete school building. Fuel tanks and vehicle fuel filler pipes were destroyed when automobiles were swept away by the tsunami smashed against the building. Gasoline leaked and caused fires.

Fig. 5. A case of automobile fuel tank pattern fire. (a) fire spread to combustible materials and a broken house floated and landed on the Kadonowaki Elementary School ground with tsunami waves; (b) burnt automobiles in front of the elementary school building.

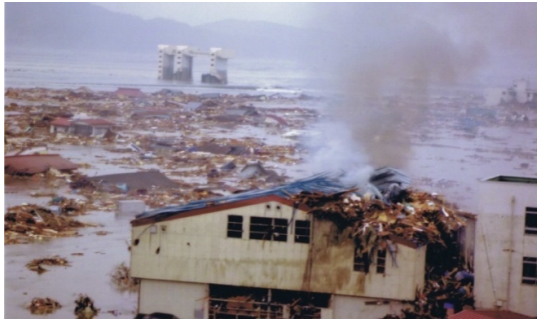
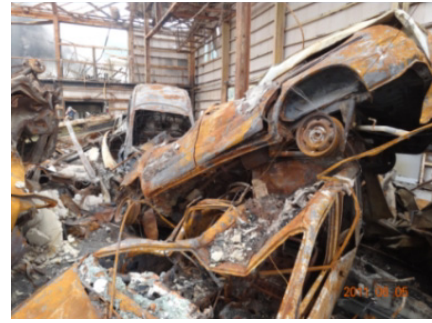
Figure 6 shows another case. After the earthquake, local people came to the ground of this elementary school by automobiles in anticipation of tsunami. There were about thirty to forty automobiles parked in front of the gymnasium. When the tsunami reached here, about ten automobiles were pushed into the gymnasium and seven automobiles were piled up between the gymnasium and the main building. A teacher at the school who had evacuated to a mountain behind the elementary school heard the sound of electric short and explosion from the gymnasium and noticed a smoke coming out of the gymnasium. Local people also heard the sound of explosion a few minutes after the hit of tsunami and noticed that one third of the roof of the gymnasium was blown off as shown in Fig. 6(a). There may have been an explosion of gasoline which leaked from the tanks of the automobiles pushed into the gymnasium by the tsunami. Fig. 6(b) shows inside of the gymnasium after the fire.

Fig. 6. A case of automobile fuel tank pattern fire. (a) a roof partially blown off by an explosion in the gymnasium of the Kesen Elementary School few minutes after the hit of tsunami; (b) burnt automobiles inside of the gymnasium of Kesen Elementary School.

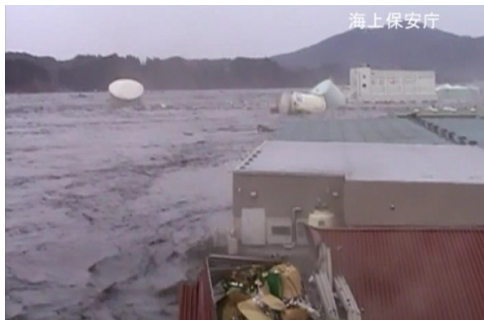
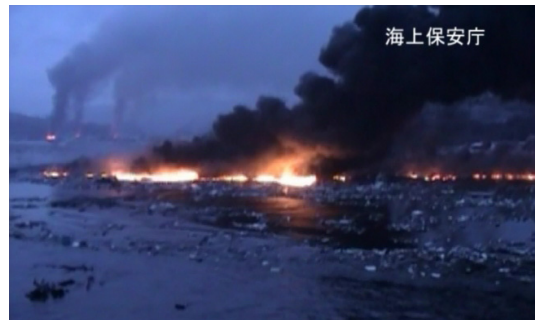
Oil-storage tanks etc. at industrial plants in harbors, ships and fish boats which had been handling flammable liquid were destroyed by the tsunami and floated on the tsunami waves as shown in Fig 7(a). The leaked oil being absorbed to timber and other materials from collapsed buildings etc. caused fires like wick combustion.

The massive fire at Kesenuma Bay was a typical of this pattern. Oil flowing out of the destroyed oil tanks at Kesenuma Port may have adsorbed to farming rafts and collapsed pieces of wooden houses swept by the tsunami, and was ignited into flames [4, 15]. These blazing objects, covering some of the water surface, drifted from Kesenuma Bay outwards to Oshima Strait to reach the tsunami-flooded coastal area where the fire spread to ships, automobiles, factories, houses and forests. These blazing objects also drifted inwards to Shishiori District where already LP Gas Cylinder pattern fires had broken out just after the tsunami reached as shown in Fig. 7(b). The people who evacuated to tsunami refuge buildings near the pier of Shishiori were surrounded by the fires of these two types until the next morning.

Fig. 7. Fire occurrence process, (a) floating oil tanks from which oil leaked onto the tsunami waves; (b) fire of combustible materials from broken houses which soaked spilt oil floating toward Shishiori District where LP Gas Cylinder pattern fires occurred.

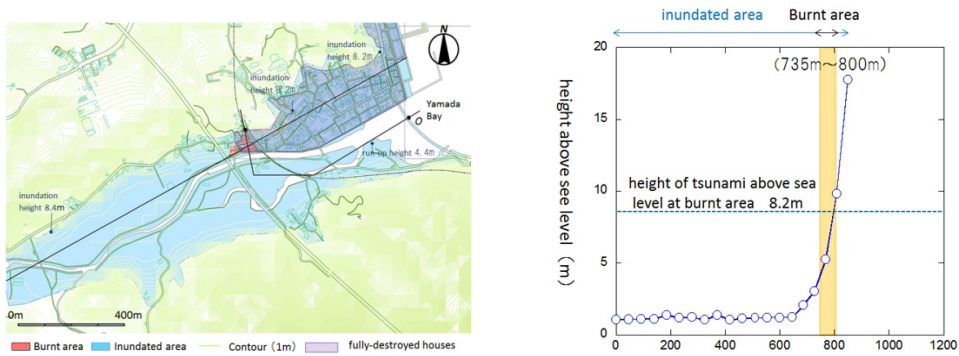
Fig. 8. Fire spread of LP Gas Cylinder pattern fire to broken houses at the edge of tsunami flooded area (Origasa district in Yamada town, Iwate prefecture). Range of burnt area was obtained by on-site reconnaissance with reference satellite image after the tsunami fire.

Figure 8 shows one case of LP Gas Cylinder pattern fires. A rolling propane cylinder floating on the water with flame jet spread fire to broken buildings in Origasa District in Yamada Town, Iwate prefecture. The depth of the tsunami was about 6 meters at the fire origin of this burnt area. Some buildings were partially destroyed by fire and at the middle height of first floors were burnt, so it seems that the height of flooded water decreased when the burning propane tank reached the site to cause a fire as shown in Fig. 9.

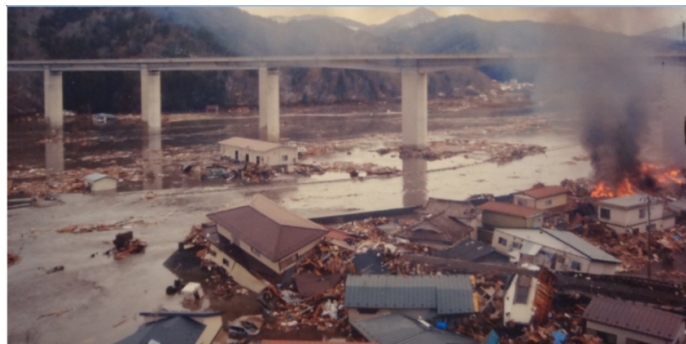
Fig. 9. Fire spread in Origasa district at 16:07, 11 March 2011 (photograph taken and offered by local people).

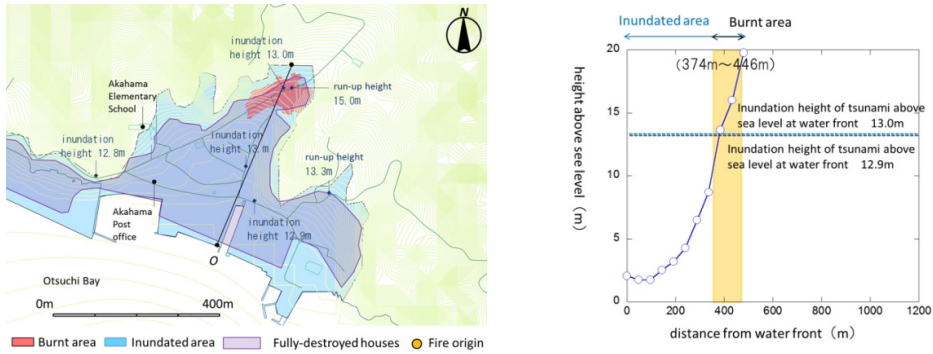
Figure 10 shows a case where there are witnesses that a leaking propane cylinder exploded to ignite a fire after the tsunami hit. Fig.11 shows the fire situation eighteen minutes after the tsunami hit this district. As the height above sea level was about 13 meters, there was no tsunami water in this area at that time. There were wooden houses and fire spread to them. Four local people tried to block fire with a hydraulic shovel and extinguished fire using home hose [1].

Fig. 10. Fire spread of LP Gas Cylinder pattern to houses at hillslope in a tsunami flooded area (Akahama district in Otsuchi town, Iwate prefecture).

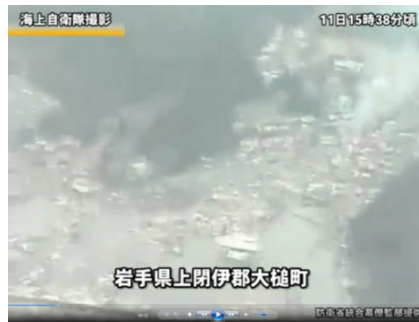
Fig. 11. Fire situation at 15:38 (18 minutes after the hit of the tsunami), 11 March 2011 at Akahama district in Otsuchi town, Iwate prefecture [17].

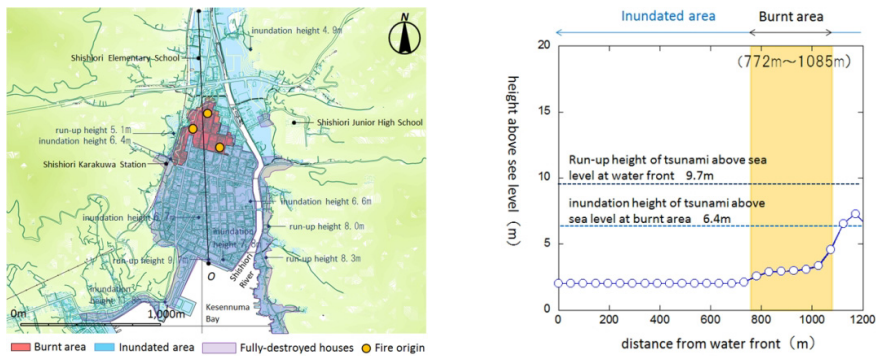
Fig. 12. Spread of fires to houses at slopes in a tsunami flooded area (Shishiori district in Kesennuma city, Miyagi prefecture).

Gradients of the slopes in the fire sites of Figs. 12 and 13 are not so steep compared with other fire sites shown in Figs. 1 and 10. It could be said that the burnt area tends to be wider at a glacial slope. Fig. 14 shows that width of the combustible material bed is wide at this glacial slope.

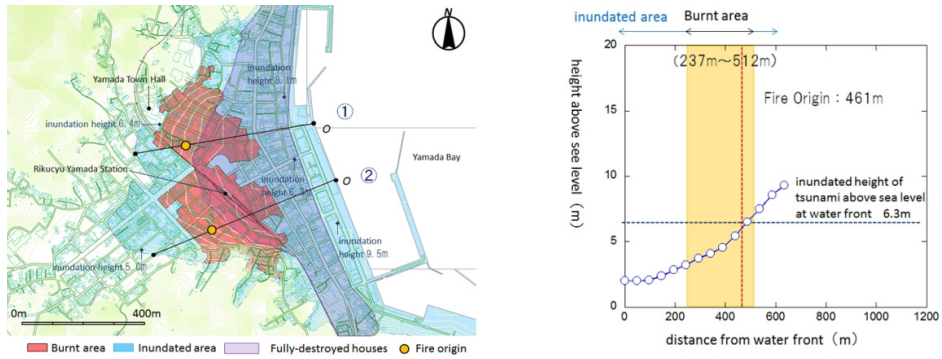
Fig. 13. Spread of fires to houses at slope in a tsunami flooded area (Yamada district in Yamada town, Iwate prefecture).

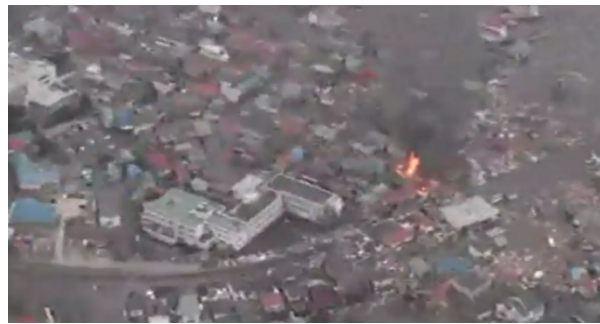
Fig. 14. Fire situation at 16:15, 11th March 2011, about one hour after the tsunami hit Yamada district in Yamada town [18].

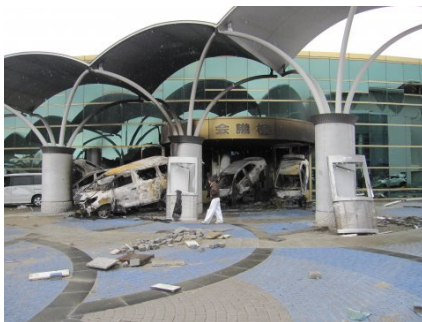
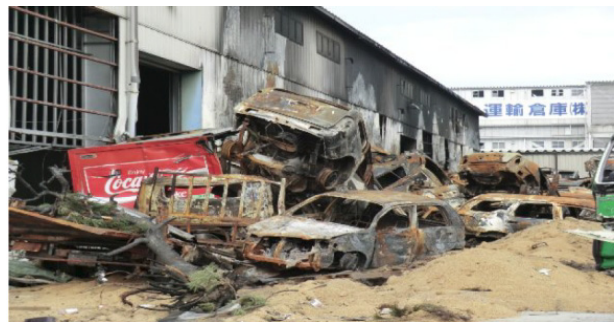
In the pattern in which a fire was triggered by parked automobiles being washed up and smashed against reinforced concrete buildings, automobiles fire spread to building when combustible materials from broken houses and floated and landed woodenhouses existed. When there were scarce combustible materials around automobiles, much of these kind of automobile fire tended not to spread to non-wooden buildings as shown in Fig.15.

Fig. 15. Automobile Fires. (a) in front of Yume Messe Miyagi; (b) in front of a warehouse where 280 automobiles swept away by the tsunami from a parking lot and landed here to ignite.

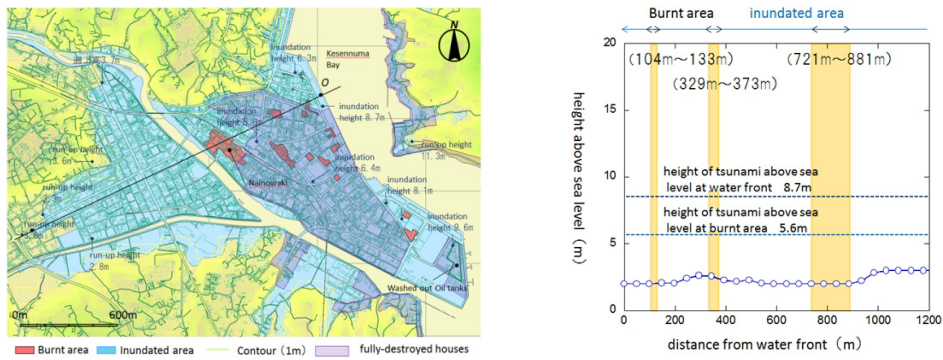
Fig. 16. Fire site of mainly spread fires from leaked oil tank patternfires in a harbor district (Kesennuma city, Miyagi prefecture).

In Fig. 16, most of the burnt areas were spread by typical leaked oil fires pattern. Because wooden building around these burnt areas and combustible materials were almost swept away as shown in Fig. 17, the spread of fire were limited to remaining buildings and fire area did not became large.

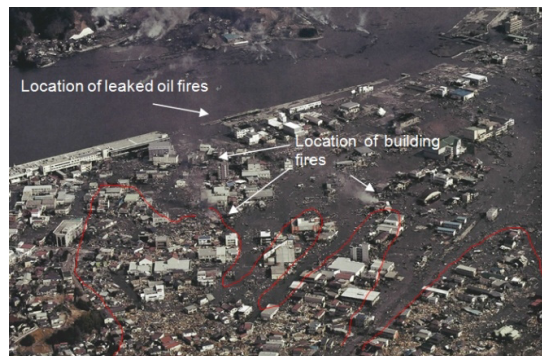
Fig. 17. Combustible material beds surrounded with red line in a harbor district on 12th March 2011, The rightmost area caught fire on 14th March 2011 by unknown process (Kesennuma city, Miyagi prefecture) [21].

This area before the fire is shown in Fig. 17. In the rightmost area there was a bed of combustible materials formed by the tsunami. Maybe because the depth of the water the tsunami brought was shallow around here or maybe by chance, the drifting fires did not reach the combustible materials bed here. As the land is flat as shown in Fig. 16, the combustible bed was shaped like a pyramid, on the top of that was a robust building. If the condition of the tidal wave had been different, the combustible materials could have caught fire from drifting fire, leading to a spread of fire to wider area.

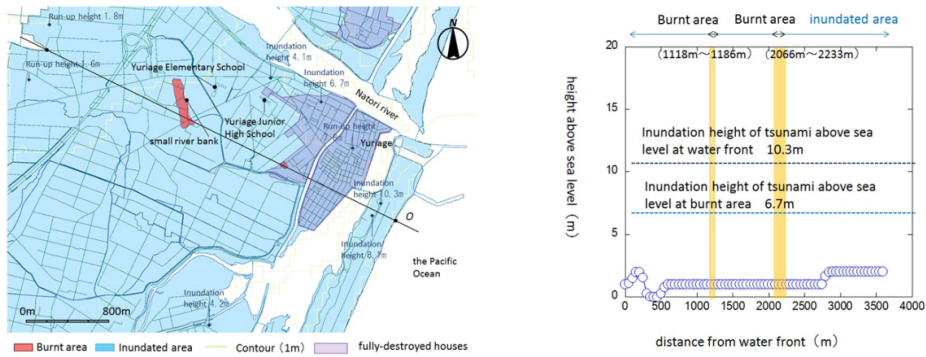
Figure 18 shows one example of fire spread in a flat area. Burnt area depended on distributions of combustible materials and areas with densely built up wooden housing. There was a variety in distributions of combustible materials from wooden houses collapsed in the tsunami, depending on the density of housing, and with or without open spaces and obstacles like railroad and highway banks. In this case burnt areas in flat area were limited.

Fig. 18. Fire site in flat area (Yuriage district in Natori city, Miyagi prefecture).

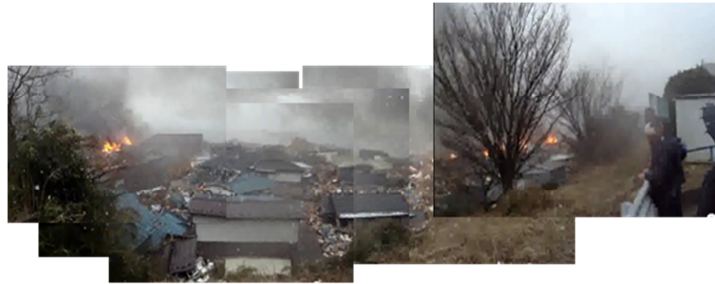
There were some people whose tsunami evacuation was delayed and left behind in the second story of wooden houses. When they survived and noticed the fire approaching, they tried to claw their way out of the house to evacuation buildings or hillsides nearby between tsunami waves through rough route with rubbles. Local people and some volunteer firefighters helped secondary evacuee to climb up the hillside near Kadonowaki Elementary School as shown in Fig. 1 (b) and Fig. 19.

Fig. 19. Location of rescue from 2 story houses in fire risk, 15:53, 11 March 2011 (Kadonowaki, Ishinomaki, Miyagi) [23].

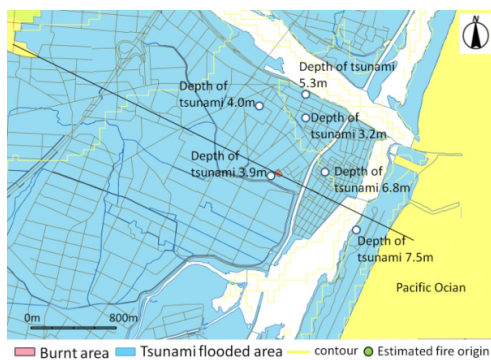
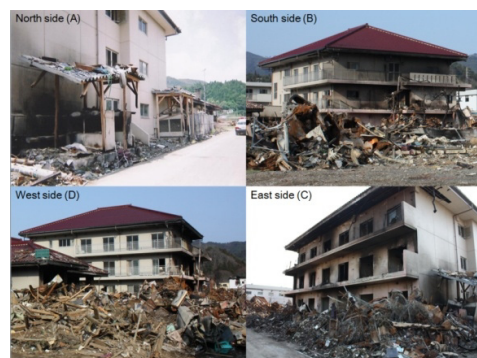
Figure 20(a) shows designated tsunami refuge buildings in Kesennuma City. Green circles with white space inside indicate the locations of refuge buildings where evacuated people saved their lives. Green filled circles indicate locations of refuge buildings with no usage experience. Inundated area is indicated by blue dotted lines and burnt area by tsunami fires are indicated by red. Although people saved their lives in the tsunami refuge buildings, there were fire spread risk because there were some combustible materials between the buildings and the fire area. In some cases, the flame spread to the buildings.

Figure 20(b) shows one example of these cases. There were about 30 aged persons and about 10 staffs in the nursing home. Staffs helped aged persons to escape to third floor before the tsunami arrival. After a meanwhile a fire ignited and spread to north side of the building. Because there were some space between the street and the building and the amount of combustible materials were few, the fire did not spread to the building. Then the fire came from south side. There were some broken houses which were floated by tsunami waves and landed in front of the east side of the building with small space. The fire spread to some resident rooms along the east side. The aged persons and staff escaped from some rooms on the third floor to one resident room on the same floor along the west side where the influence of the fire was minimum, still inside of the room was hot like summertime.

Fig. 20. Tsunami refuge buildings (a) location in Kesennuma city, Miyagi prefecture. (b) one example of tsunami refuge buildings where tsunami fire spread to some part of the building.

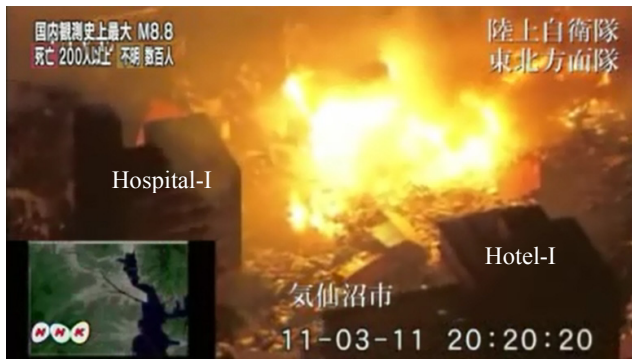
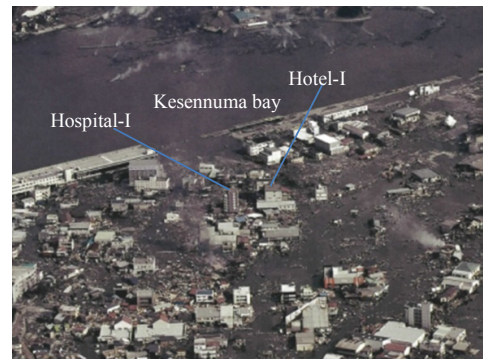
Fig. 21. Tsunami refuge buildings. (a) in fire risk; (b) the day after the earthquake.

Figure 21(a) shows tsunami refuge buildings in Bentencho, Kesennuma City. About seventy local people including twenty vulnerable aged persons evacuated to Hotel-I before the tsunami arrival. There were five staffs in the hotel. In the evening of 11 March 2011, a fire broke out in the vicinity of the hotel as a result of fire spread from oil tank pattern fire from the kesennuma bay. Around 21:00 the fire spread to a building next but one to the hotel as shown in Fig. 17 and Fig. 21(a). The staff considered secondary evacuation but it was almost impossible to evacuate the building because of twenty vulnerable aged persons who could not walk themselves. So, they tried to seek rescue and prepared for fire fighting with indoor fire hydrant. Finally the fire did not spread to the hotel and local people in the hotel were rescued by a helicopter of Tokyo Fire Department in the afternoon of 13 March. Patients including infants were also rescued from Hospital-I next to the hotel at that time.

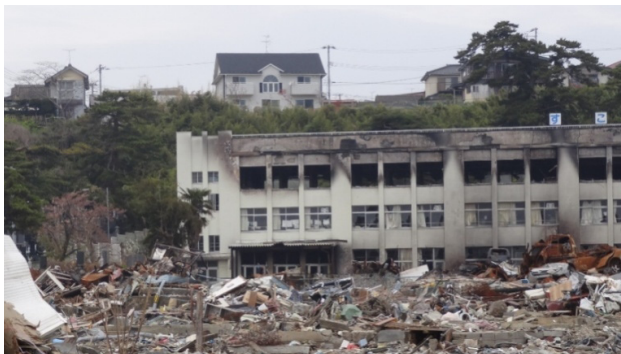
(a) Kadosowaki, Ishinomaki, Miyagi

Fig. 22. Tsunami refuge building. (a) burnt tsunami refuge building by hillside. (b) a platform for bridge at the backside of the elementary school.

In Ishinomaki City, an elementary school was functioned as a tsunami refuge building but when the tsunami came here, automobile pattern fires occurred as shown in Fig. 5. About 50 local people helped each other to escape from this building up to the hillside as shown in Fig. 22(a). As there was a gap between the building and the hillside, they throw a bridge using a platform over the gap to get out of the building as shown in Fig. 22(b). This secondary evacuation was taken place in emergency situation with fire and smoke inside of the building.

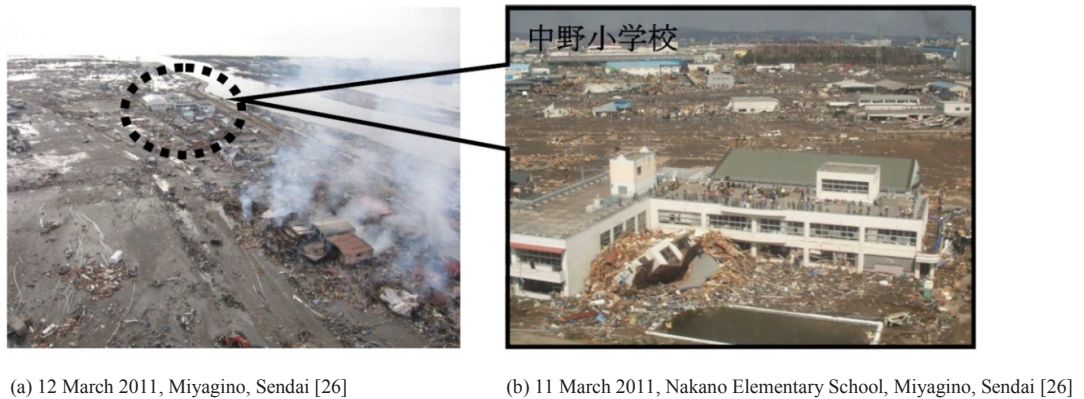
In Miyagino Ku, Sendai City, There were 537 evacuees at Nakano Elementary School. At about 200 meters west side of the school, about ten buildings, combustible materials from broken wooden buildings and about 50 automobiles got fire and spread in the direction of the school with strong west winds. Fire-fighting operation with helicopters was done in success.

Fig. 23. Tsunami refuge building in fire risk. (a) location of elementary school and the fire; (b) elementary school with a lot of combustible materials.

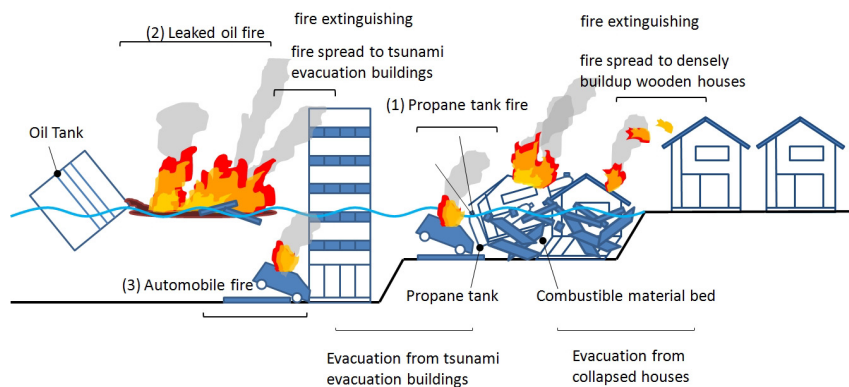
Fig. 24. Mechanism of tsunami fire and responses [27].

It is **difficult to evacuate from a tsunami refuge building** or a collapsed house in case of fire, it is necessary to consider secondary evacuation routes, safe zones in the building, fire extinguishing equipment and other strategies. It is also important to consider the possibility of secondary evacuation in case of tsunami fires for emergency evacuation plan against tsunami.
