**RE: ROBBINS PROPERTY PIPE STUB INVESTIGATION  
JURGENSEN TRUST AND ROBBINS PROPERTY (AKA UPTOWN BAKERY)  
513-525 QUEEN ANNE AVENUE NORTH  
SEATTLE, WASHINGTON 98109  
VCP NO.: NW 2261**

**PACIFIC CREST PROJECT NO: 108-004**

**PIPE STUB INVESTIGATION**

**APPENDIX A  
PHOTOGRAPH LOG**

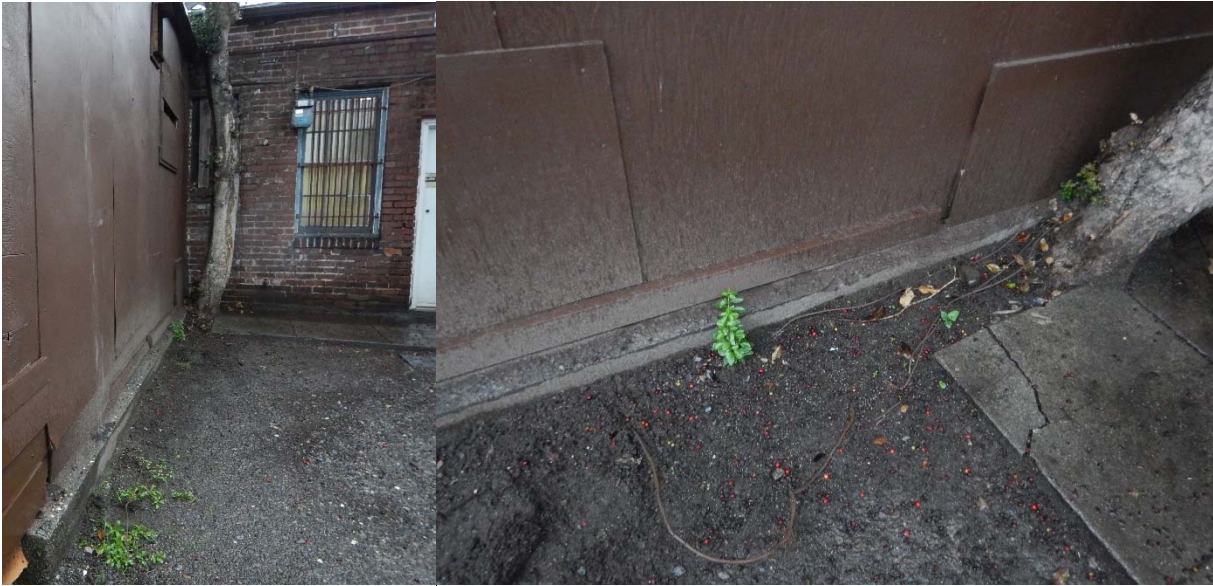
**Photograph 3:** Southern border of the Building Addition, facing east, showing wiring identified by the utility locator to be conductively grounded to the same location as the three pipes. The wiring led from the window behind the tree pictured, and continued below ground and potentially beneath the Building Addition.

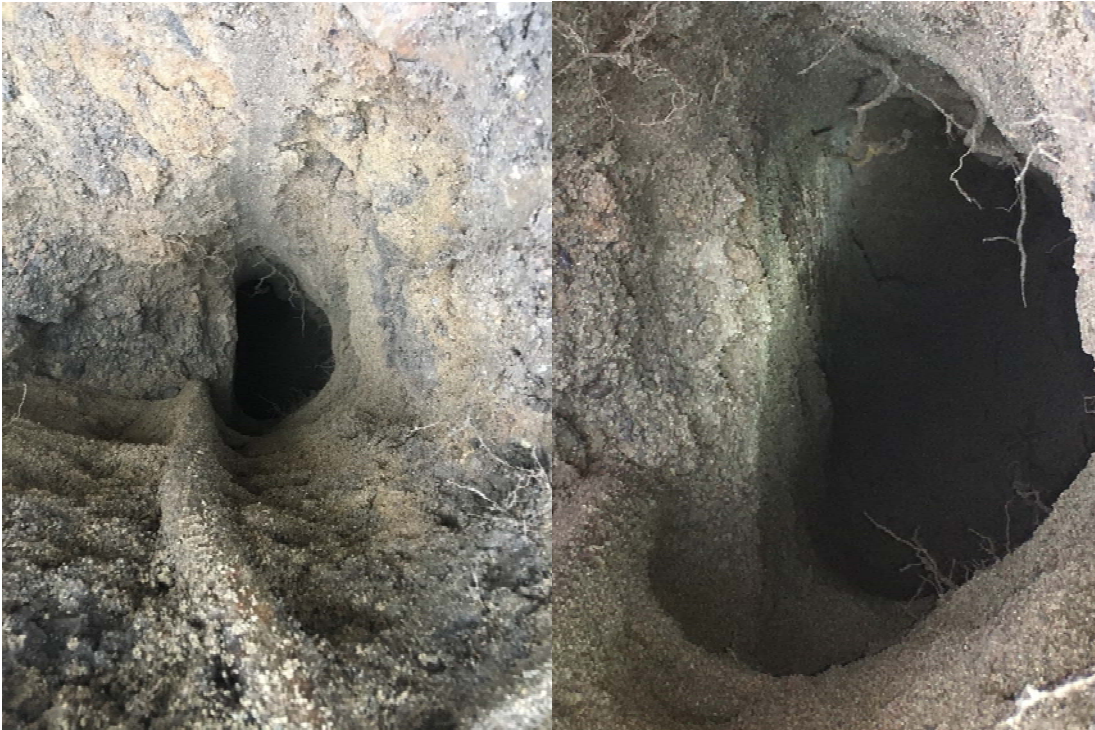
- Soil samples were collected for field screening throughout the advancement of the excavation, including along the pipes, at the pipe connections to the UST, and below the east and north sides of the UST. The field screening results did not indicate evidence of

petroleum odor, discoloration, sheen, or elevated PID readings in association with the soil.

**Photograph 6:** View along Pipe 3 and the eastern sidewall of the tank. The tank was determined to be 4.5 feet in height. The excavation reached approximately 8 feet bgs and no groundwater or petroleum impacted soil were observed.

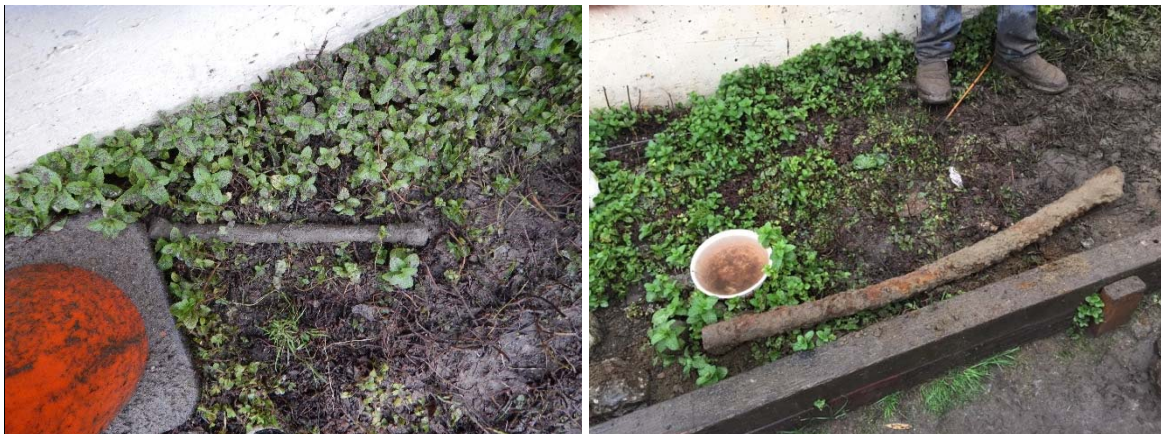
**Photograph 8:** Loose pipes discovered within the excavation area, the first being approximately 1.0 feet in length and the second 4.0 feet in length.

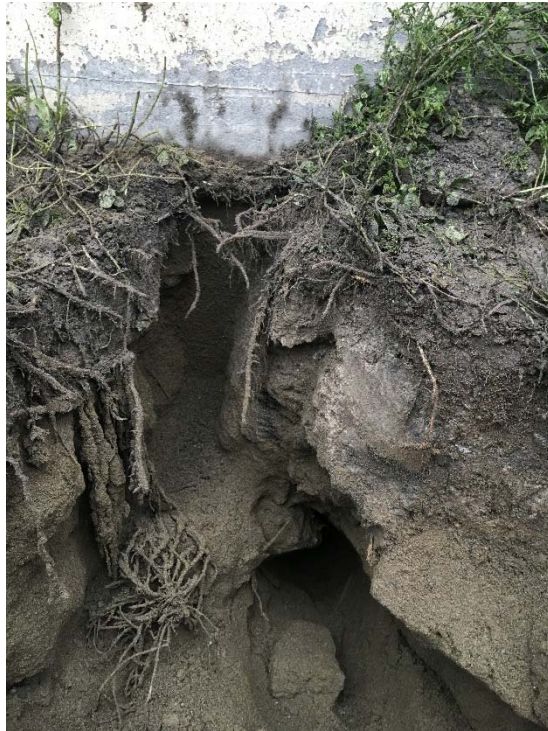
**Photograph 9:** View of the northern extent of the excavation area, facing north with the Jurgensen building in the background. There were no features observed extending across the property boundary.
