**RE: ROBBINS PROPERTY PIPE STUB INVESTIGATION
JURGENSEN TRUST AND ROBBINS PROPERTY (AKA UPTOWN BAKERY)
513-525 QUEEN ANNE AVENUE NORTH
SEATTLE, WASHINGTON 98109
VCP NO.: NW 2261**

PIPE STUB INVESTIGATION

JURGENSEN TRUST AND ROBBINS PROPERTIES
513 TO 525 QUEEN ANNE AVENUE NORTH
SEATTLE, WASHINGTON

PACIFIC CREST NO. 108-004

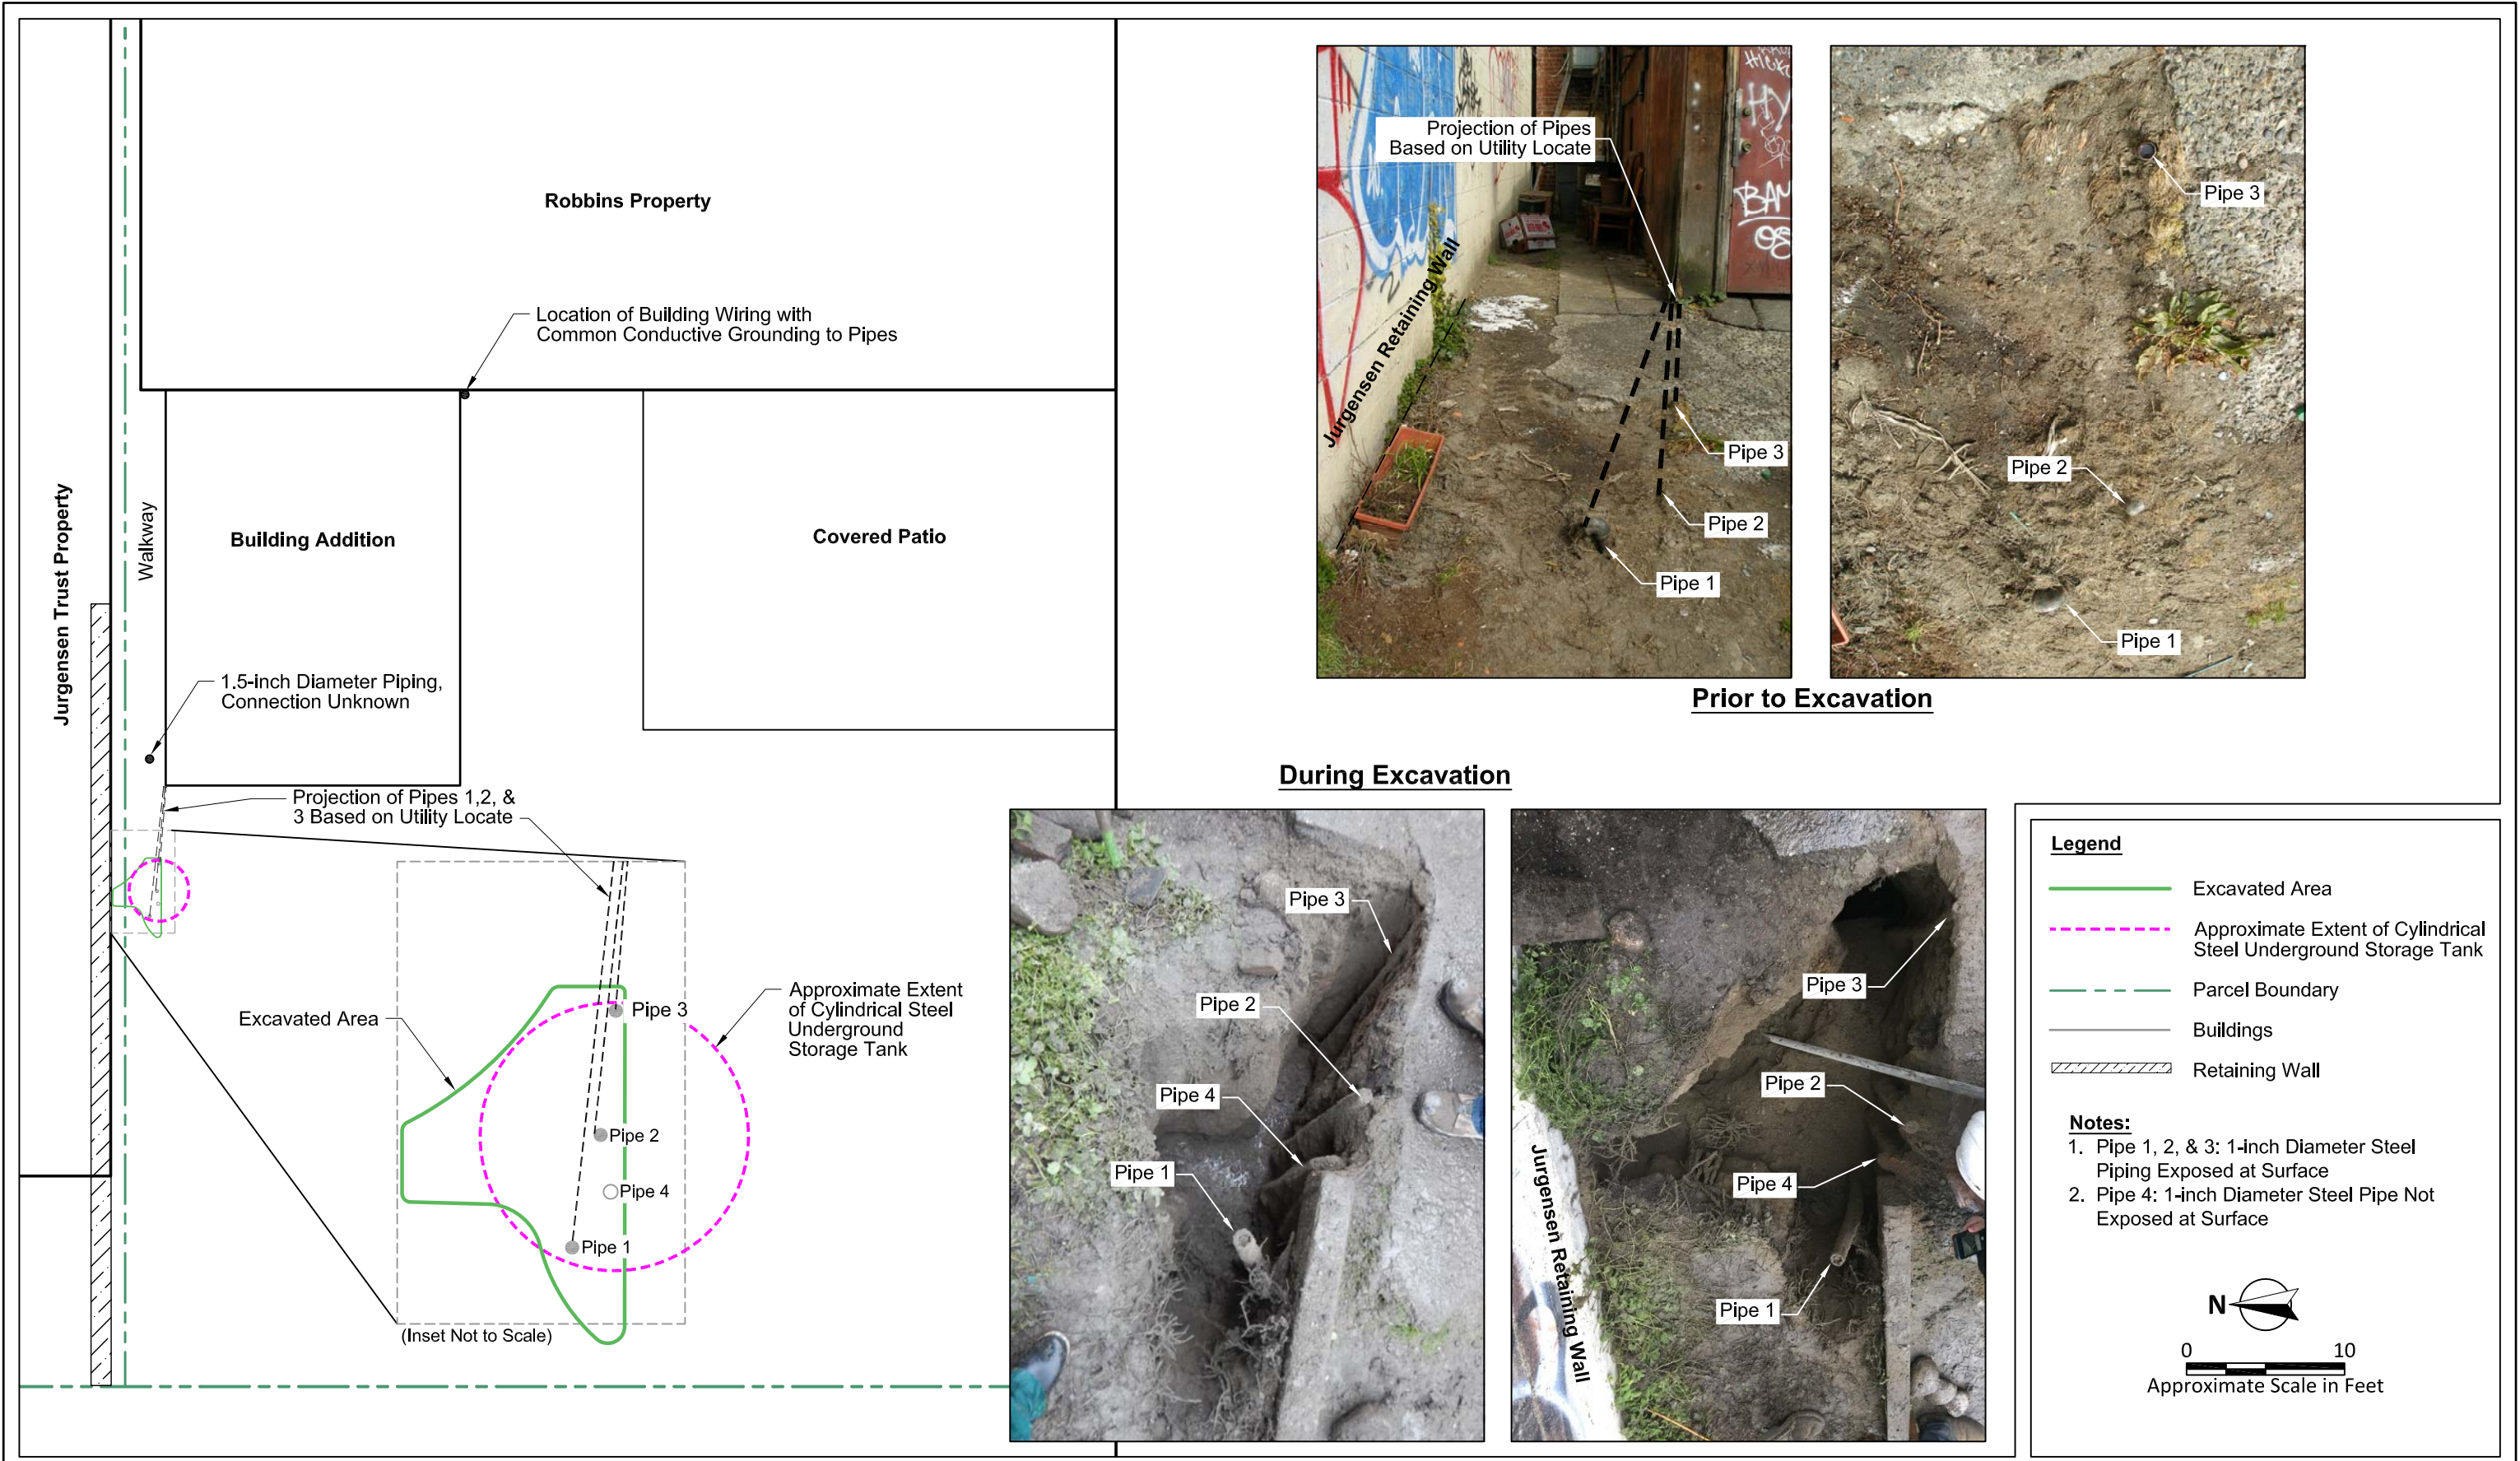
Figure 2
Pipe Investigation and Soil Vacuum Excavation Area

The field activities were conducted in the northwest portion of the Robbins Property on October 26, 2016. The features in the northwest portion of the Robbins Property include a gravel parking area, a covered patio, and a Building Addition with a fenced walkway located north-adjacent of the Building Addition. The pipe stubs are located west-adjacent of the northwest corner of the Building Addition (Figure 2).

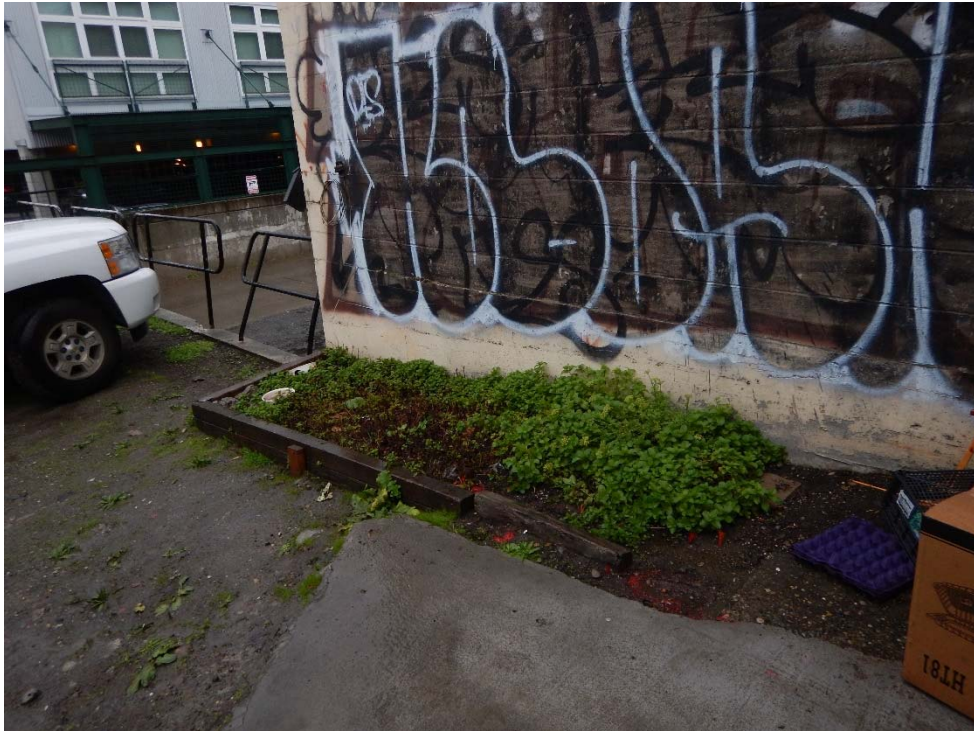
Photograph 1: View of excavation area, retaining wall, and Jurgensen building prior to excavation activities, facing northwest.

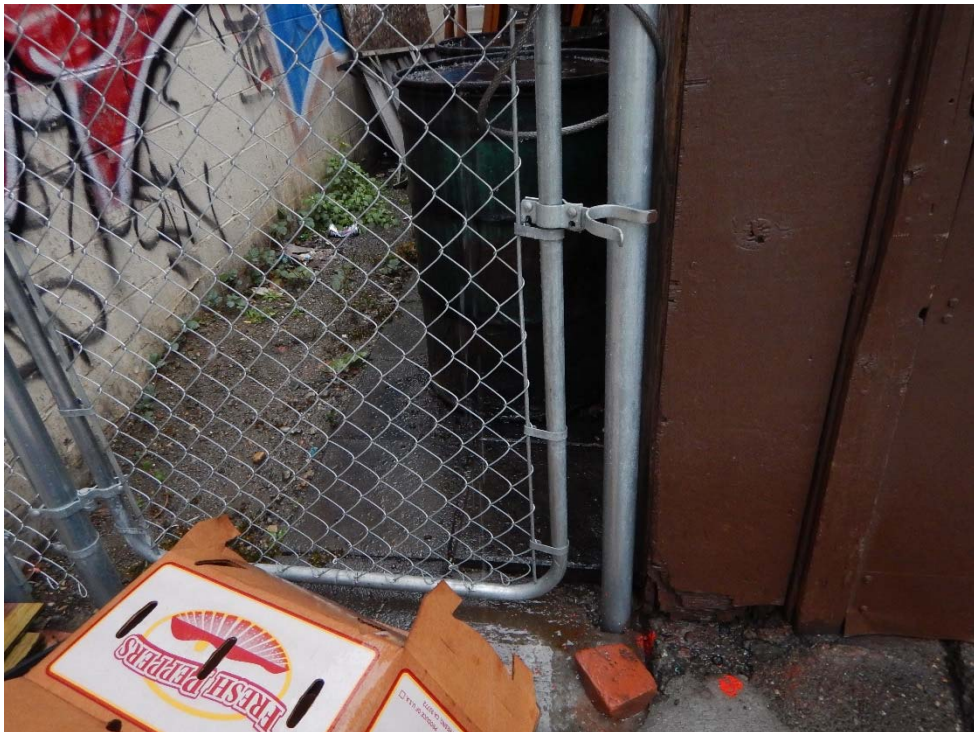
Photograph 2: View of fenced alley and Building Addition, facing east. Orange paint marks the continuation of Pipes 2 and 3 identified by the utility locator. The locate marking for Pipe 1 was located directly north of the red brick in view, but was obscured by heavy rainfall.

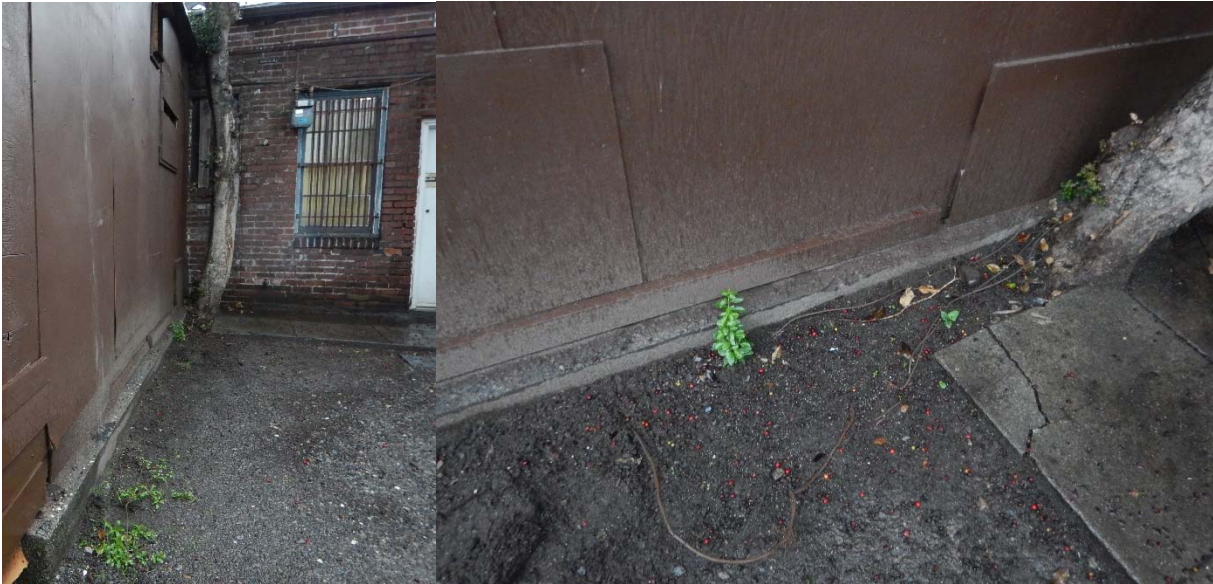
Photograph 3: Southern border of the Building Addition, facing east, showing wiring identified by the utility locator to be conductively grounded to the same location as the three pipes. The wiring led from the window behind the tree pictured, and continued below ground and potentially beneath the Building Addition.

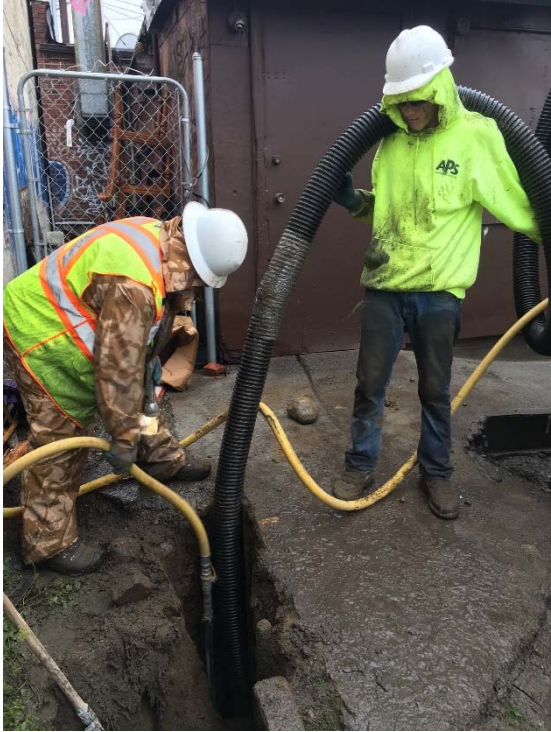
Photograph 4: Excavation in progress adjacent to Pipe 3, facing east.

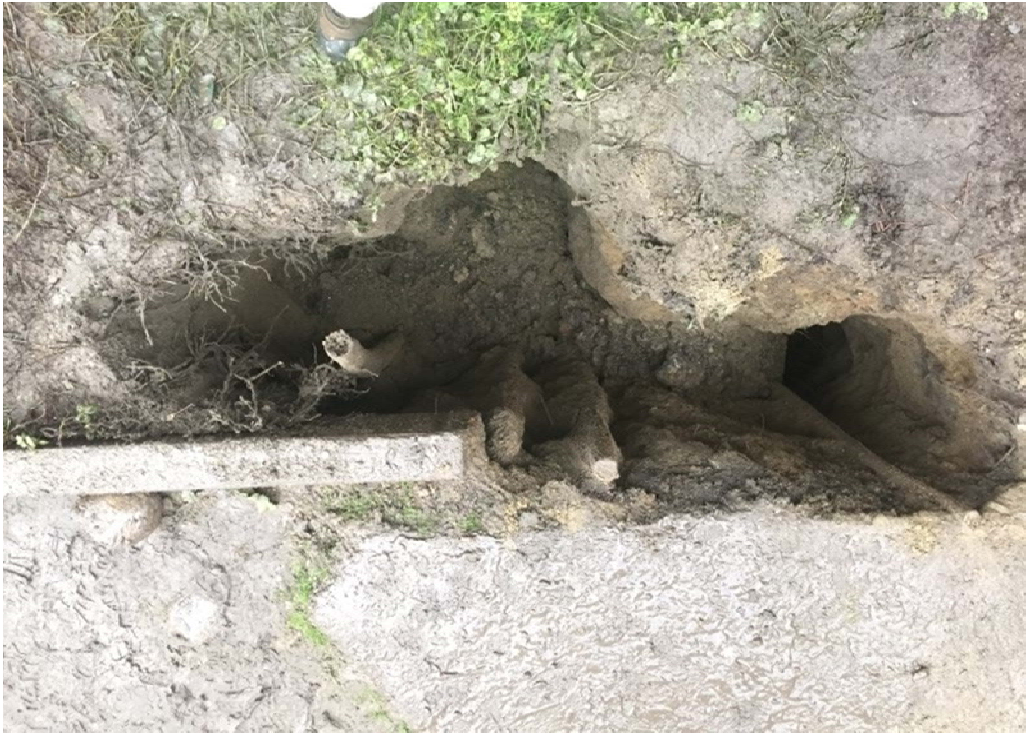
- Following departure of the APS locating crew, the APS vacuum excavation crew arrived on site with a System 4000 Air/Vacuum Excavation truck. Excavation began around Pipe 1. At a depth of approximately 3.3-feet below ground surface (bgs), APS discovered that Pipe 1 was connected to a flat, steel surface. Excavation continued towards Pipe 3, which exposed a fourth pipe (Pipe 4) between Pipe 1 and Pipe 2. Pipe 4 terminated at approximately 3-inches bgs, preventing observation prior to excavation. All four pipes were connected to the flat surface of a cylindrical steel UST approximately 4.0-feet in diameter by 4.5-feet in height (approximately 420 gallons in capacity). When struck, the UST sounded hollow or partially-hollow. Loose piping that was not connected to the UST was discovered within the excavation area, which included a 1-foot long pipe and a 4-foot long pipe. The excavation was advanced to the north to the retaining wall area. No subgrade connections from the UST to the Jurgensen Trust Property were observed.

- The Pipe Stub Investigation activities led to the discovery of a 420-gallon “orphan” UST located on the Robbins Property. The UST is not registered with Ecology and has been out of service for more than one year. The content and historical use of the UST are unknown. Ecology UST regulations (Chapter 173-360 WAC) require that USTs that have been out of service for more than one year undergo permanent decommissioning and site assessment activities by International Code Council (ICC)-certified UST service providers. Pacific Crest suggests that the responsible party (owner) of the UST proceed with the expeditious permanent closure of the UST in accordance with Ecology and City of Seattle regulations.
- The Pipe Stub Investigation did not provide any indication of the presence of the three alleged historical “gasol” USTs on the Jurgensen Trust Property.

Photograph 5: Excavation in progress with four pipes and steel tank surface in view approximately 3.3 feet bgs (Pipe 1 on the far-left [west], followed by Pipe 4, Pipe 2, and Pipe 3). The tank was observed to be cylindrical and have a diameter of approximately 4.0 feet.

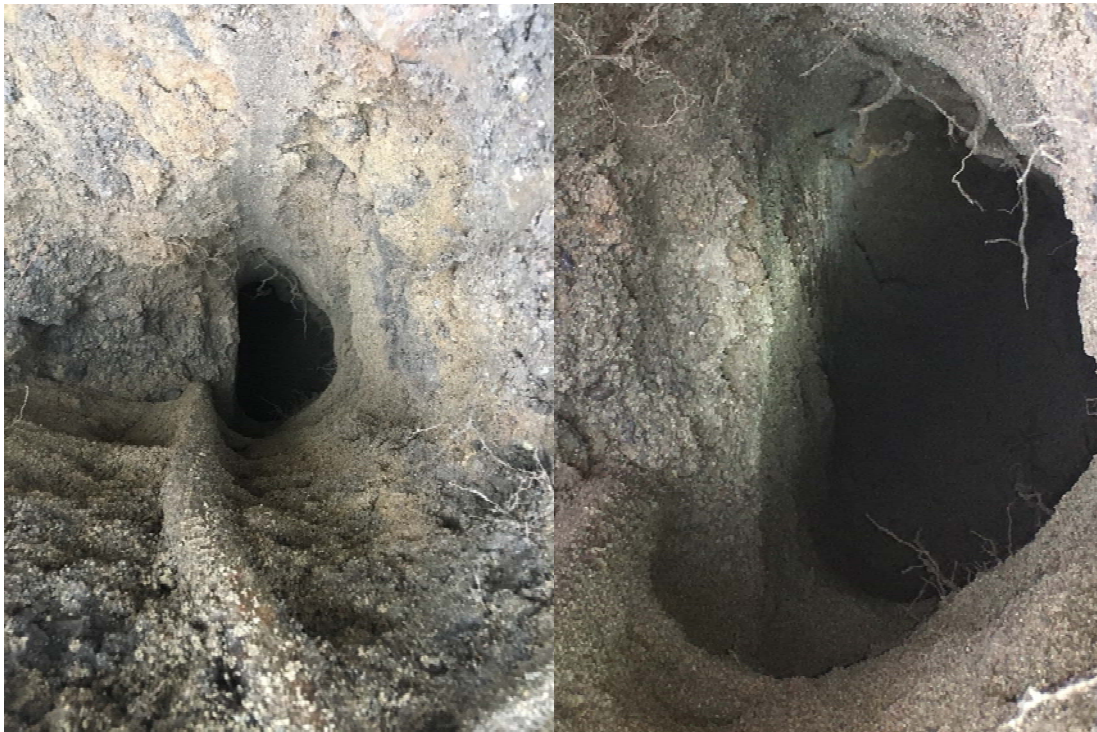
Photograph 6: View along Pipe 3 and the eastern sidewall of the tank. The tank was determined to be 4.5 feet in height. The excavation reached approximately 8 feet bgs and no groundwater or petroleum impacted soil were observed.

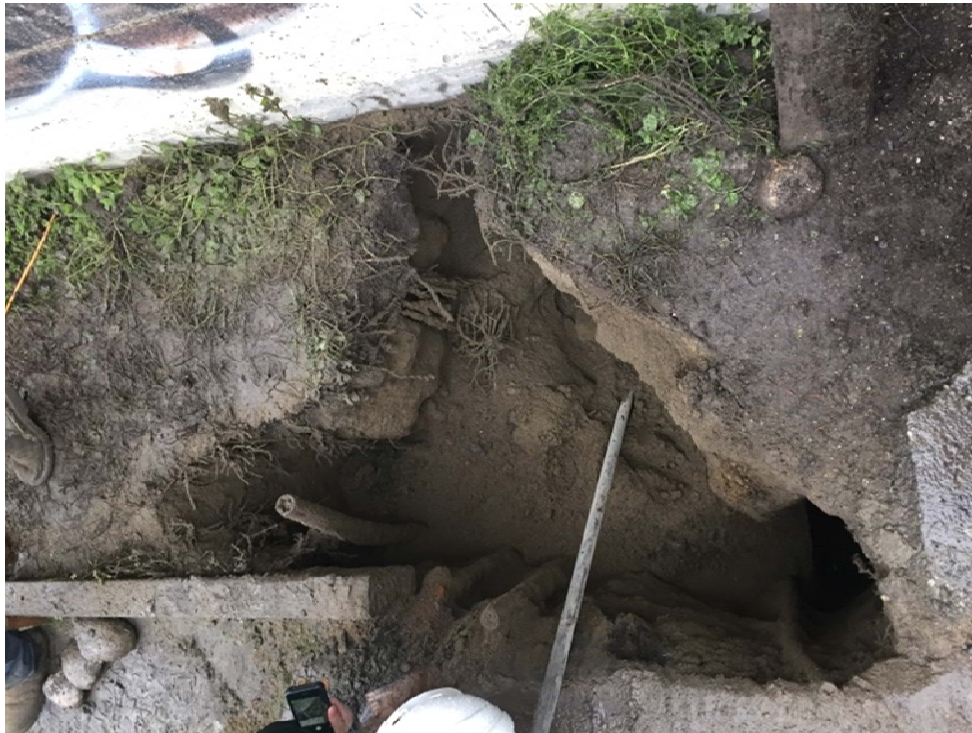
Photograph 7: View of total extent of the excavation, with the Jurgensen building retaining wall in view.

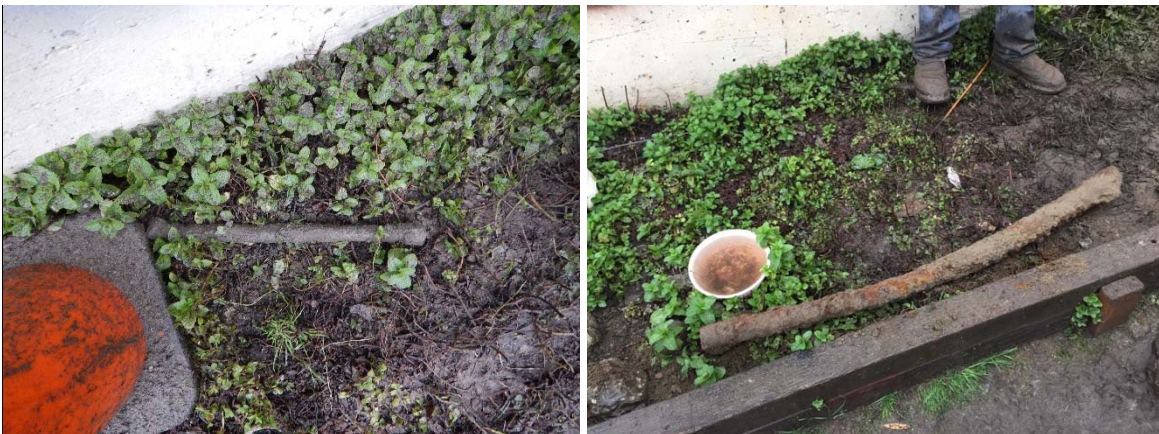
Photograph 8: Loose pipes discovered within the excavation area, the first being approximately 1.0 feet in length and the second 4.0 feet in length.

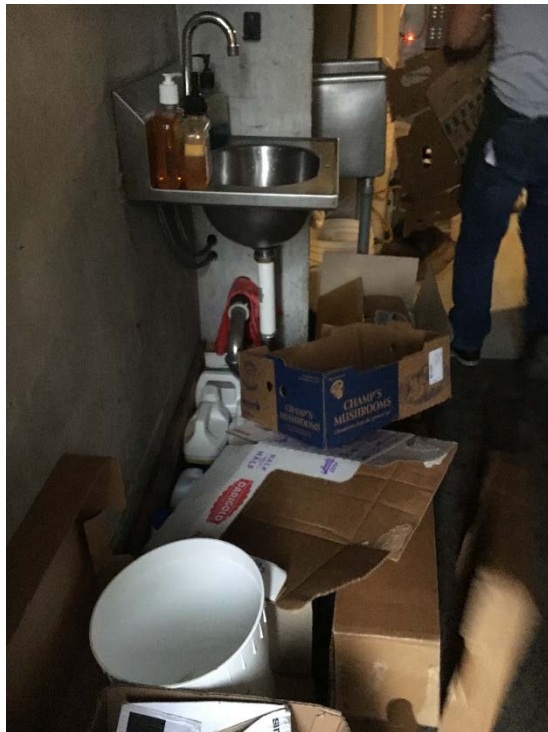
Photograph 10: View inside of the Building Addition, facing east. A sink, several boxes, and restaurant supplies were observed.

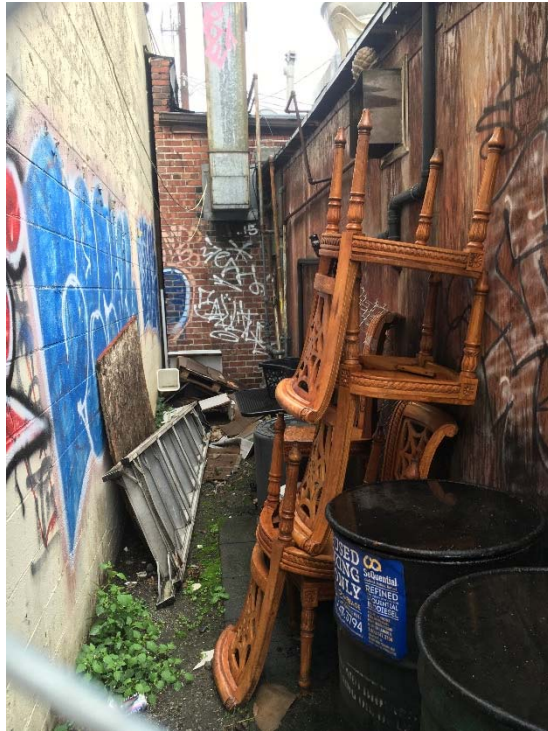
Photograph 11: View of the walkway located north-adjacent to the Building Addition, facing east. Pictured are two drums apparently used to store cooking oil.

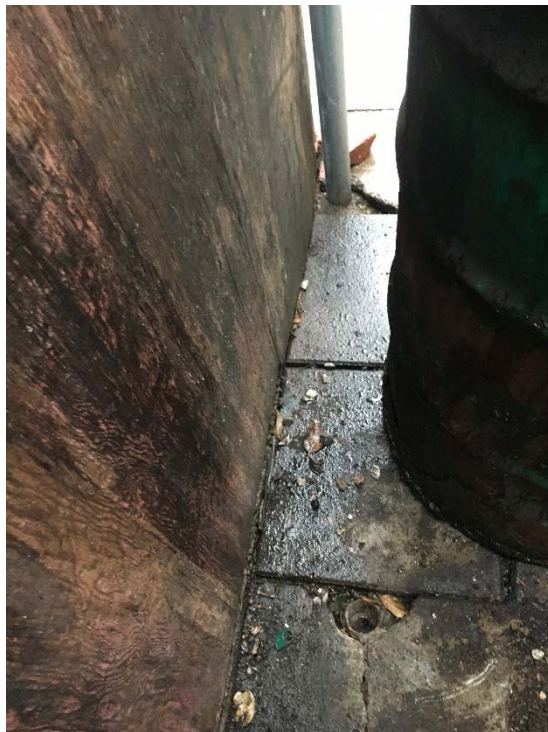
Photograph 12: A pipe was discovered beneath one of the cooking oil drums, facing west. The pipe was unfilled and appeared to extend to at least 9.0 feet bgs.

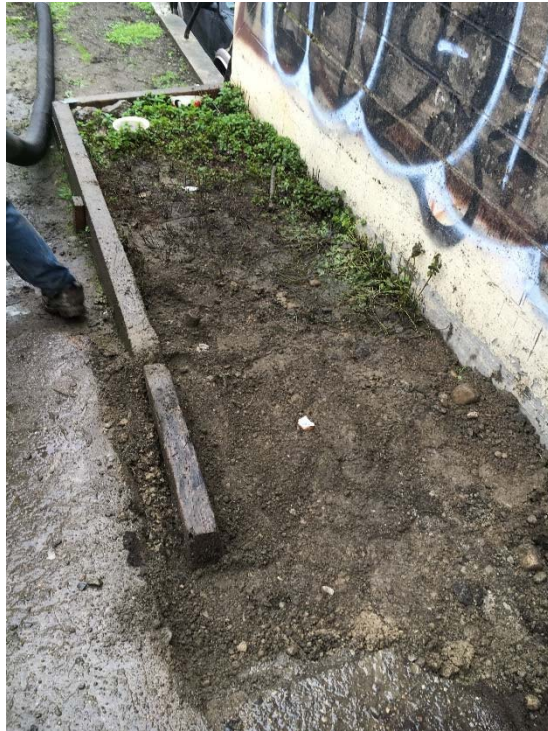
Photograph 13: View of the excavation area after backfilling, facing west-northwest. Field screening did not indicate the presence of petroleum-impacted materials; therefore, the excavated soil was backfilled into the excavated area.
