Bainbridge, Ohio and north Texas - connecting the layers

REPORT ON THE BAINBRIDGE INVESTIGATION

## Report on the Investigation of the Natural Gas Invasion of Aquifers in Bainbridge Township of Geauga County, Ohio

September 1, 2008  
Ohio Department of Natural Resources  
Division of Mineral Resources Management

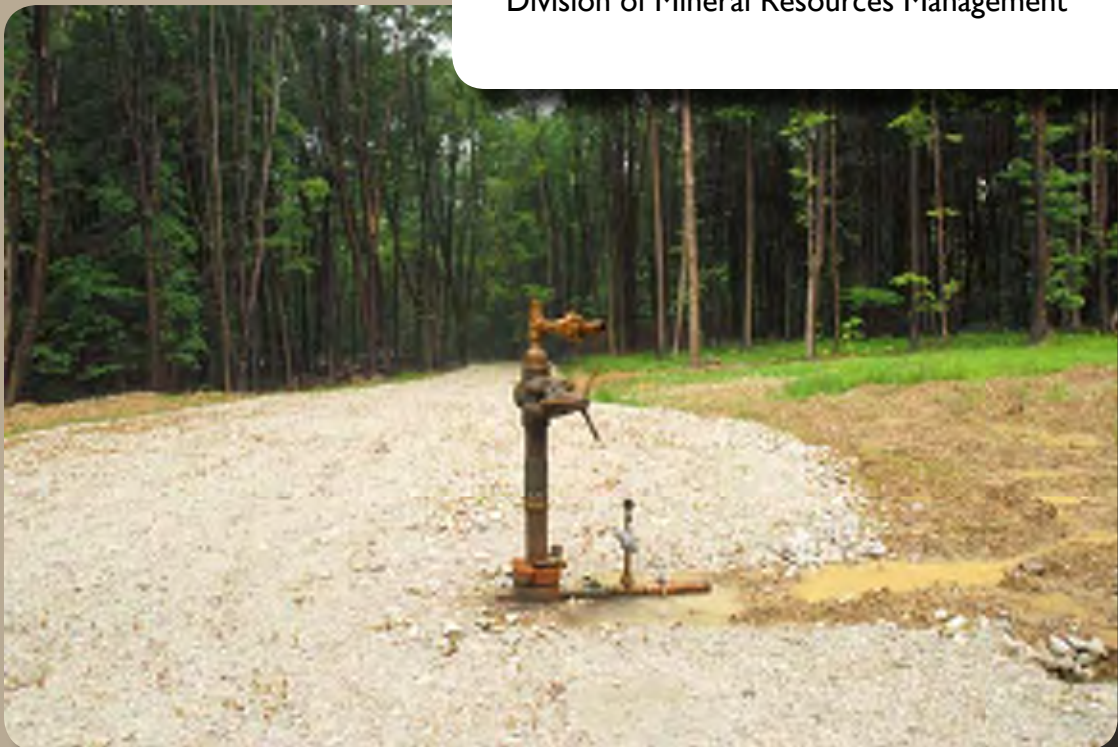
**English No.1 Well**

The DMRM determined that accumulation and confinement of deep, high-pressure gas in the surface-production casing annulus of the English No.1 Well, between November 13 and December 15, 2007 resulted in over-pressurization of the annulus. This over-pressurized condition resulted in the invasion, or migration, of natural gas from the annulus of the well into natural fractures in the bedrock below the base of the cemented surface casing. This gas migrated

vertically through fractures into the overlying aquifers and discharged, or exited, the aquifers through local water wells.

Three different factors in the drilling and completion of the English No.1 Well are believed to be the primary contributing factors that led to the gas invasion of the shallow aquifers and subsequent explosion in the house on English Drive. The first contributing factor was inadequate cementing of the production casing prior to remedial cementing on December 15 2007. The second contributing factor was the decision to proceed with stimulating, or hydro-fracturing, the well without addressing the issue of the minimal cement behind the production casing. Hydro-fracturing is the process in which fluid is pumped into the oil and gas reservoir through perforations in the production casing to enhance fractures and improve the flow of gas and/or crude oil into the production casing. Finally, the third and most critical contributing factor leading to the incident was the 31 day period after the fracturing stimulation of the “Clinton” sandstone during which the annular space between the surface and production casings was mostly shut in. This confined the deep, high-pressure gas from “Newburg” and/or “Clinton” within this restricted space. Readings taken and reported by OVESC during this shut in period were consistently 320 psi or greater.

1. Inadequate primary cementing of the production casing has been remedied by the subsequent squeeze cementing operations;
2. The deep high-pressure gas zones that were the source of over-pressurization of the aquifers have been isolated and sealed from the well bore through the squeeze cementing procedures;
3. The confinement of annular gas, which caused the build up of pressure, has been eliminated.
