# NONPOINT SOURCE SUCCESS STORY

### Federal-State Partnerships Remediate Legacy Mine and Improve Water Quality in Harshaw Creek

EPA 841-F-22-001T  
September 2022

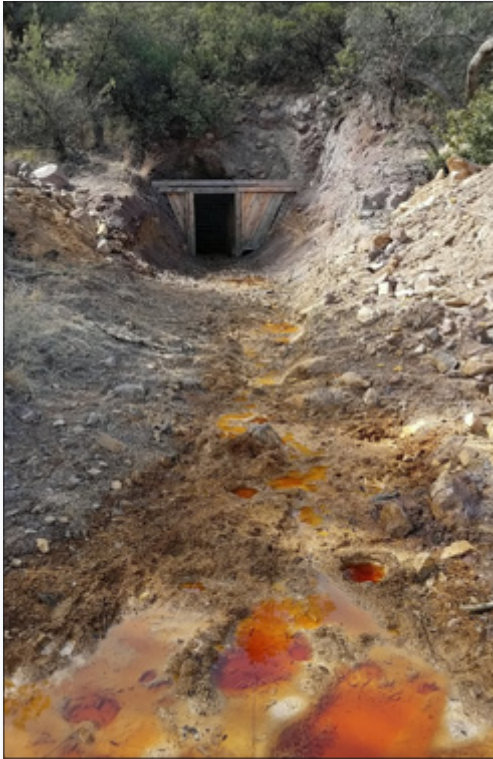
Large-scale mining began in the Harshaw Creek Basin in the mid-1800s and continued for approximately 100 years. The Lead Queen Mine site is on USFS land and is inactive. The underground lead, gold, silver, zinc, and copper mine was discovered in 1897 and was in production between 1898 and 1940. Historic mining activities left behind a variety of waste rock piles, adits, and shafts (Figure 2). Rain falling on the site produced acidic stormwater runoff and leached metals from surrounding mineral-rich rock, tailings, and waste rock. The runoff carried the metals into Harshaw Creek.

Figure 2. The adit at Lead Queen Mine, before remediation.

Entry to the open shafts were closed with bat-friendly gates, while others were sealed using polyurethane foam. A total of 11 zeolite gabion basket structures were installed in the stream channel at various locations downstream of the main adit in order to mitigate stormwater contact. However, the remedy at the main adit began to fail, allowing discharge of pollutants. USFS investigations discovered that the foam plug was intact, but that fractures and faults near the opening were seeping tunnel discharge that was then flowing downstream. USFS built a retention basin to contain and treat the small seep and flow. In 2019, USFS installed a hydraulic plug—a more long-term solution—to cease the discharge. Subsequent site visits confirmed no new seepage coming from the former adit opening.
