Re: Basin Disposal, Inc. and Pasco Sanitary Landfill, Inc.'s Comments on Draft  
Consent Decree, Pasco Landfill NPL Site

# **EXHIBIT 1**

**Annual MSW Landfill Cover Inspections  
Natural Disturbances**

No differential settlement has occurred at the MSW Landfill since the cover was installed in 2002. The topography at the MSW landfill has remained the same, and no indentations or collapses in the landfill cover have ever been observed.

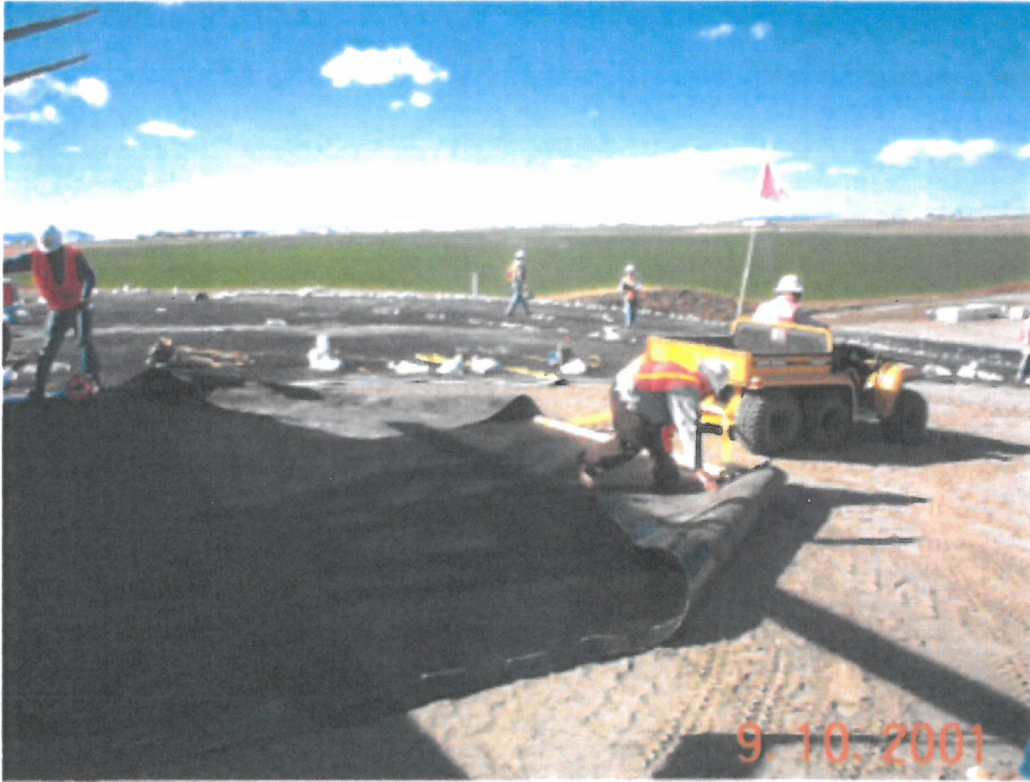
Deployment of 40 mil textured LLDPE geomembrane north slope MSW area.

acre expanse. *See Exhibit 1.* We believe you are aware that the cover, alone, costs millions to purchase and install. After installation the cover was overlaid with 18-24 inches of soil which then facilitated vegetative growth atop the overlay.

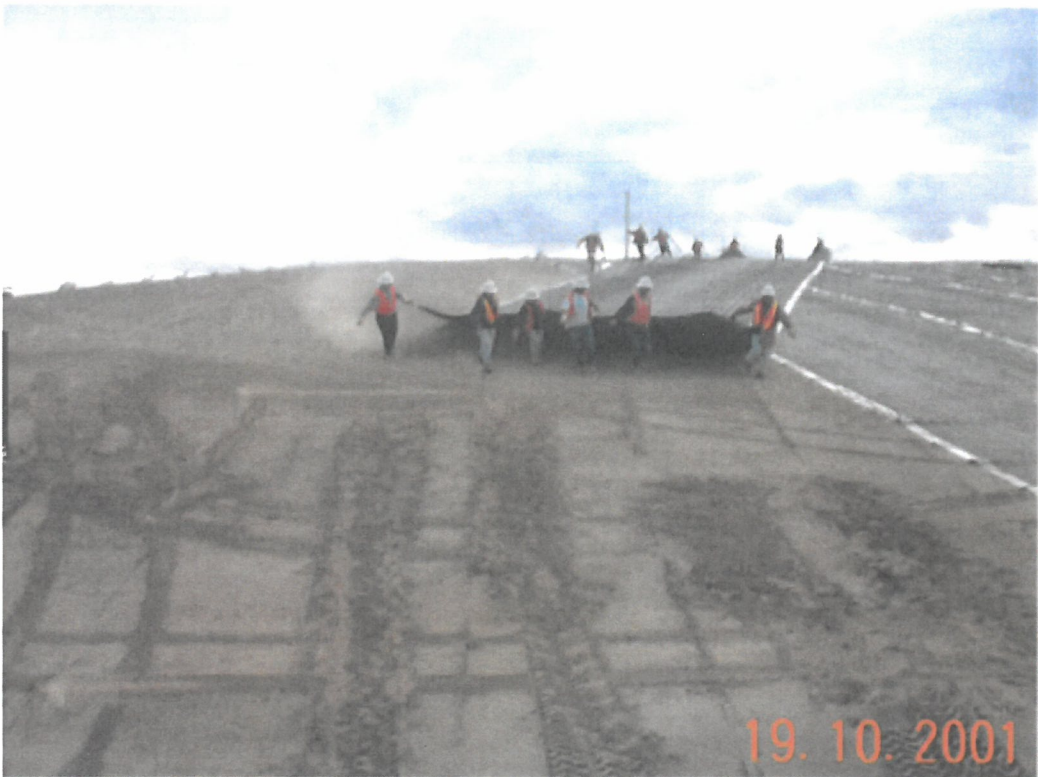
Deployment of 40 mil textured LLDPE geomembrane on west slope MSW area.

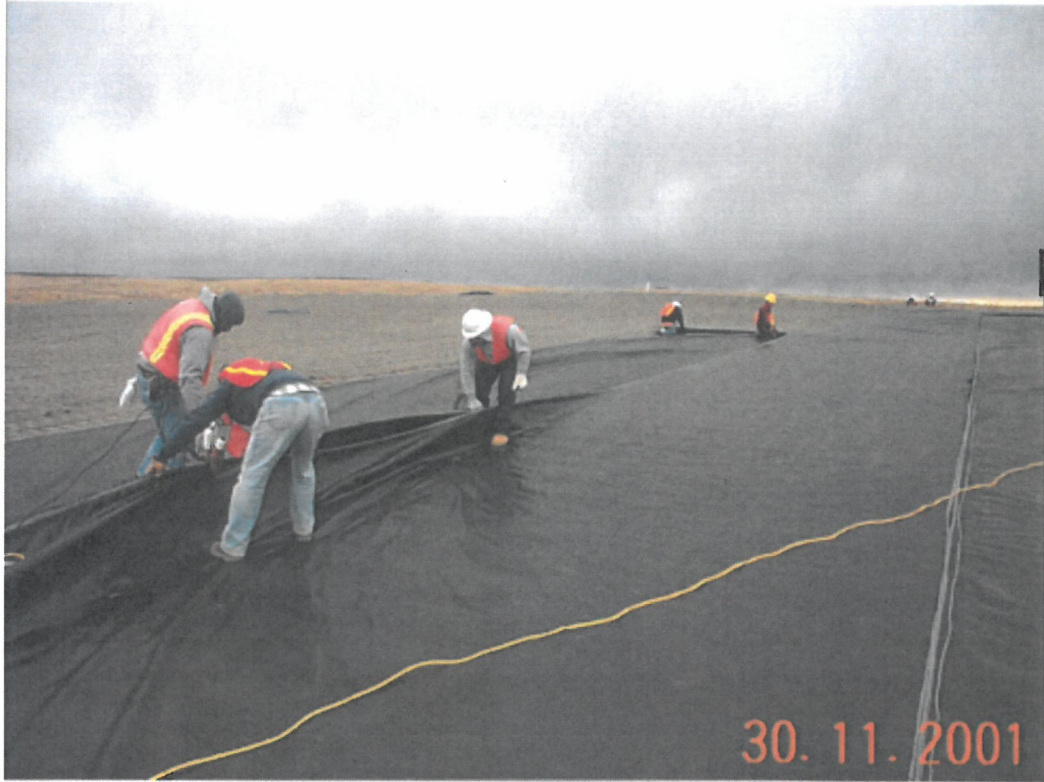
Field Lining Systems sewing geotextile.

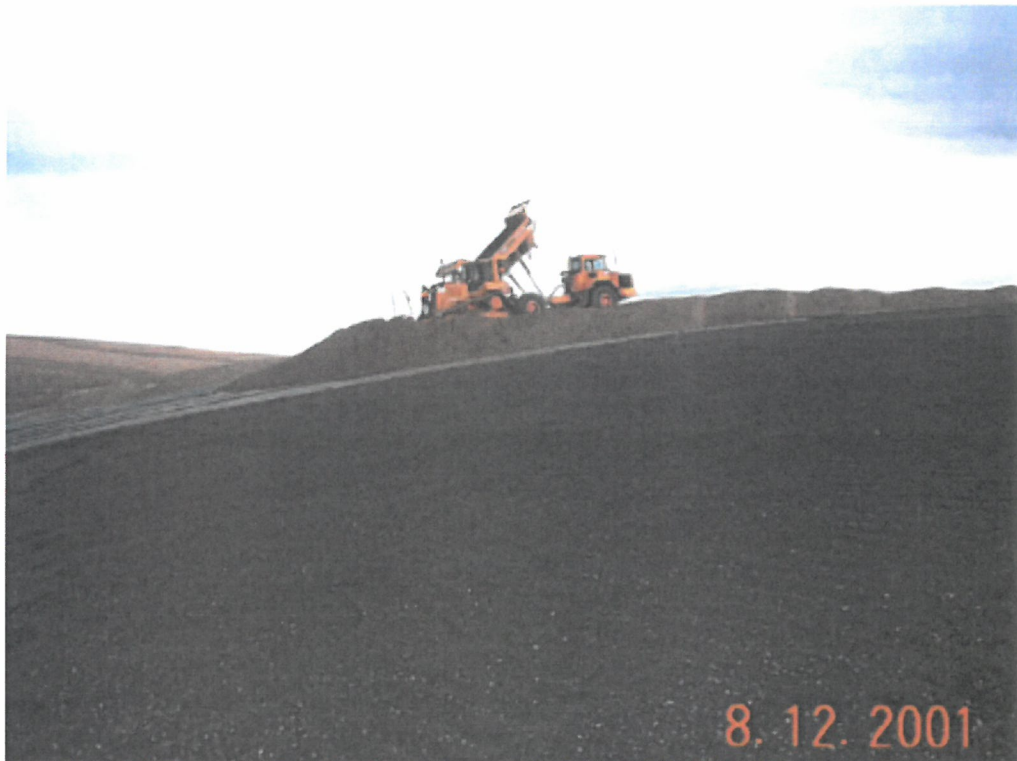
Vegetative soil layer placement on north slope of MSW area.

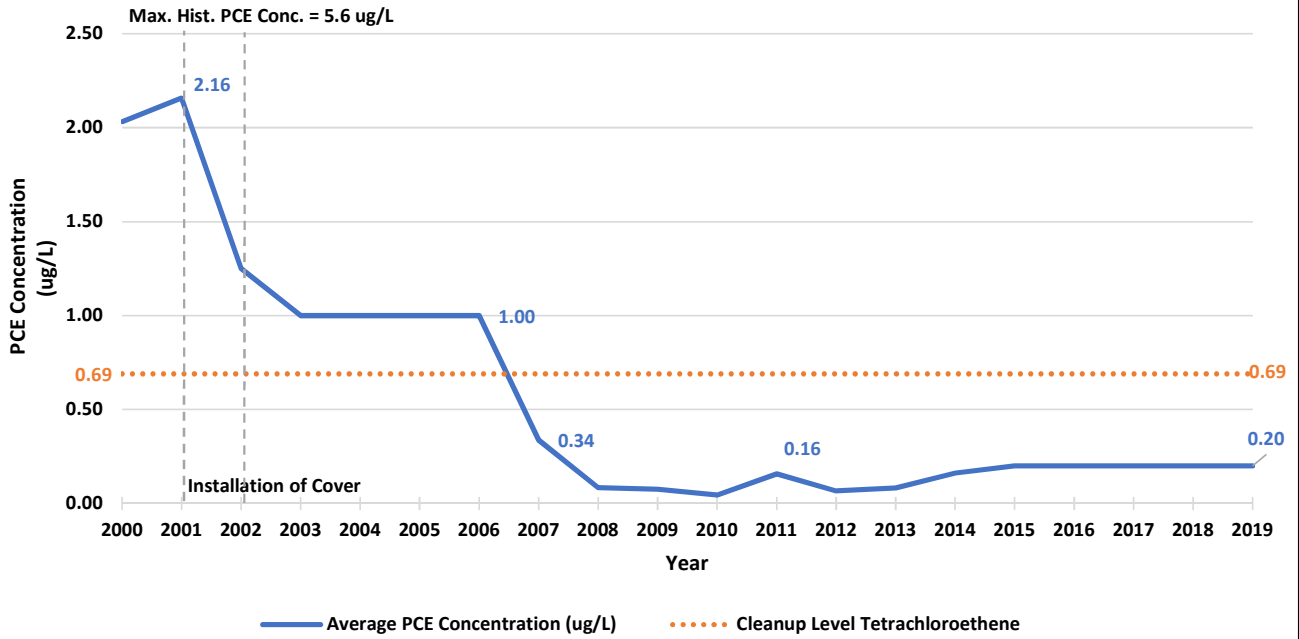
# **EXHIBIT 6**

### Average Annual PCE Concentrations at MW-16S 2000 - 2019

### Average Annual PCE Concentrations at LF-4R 2000 - 2019

### Average Annual PCE Concentrations at MW-17SR 2000 - 2019

### Average Annual PCE Concentrations at MW-22S 2000 - 2019

### Average Annual PCE Concentrations at MW-23S 2000 - 2019

Excellent progress has been made in remediating the small amounts of PCE present at the MSW as well, though PCE remains at slightly above cleanup levels in a single well, presently. If, as expected, PCE levels continue to drop consistent with their long-term declining trajectory, Basin and PSLI expect PCE levels to drop below cleanup thresholds in the next few years. These trends are depicted, across five different wells in the MSW, in Exhibit 6.

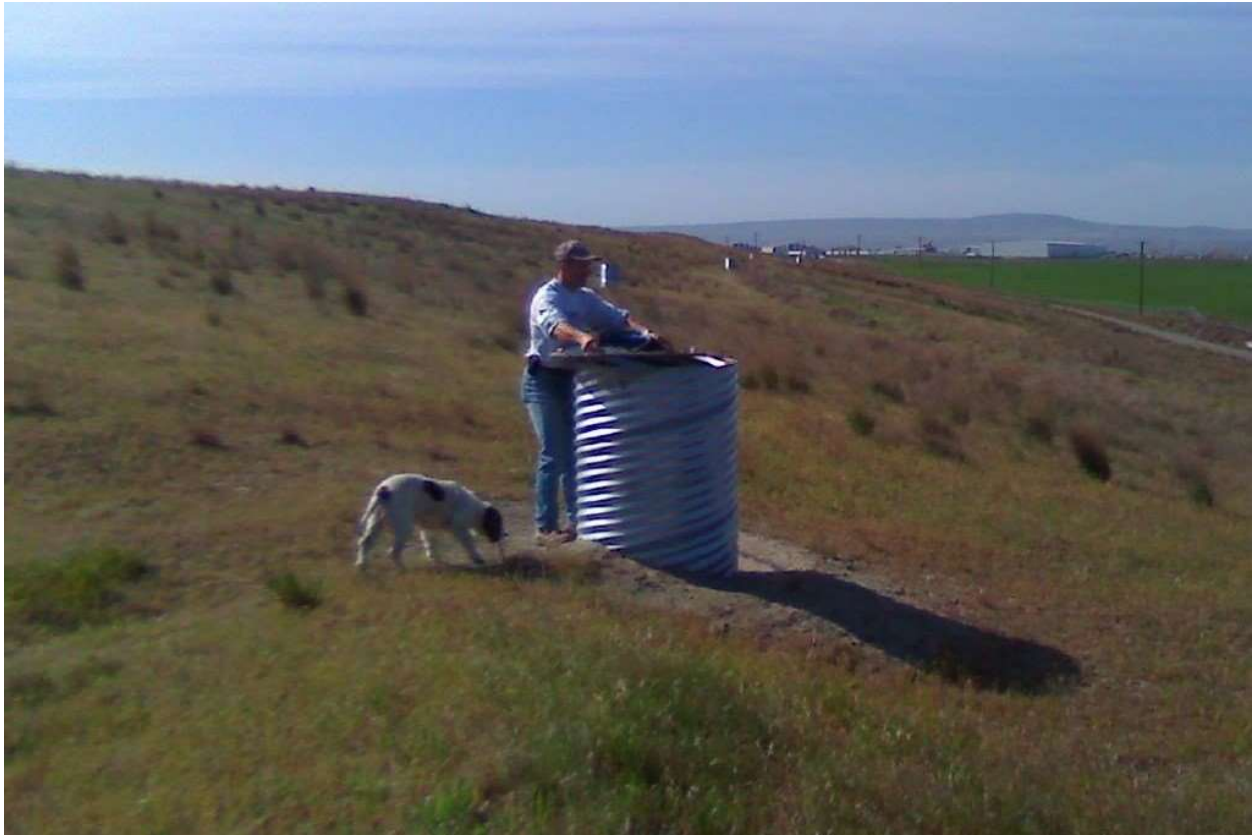
Photo of portion of MSW Landfill cover in 2010

The topography of the land above the MSW remains virtually identical to its topography when the cover was installed. As the photos from 2010, and 2019 (attached in Exhibit 8) show, there are no areas of differential settlement in the MSW. Given that differential settlement can, when extreme, damage or compromise the cover, its absence supports the opposite inference: the cover is experiencing no strain since there is no observable differential settlement after 17 years of cap service.

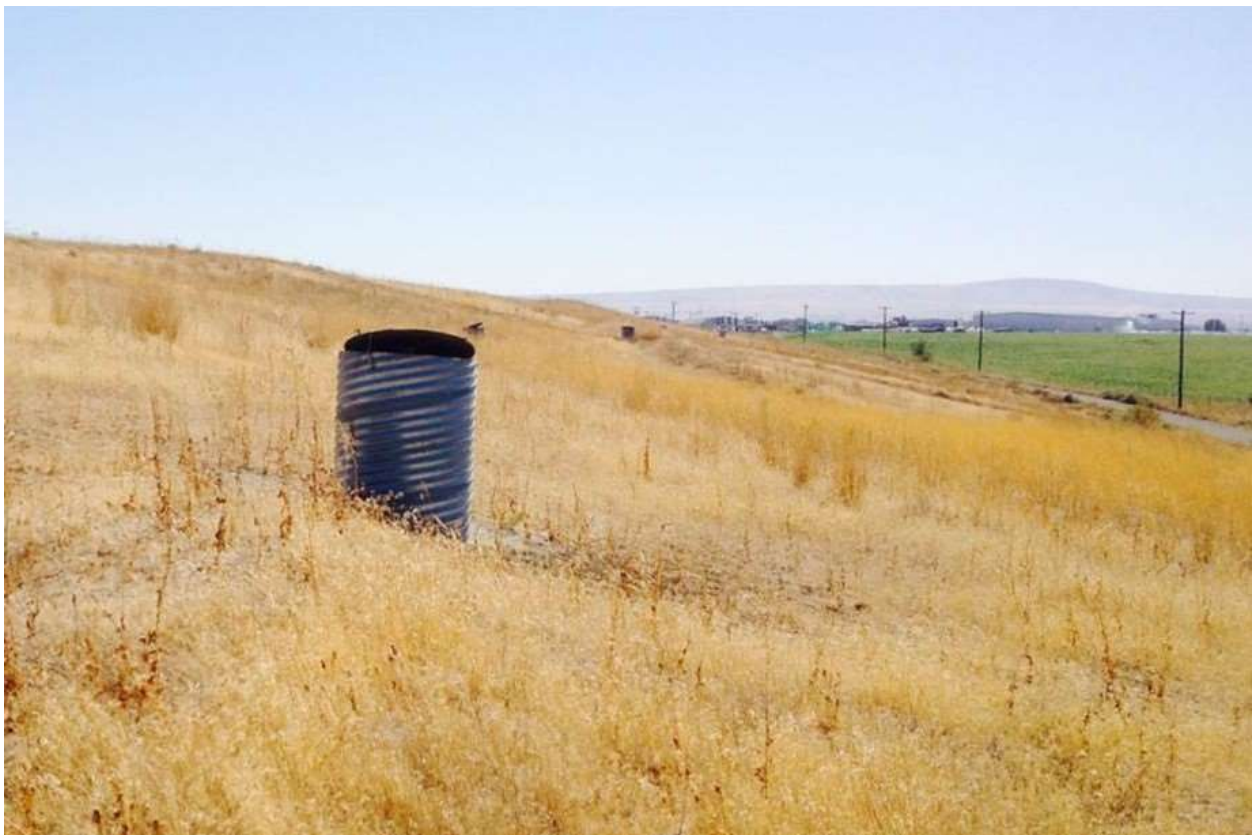
Photo of same portion of MSW Landfill cover in 2019

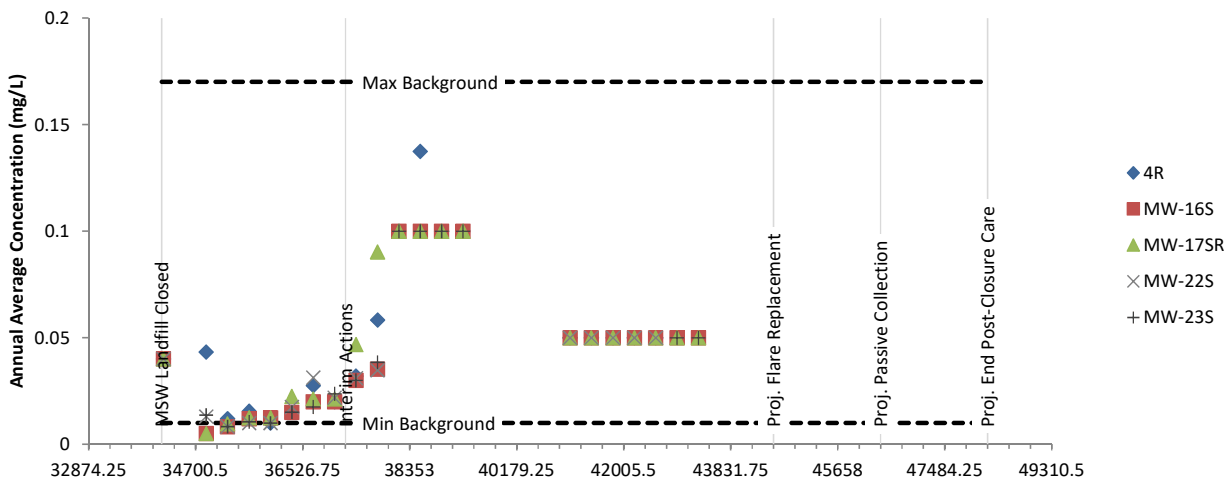
### Ammonia in Groundwater

Groundwater conditions downgradient of the landfill have been within the natural variability of the aquifer. The maximum background concentrations for total dissolved solids (salts), total organic carbon (non-toxic decomposition byproducts), and ammonia reflect land use upgradient. If groundwater downgradient had higher concentrations than the maximum background concentrations, or increasing trends, it would indicate a potential source of leachate from the landfill. Thus, there have been no leachate impacts from the MSW landfill historically. The risk of leachate production in the future is lower than in the past due to aging waste and excellent cover system performance keeping water out of the waste, yet another consistent marker of the efficacy of the present cover. We expect no future leachate impacts from the MSW landfill.

These results are shown in the collection of figures at Exhibit 9.
