## **Ennis Creek & Estuary Restoration Conceptual Plan: A Synopsis of the Ennis Technical Team's Planning Efforts**

# Ennis Creek and Estuary Restoration (Rayonier Mill Site)

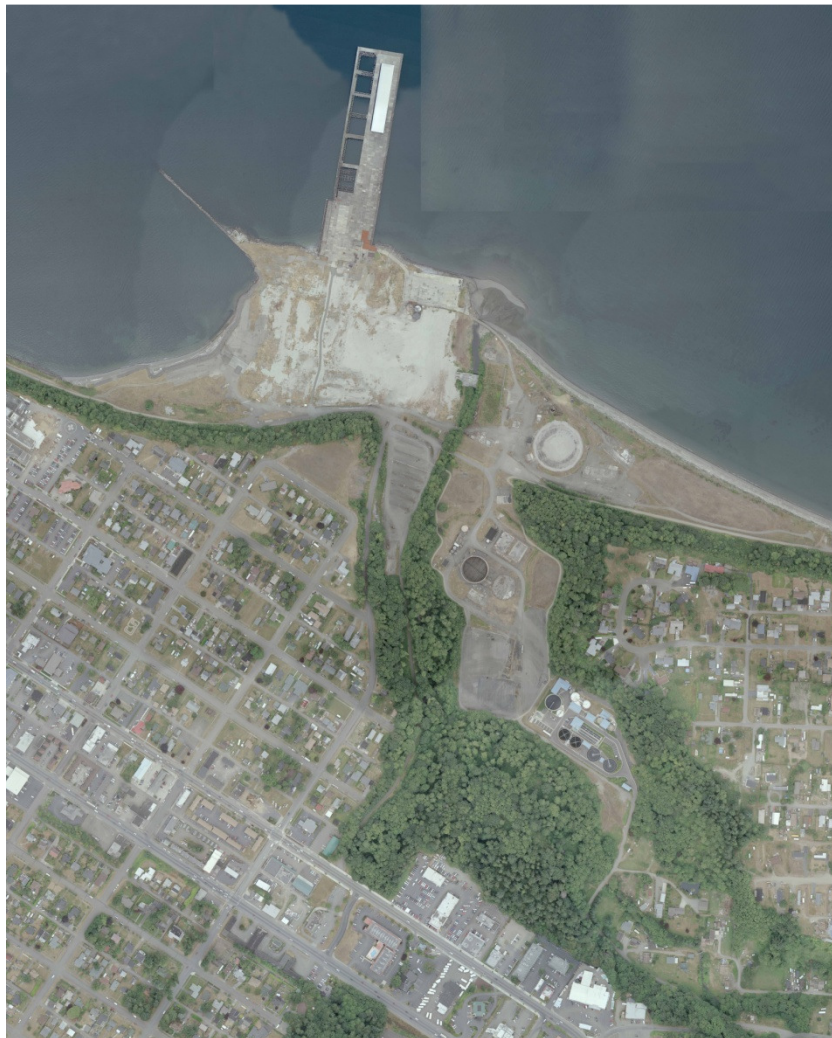
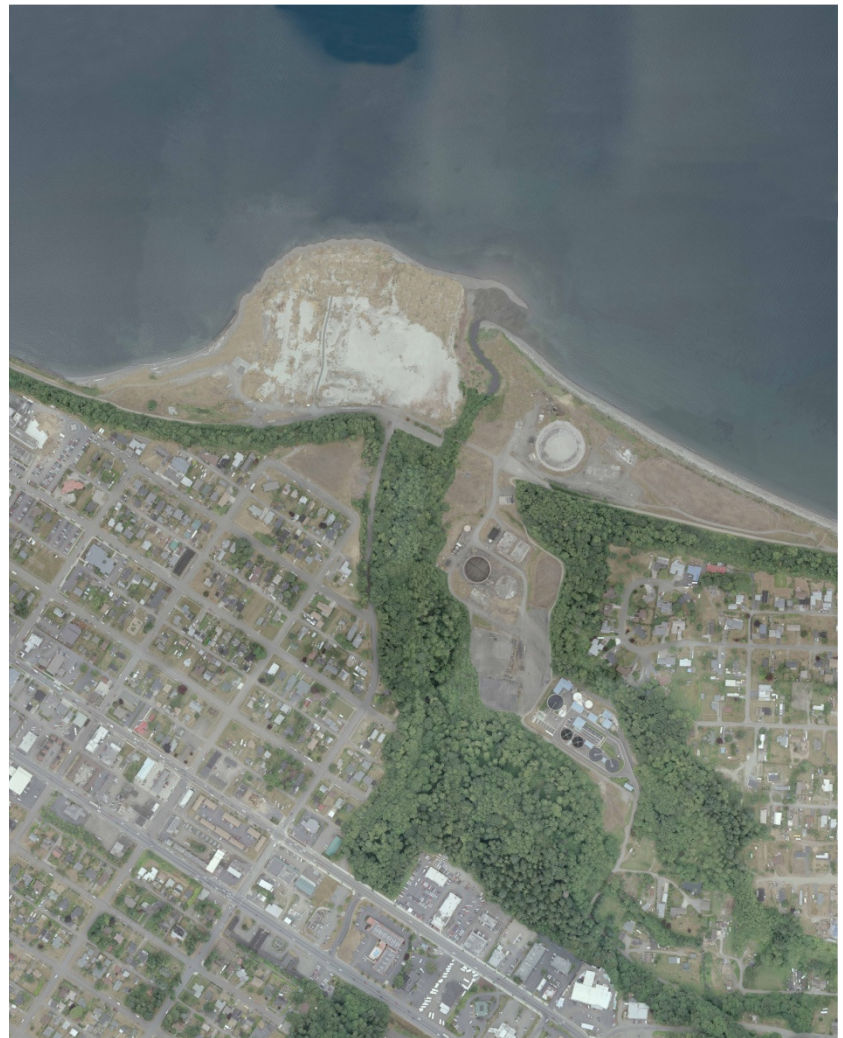
Figure 3. Depiction of Ennis Creek and Estuary pre-restoration (left) and post-restoration (right) (graphics by Randall McCoy).
