Rich Passage Estates Homeowners' Association
PO Box 11683
Bainbridge Island, WA 98110

Updated permits issued in July 2019 incorporate lessons learned from the net pen failure

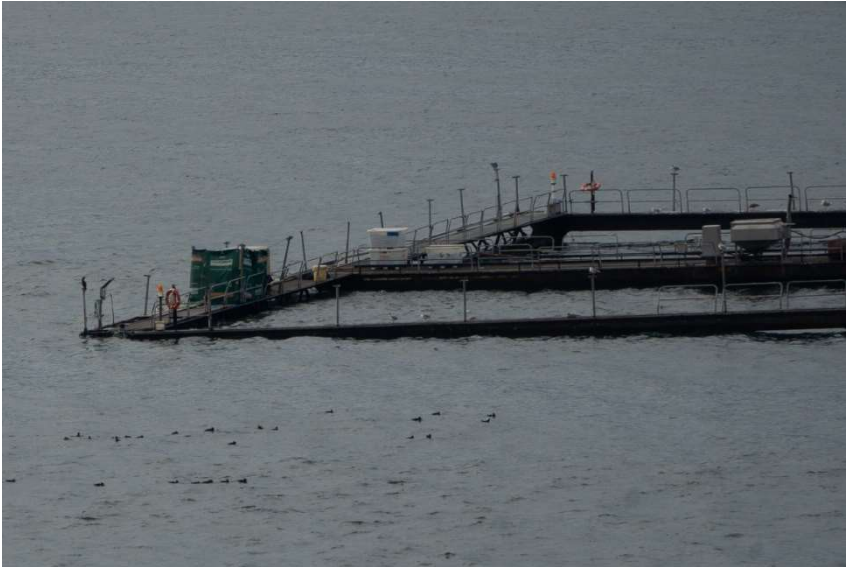
On October 15th we observed the pens in Orchard Rocks south much lower than usual.

October 16, 2019 photo shows submerged corner of pen with what appears to be a generator covered with noise-abatement material and mort containers nearby

We are aware that the cause was a leaky pontoon that required days of work to re-engineer the net pen structure.

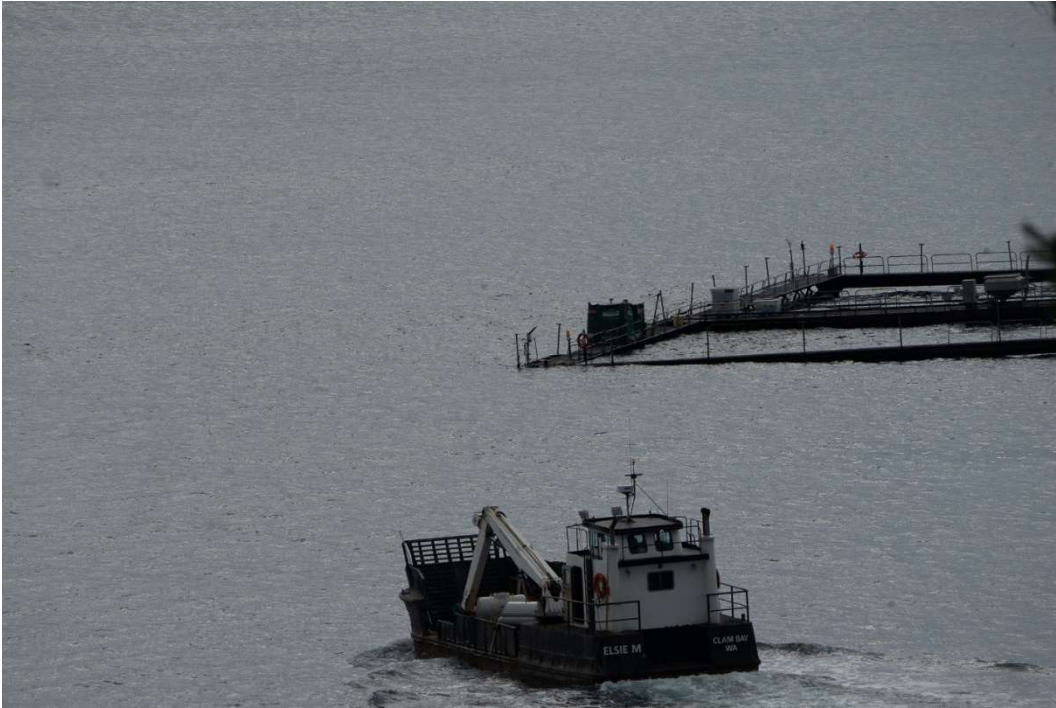
Photo taken about one hour before high tide on October 16, 2019

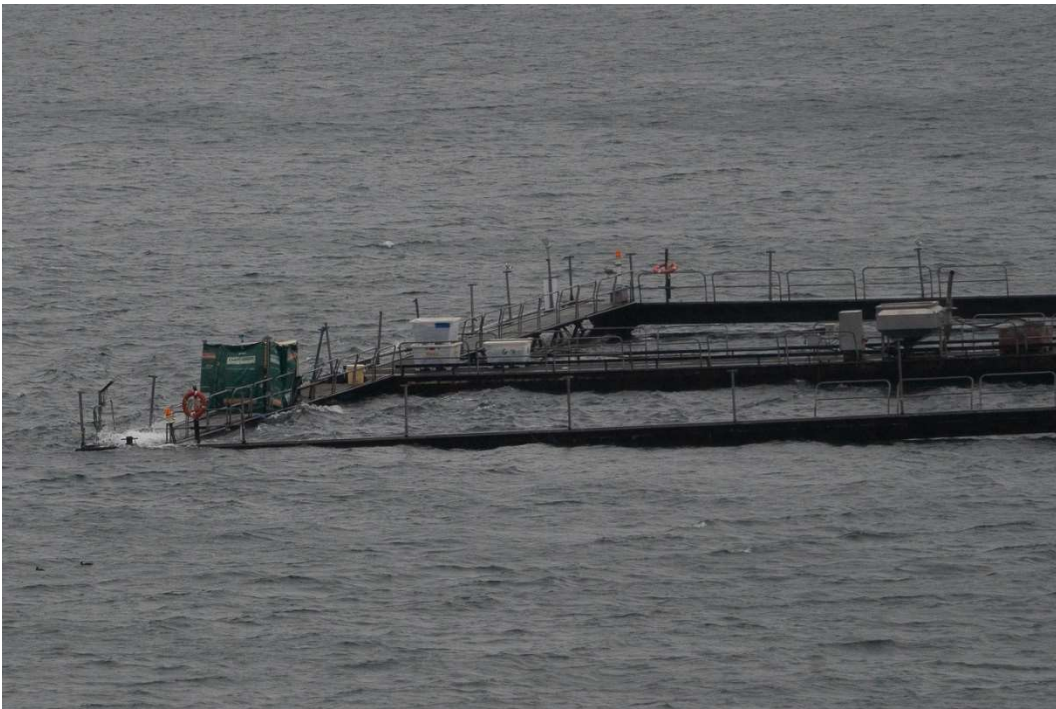
October 17, 2019

A generator appears to have been moved and noise abatement material removed to the walkway.

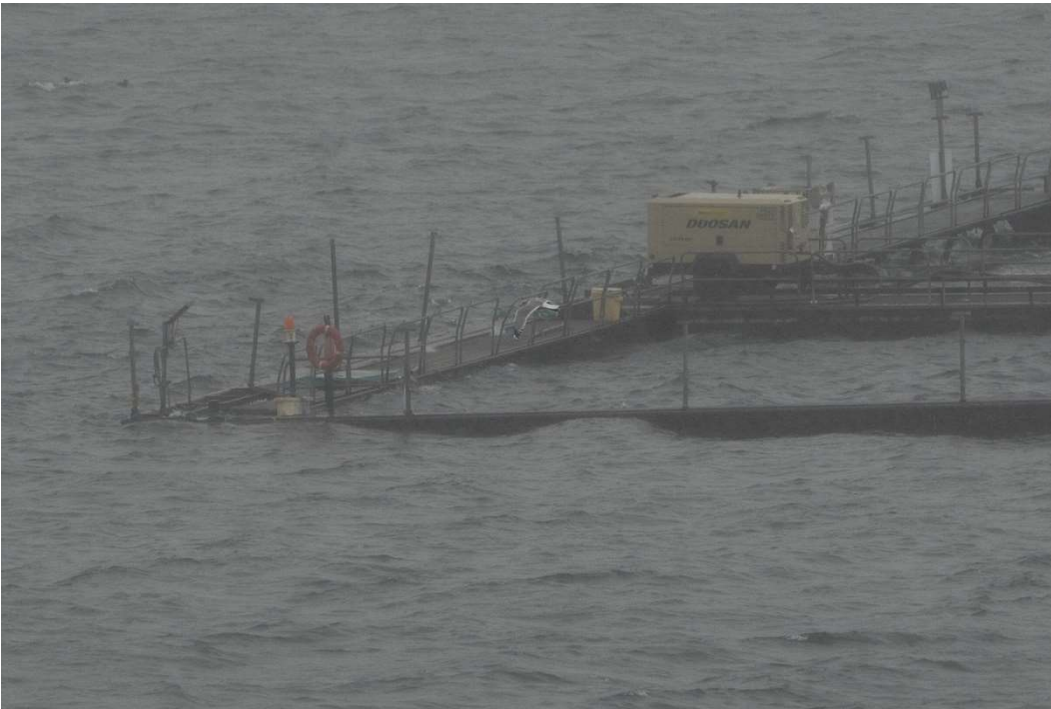
October 19, 2019

Photo of what appears to be noise abatement material floating in the pen

We observed what looked like noise abatement material floating in the submerged pen on 10/19/19. Later that same day, a neighbor emailed that what looked like something from the fish farm had washed up on the shore of nearby Fort Ward Park. We reported this to an employee on the dock who said he didn't have any contact information other than "Ronnie" on the Clam Bay side. The information was reported to farm management by us and, to our knowledge, debris retrieved the next day.

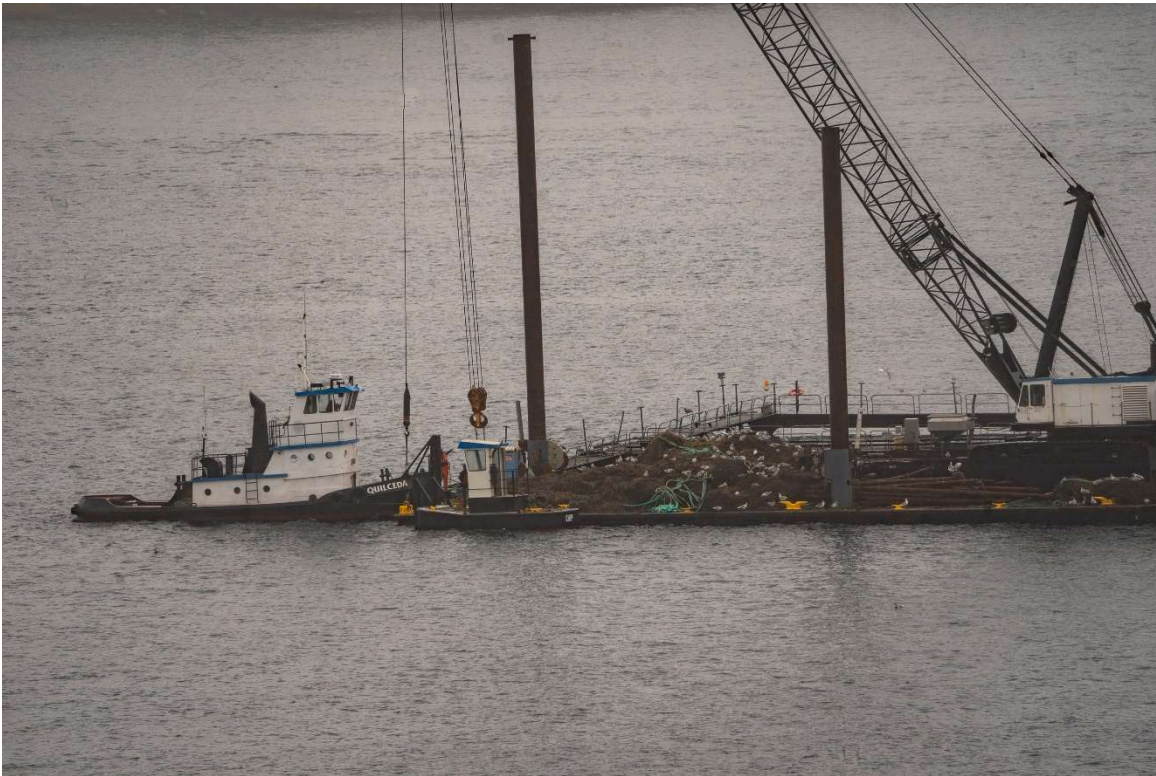
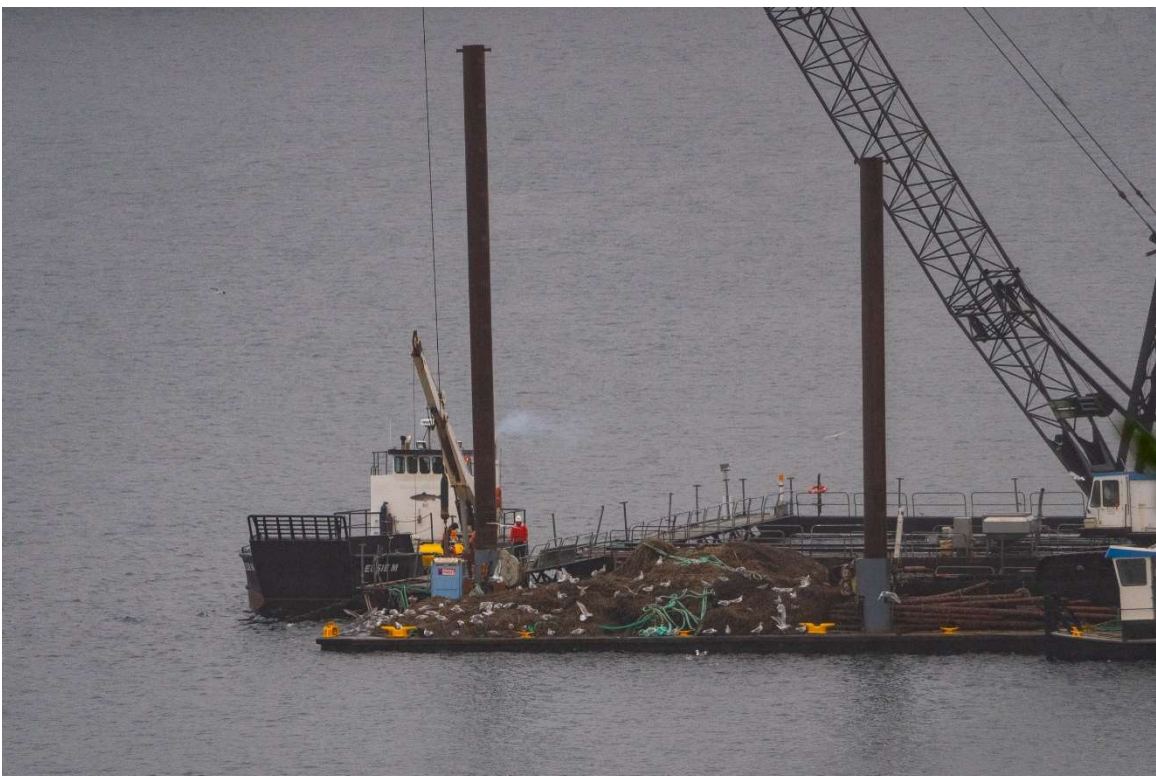
Media accounts minimized the failure by referring to a “dime-sized” hole in a pontoon, but the facts remain. The farm did not report a sinking net pen for days and did not do so until alerted by the Deputy Director of WDFW who, coincidentally, was visiting nearby and called the Coast Guard to secure the perimeter.

Needed repairs to the pen spanned over several days: Two photos taken on October 22, 2019

We are aware that updated NPDES guidance is in place to address this type of failure.

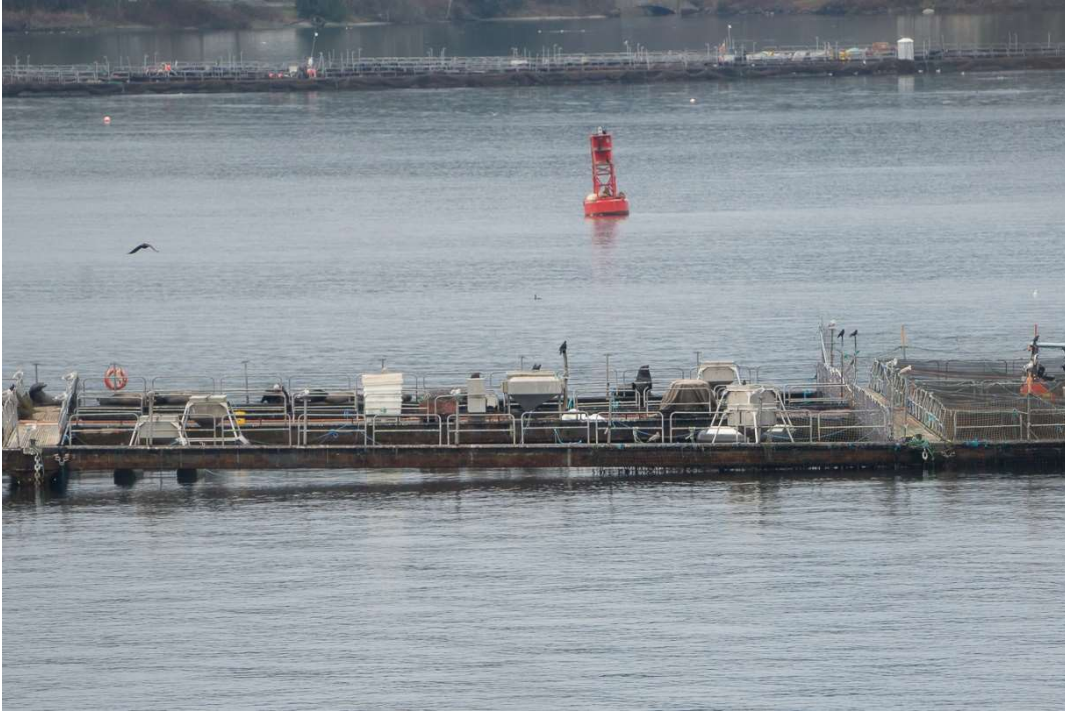
December 8, 2019 East side of Orchard Rocks South

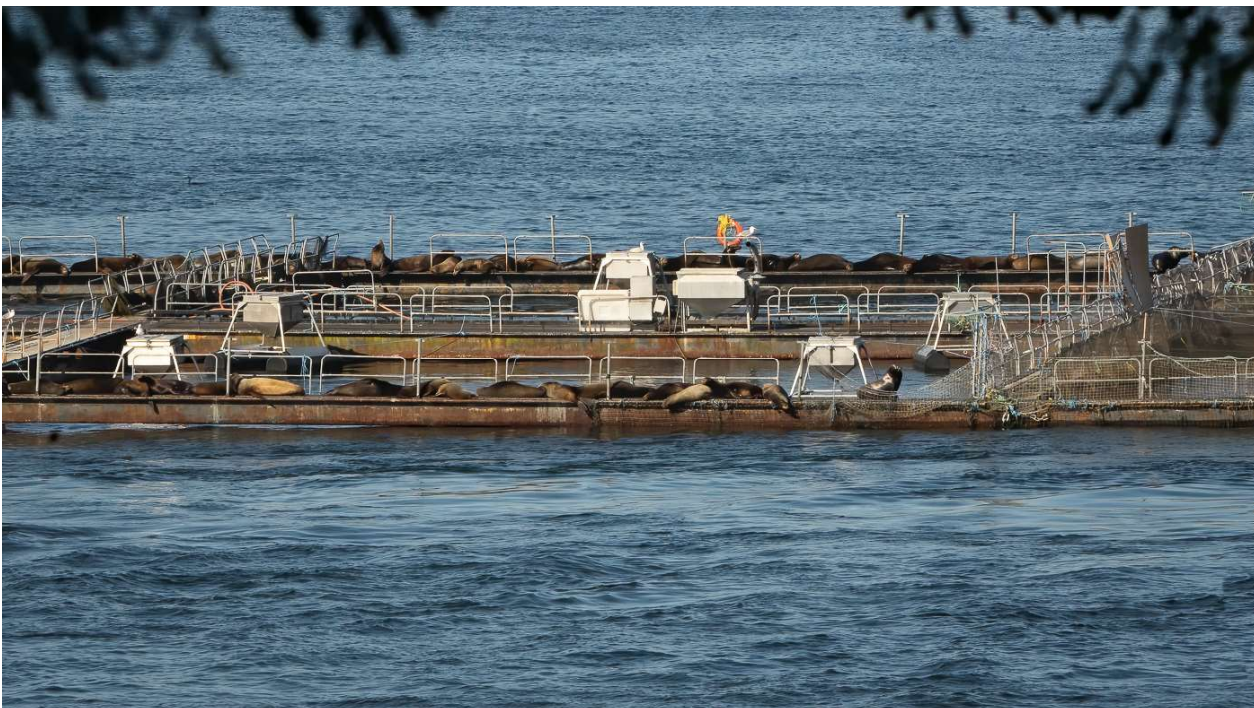
May 5, 2020 East side of Orchard Rocks South (pens to the right of the marine mammals contain fish)

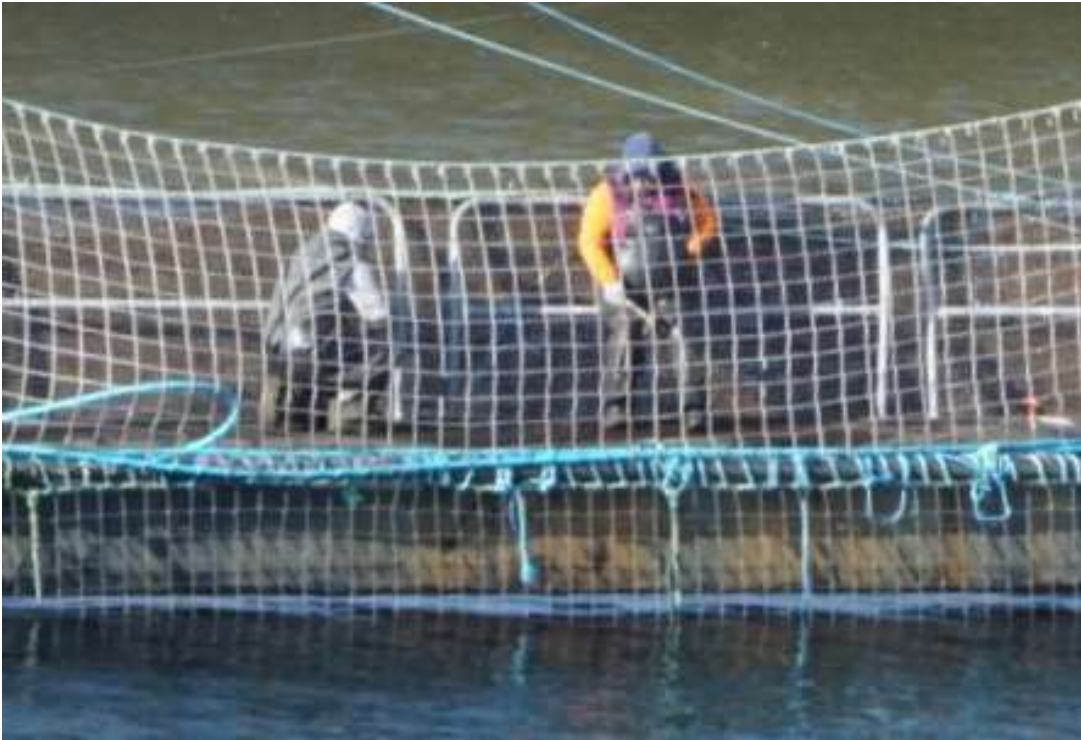
Photo of workers hammering rust off the Orchard Rocks facility 2018

In addition to the noise complaints with the city, Ecology was contacted as **no containment measures were observed. For all incidents related to noise and pollution, the public has to provide evidence that an infraction has taken place. Cooke is not required, in these instances, to provide evidence that their procedures are actually being followed and is allowed to continue on their good word. We urge you to employ the same type of proof from the net pen operator that you require from the public to ensure that containment measures are actually in place like photos or video evidence.**

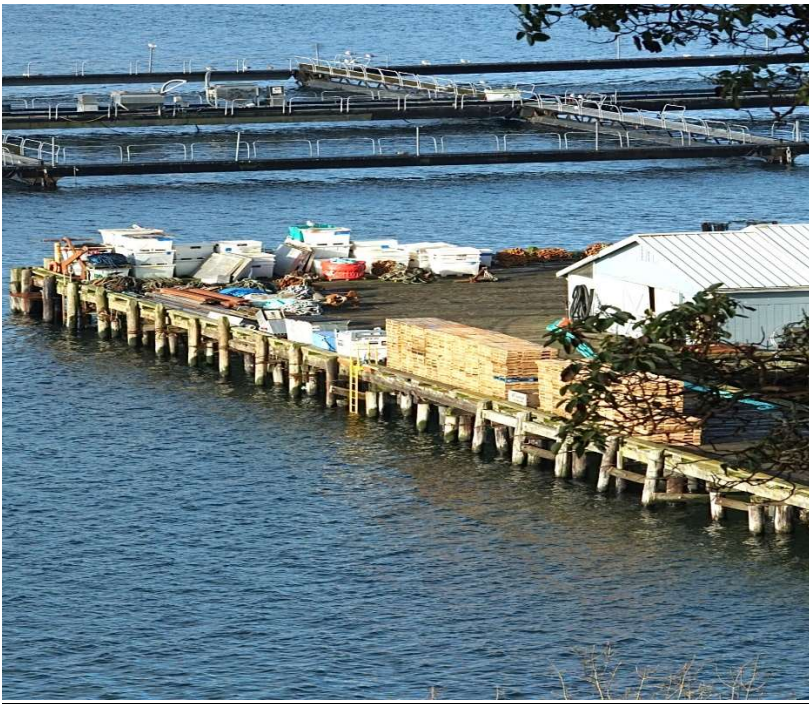
February 2, 2020 shows an over accumulation of pallets

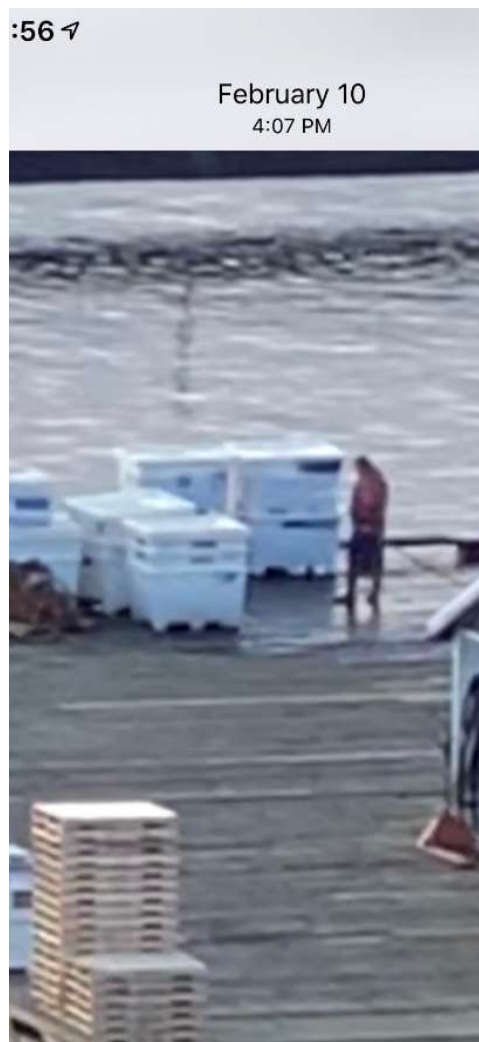
We are encouraged that the intentional pressure washing of equipment that resulted in fines had ended, but were surprised to document twenty minutes of washing of the dock in February of 2020 which included the outsides of containers that held dead fish or morts that were being stored on the dock. We understand that morts are supposed to be in totes lined with plastic and while not pressure washed per se, see no reason to wash the outside of these containers slated for transport or the dock itself.

Screen shot from video taken February 10, 2020

Any washing of containers that hold dead fish should be prohibited to prevent discharges to State waters.

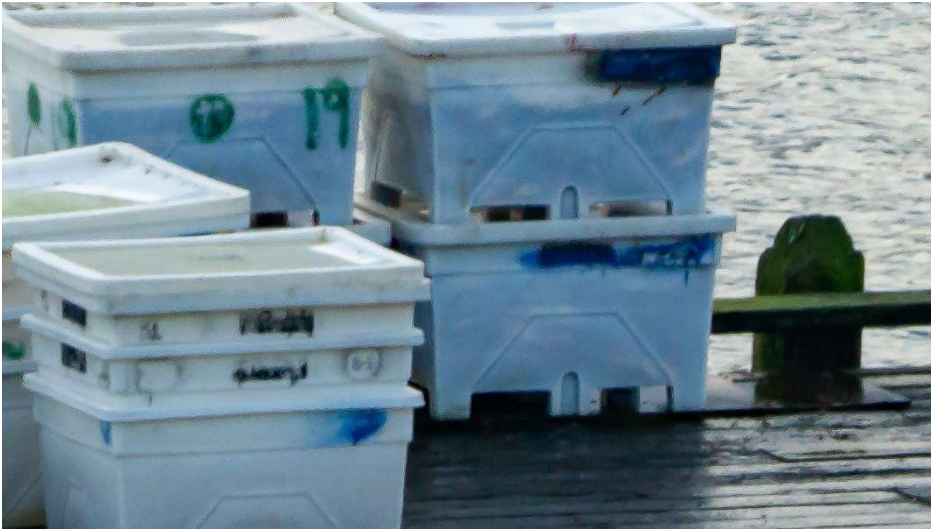
The four totes in the back contain dead fish shown in the close-up shot February 10, 2020

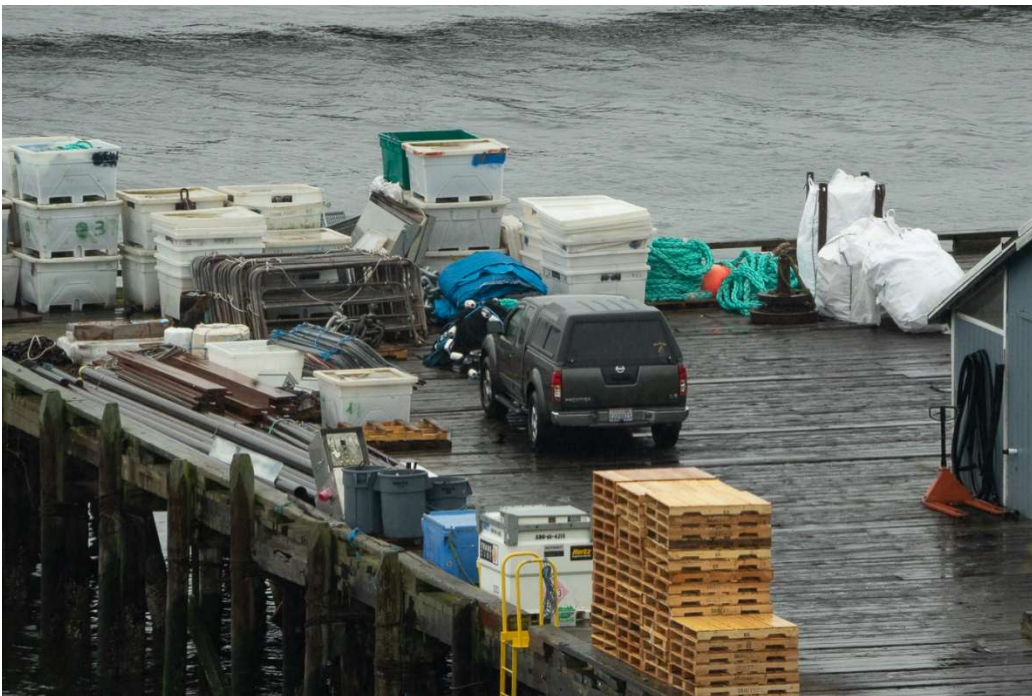
May 25, 2020

Additionally, the dock is often traveled by eighteen wheelers, delivery drivers and workers in their personal vehicles who may not wish to walk the length of the dock from the parking area.

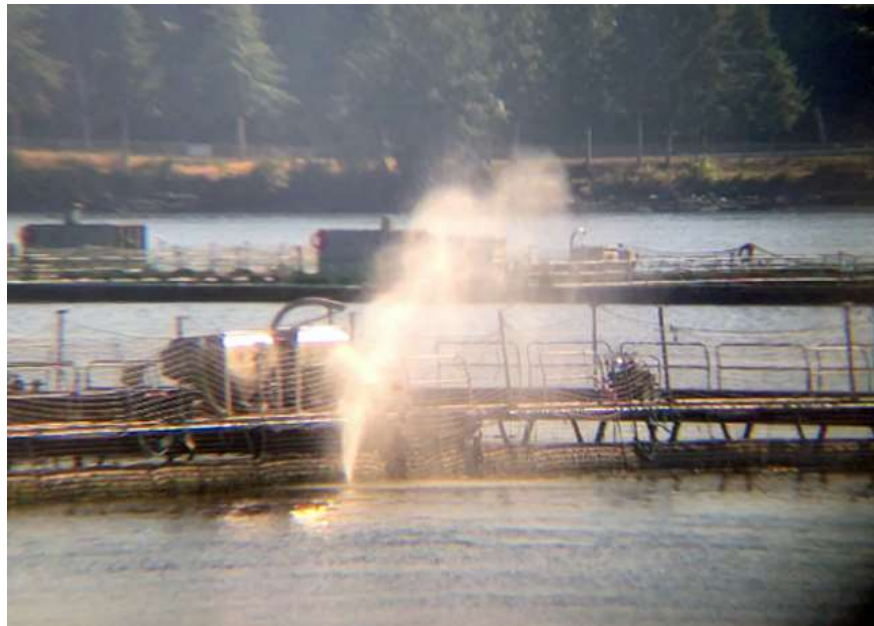
Like thousands of others, we are well aware of the dangers of poor net-maintenance as demonstrated by the failures and mismanagement at Cypress Island. Last summer, at the end of the growing cycle, instead of predator nets being removed from the Fort Ward Pens here on Bainbridge, nets were cleaned by divers using power washers...the spray shooting many feet into the air.

We are asking that the net cleaning procedures at the end of the growing cycle be strictly adhered to in the future. The net pen operator should be in full compliance with the NPDES guidelines. Less than optimal cleaning such as cleaning with hand-held washers, should not be conditioned on the farm’s desire to stock pens quickly at the end of a growing cycle when more rigorous net cleaning at a net cleaning facility is required as a condition of the permit.

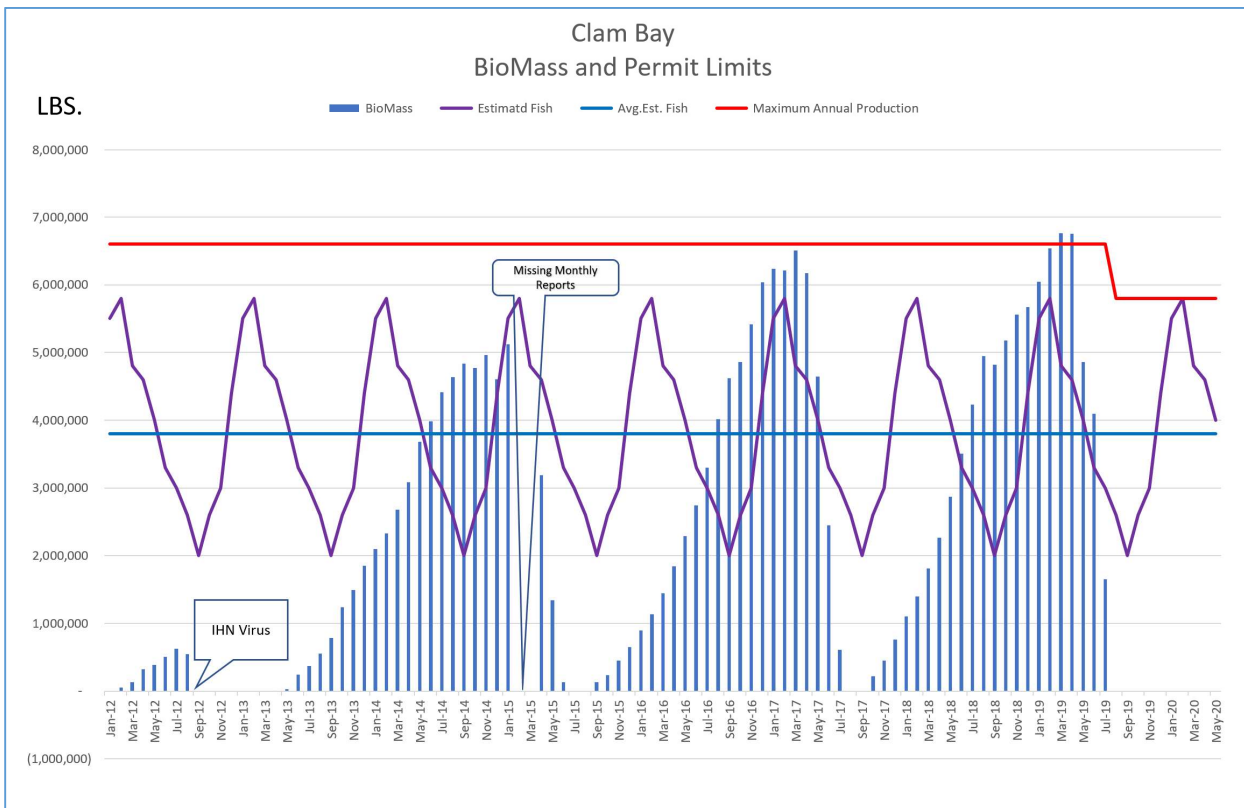
Clam Bay is reaching or exceeding the Production Maximum during the production cycles. Can Ecology explain why?

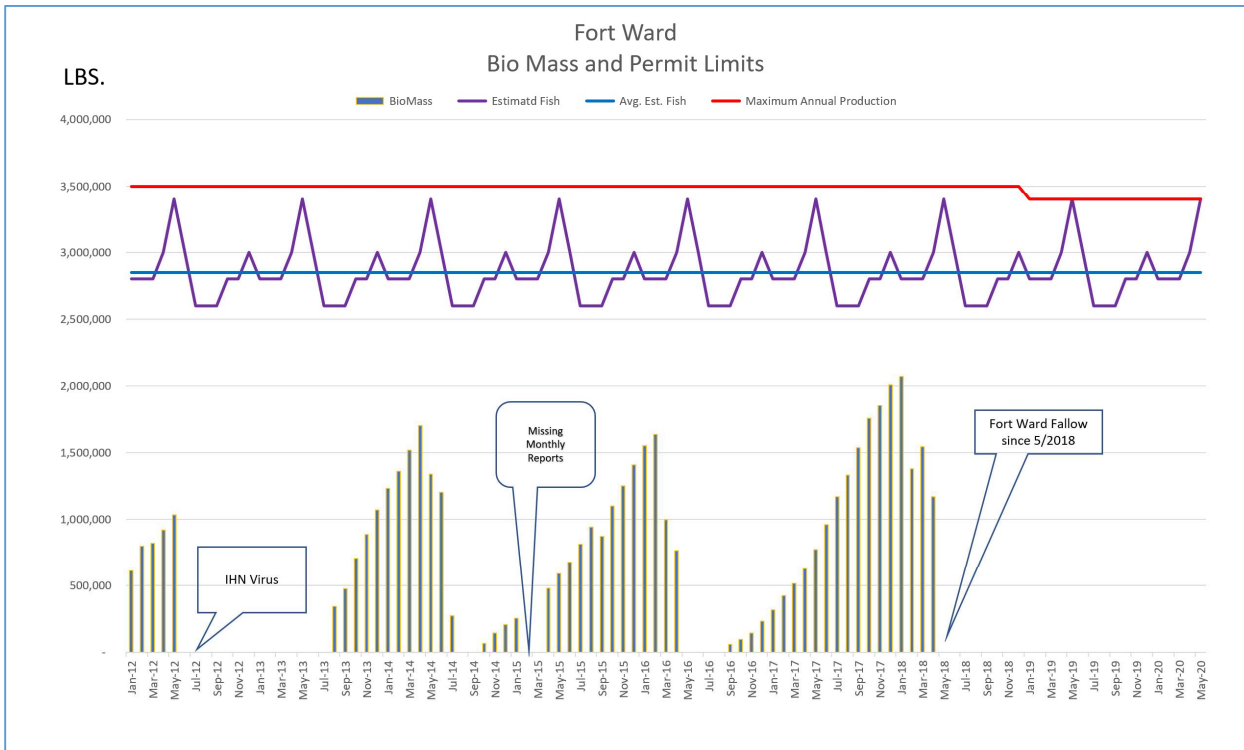
Fort Ward is operating significantly under due to long fallow periods for some unknown reason. Can Ecology explain why? Note: Fort Ward was denied a Fish Transfer Permit at the end of their last cycle in 2018.

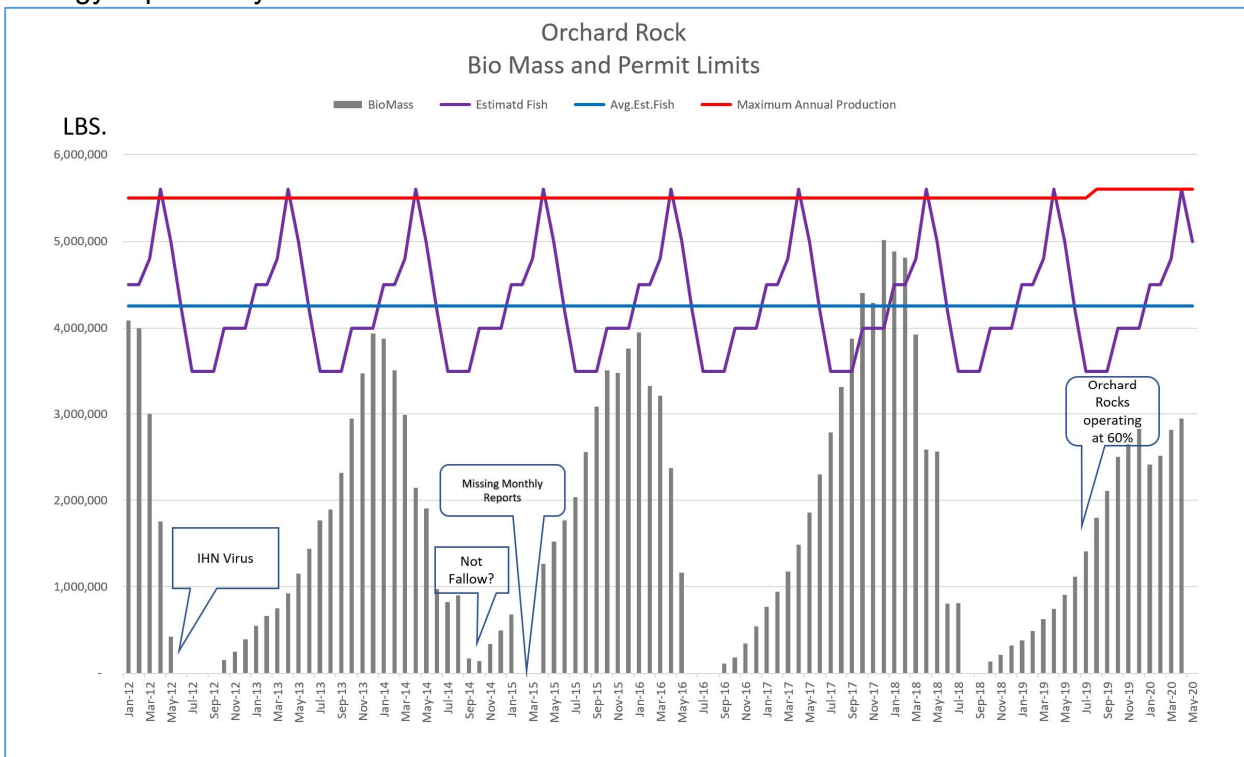
Orchard Rock appears to be within parameters currently operating at 60% capacity (12 of 20 pens) Orchard Rock appears to not have been allowed to stay fallow for two months in the 2014 production cycle. Can Ecology explain why?

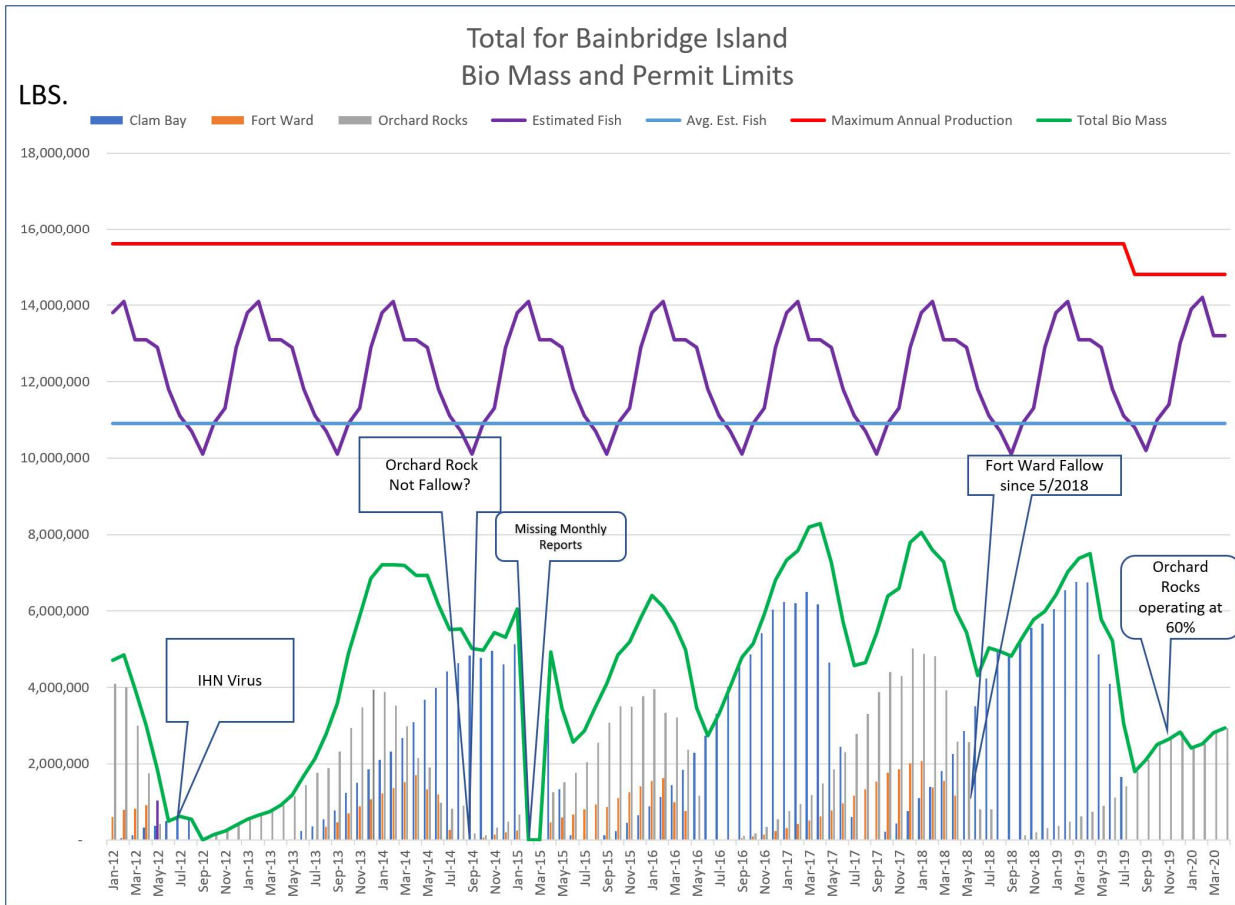
If all sites were operating at their permit maximum level with their production cycles aligned in Rich Passage, there would be significant increases in biomass, regular and medicated feed, and fish waste above the historical levels and this could potentially lead to in a net loss in water quality.

Ecology needs to take into consideration a worst-case scenario.

We recommend that production maximums be reduced to align with historical levels and an annual maximum to control for a worst-case scenario.

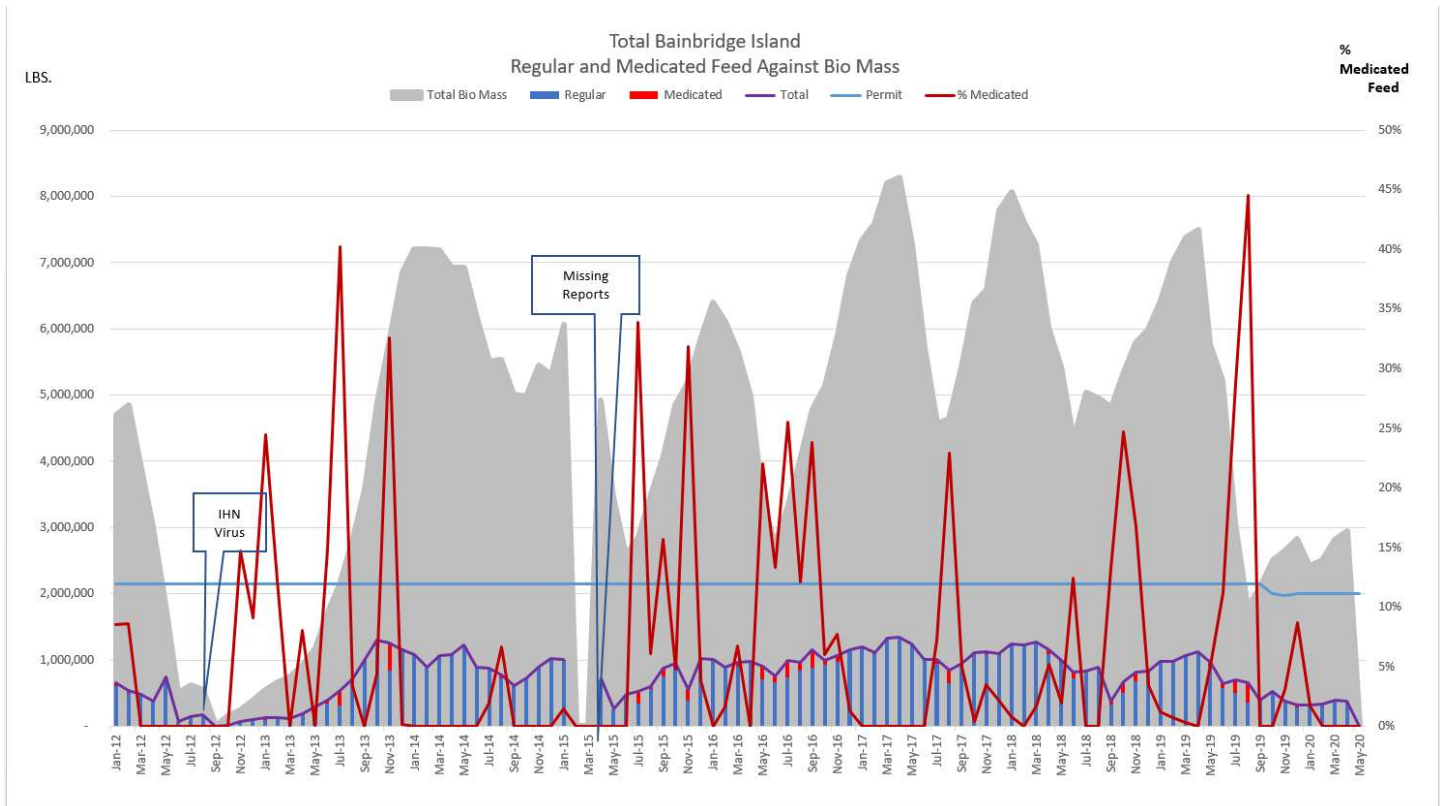
For our purposes the analysis of feed, both regular and medicated, is shown in relation to biomass for 2012 until present using data available from the PARIS website for the Rich Passage net pens. In section S2.L. Antibiotic Resistance Monitoring of the current NPDES permit, Ecology is required to monitor unusually high usage levels of antibiotics by the Permittee.

The graph below appears to show consistent peaks in the use of medicated feed use. What monitoring is performed by Ecology?

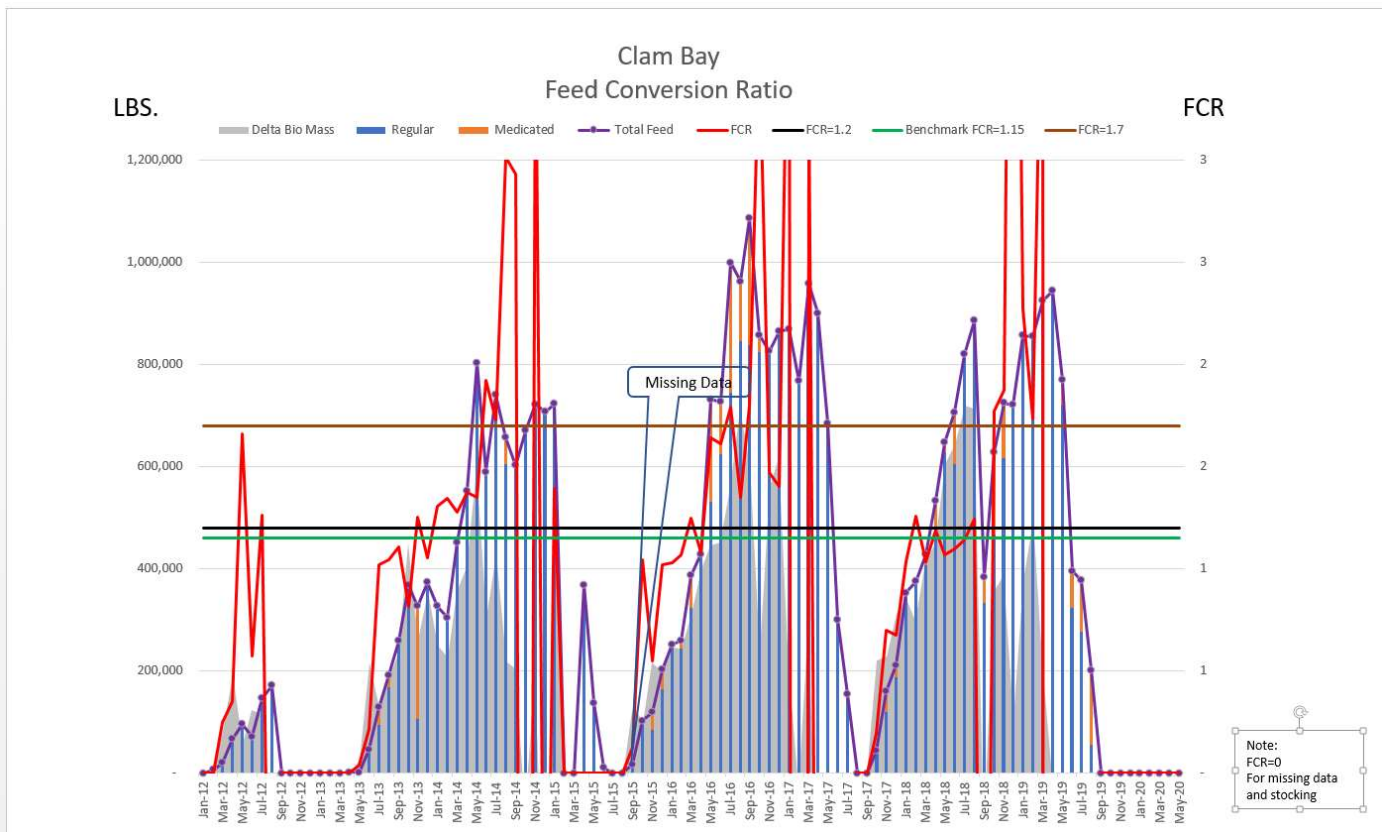
Not being fish scientists, we tried to view the simple relationship between Total Feed and delta Bio Mass for each month using the limited data available to the public. Using Clam Bay as an example, below, there would appear to significantly more variability than was described in Ecology's response during the last comment period. The Feed Conversion Ratio is critical to determining and controlling pollution from uneaten food and fish waste.

We recommend that a model for calculation and visualization be developed and additional data be added to the DMR data available to the public. These would include but not be limited to:

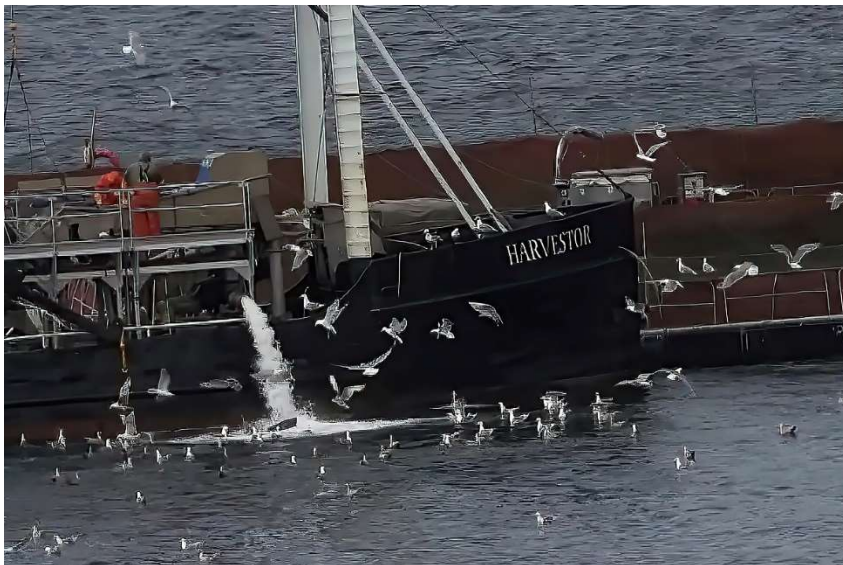
We're wondering then, **what** attracts large numbers of sea birds and marine mammals to the discharge from the Harvester pictured below during the harvesting operation? Has the discharge ever been tested? What is the potential impact from that outflow on water quality?

Harvesting operation Orchard Rocks net pen May 15, 2020
