Subject: Comments: Draft Permit MN0021440 for Spring Grove Wastewater Treatment Plant

NEC/Dayforce Remediation of TCE contamination, MPCA ID SA0000168

# PHOTOGRAPHS: Comments on Draft NPDES Permit, Spring Grove Wastewater Treatment Facility MN0021440: Spring Grove, Minnesota

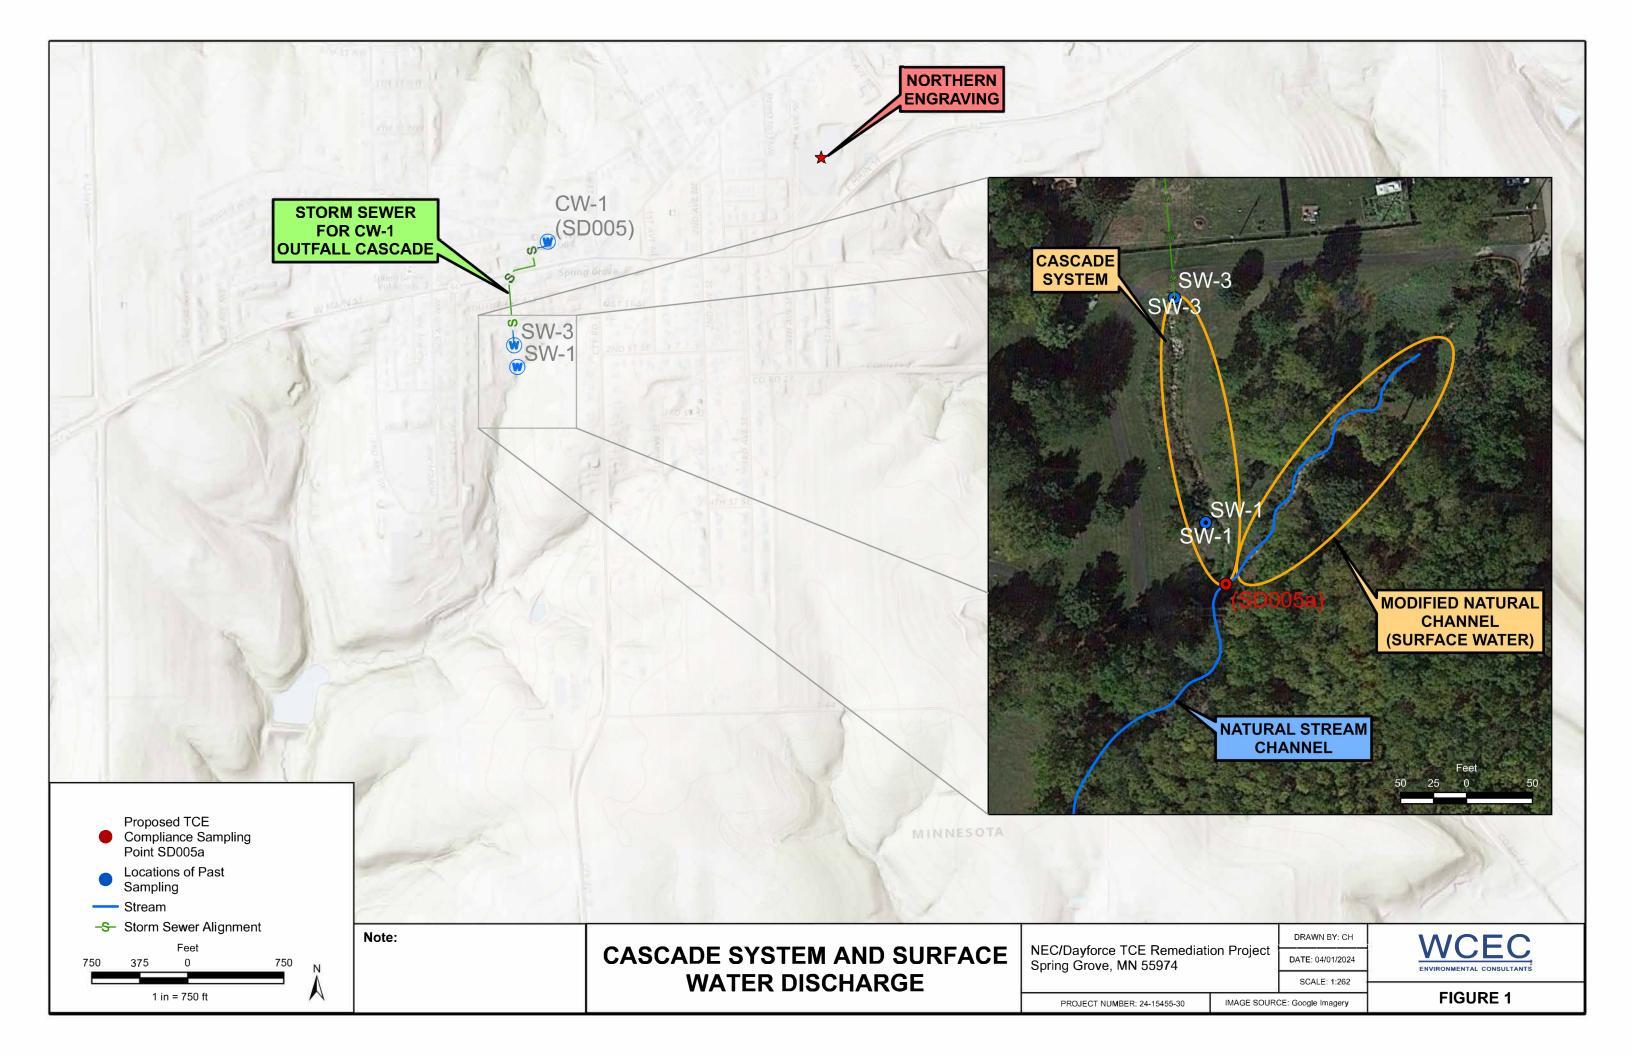
1. Figure 1

Attached Figure 1 illustrates key features of the NEC/Dayforce-designed remedial pumping of CW-1, from supply well through the storm sewer components mentioned, and discharge via pipe to the treatment works (cascade system) prior to its discharge into surface water.

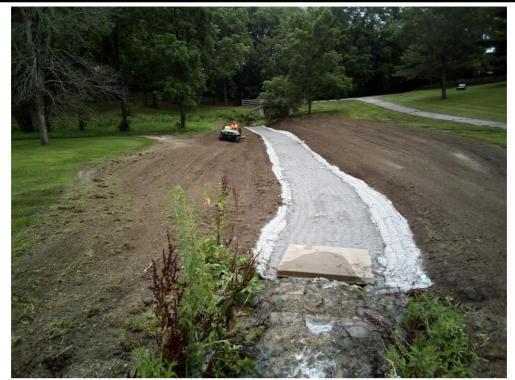
PHOTO NO. 1: View from storm sewer outfall (SW-3) facing south during cascade channel construction in 2020. The surface water (un-named stream) is beyond the far end of the flexamat-lined flow channel, past the trees and upstream of the bridge in the background.

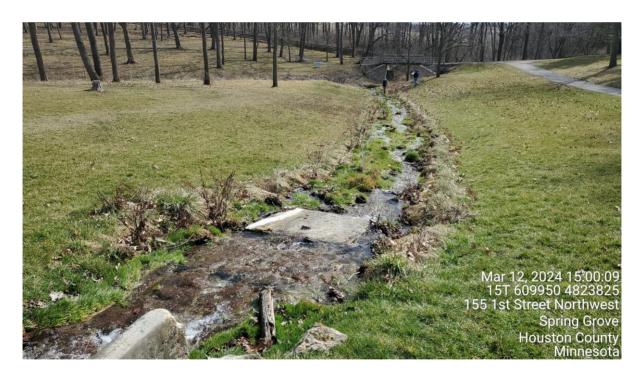
PHOTO NO. 2: View of the cascade channel in 2024, photo was taken from near SW-3 and facing downslope along the aeration cascade system.

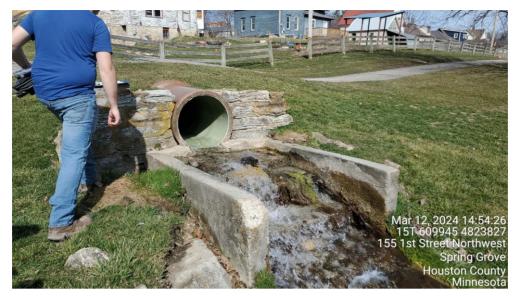
PHOTO NO. 3: View of water from pumping CW-1 entering the cascade aeration channel at sampling location SW-3.

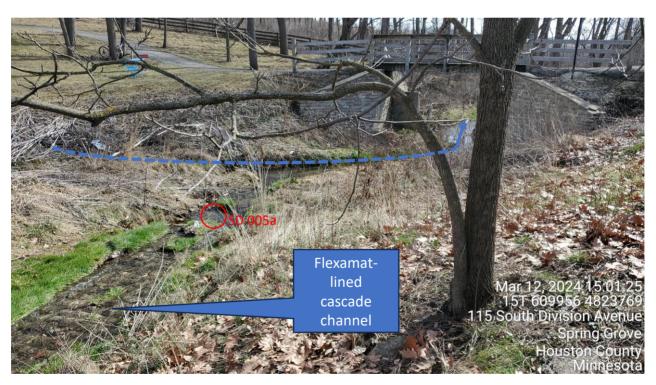
PHOTO NO. 4: Photo facing south, taken at base of cascade aeration channel just before it discharges to the natural stream channel (dashed line) which would flow from left to right in this picture. The proposed sampling station SD 005a is depicted. This photo was taken just upstream of a recreational trail bridge crossing the channel.

The location of this additional sampling station is at the end of the treatment cascade system channel, just upstream of the point where it discharges into the natural, intermittent stream channel. The coordinates of this station would be (UTM NAD83) as follows:

X: 609965.470386 Y: 4823767.759141

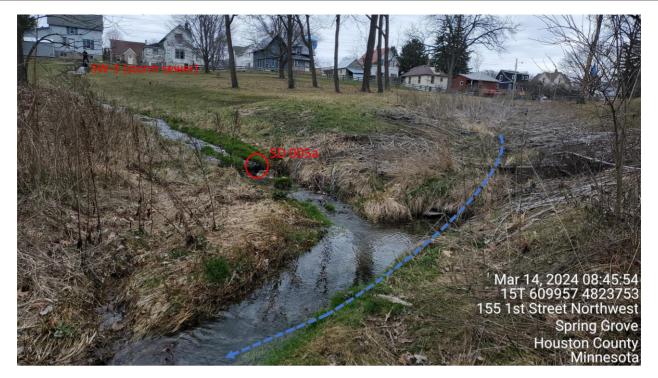
PHOTO NO. 5: Alternate view of the cascade aeration system discharge into the un-named stream channel, tributary to North Bear Creek. The natural intermittent stream would flow down from the background, toward the left of this photo. Station SD 005a is depicted.

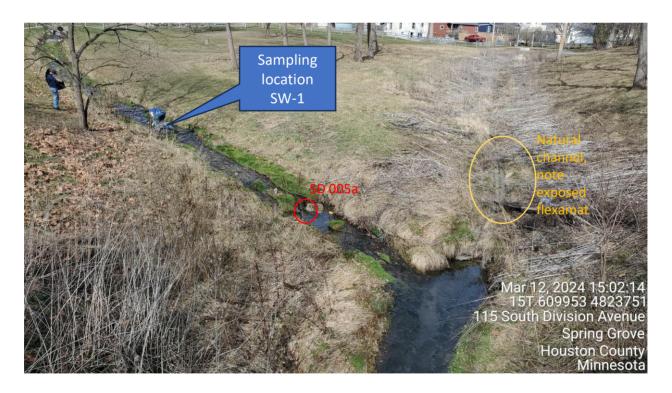
PHOTO NO. 6: View of station SD 005a taken from the trail bridge. The storm sewer outlet is visible at the far upper left of photo, the sampling team is collecting a sample from existing cascade system sample location SW-1.

Note the natural stream channel was protected with Flexamat in the past.

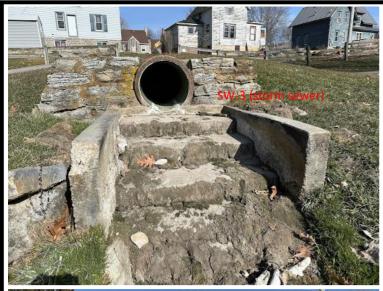
PHOTO NO. 7, top: Inspection of the CW-1 storm sewer outfall and cascade aeration system was conducted February 27, 2024 during a period when CW-1 was not pumping due to failure of the motor and pump stack.

The constructed channel resembles a stream when CW-1 is pumping. It is, however, a purpose-built treatment structure conveying water to the unnamed creek where the discharge to surface water occurs. Recently, CW-1 experienced a catastrophic pump and motor failure, and pumping did not occur from February 20 to February 29, 2024. This provided an opportunity to inspect the cascade system, which was totally "dry," and the unnamed creek bed was dry to a point approximately 0.2 miles downstream from the cascade system discharge. Water could be seen entering the intermittent stream channel from tile lines and snow melt, so the channel had a small flow once it reached station SD004 by the wastewater treatment plant. The photographs provided with these comments help to illustrate this.

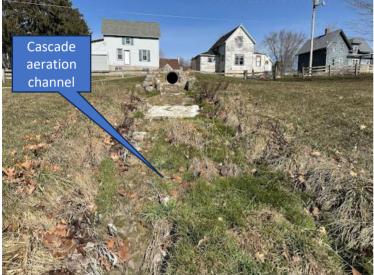
PHOTO NO. 8, middle: Without flow coming from CW-1, there was no flow exiting the storm sewer and the cascade aeration channel dried up.

The channel was in good condition.

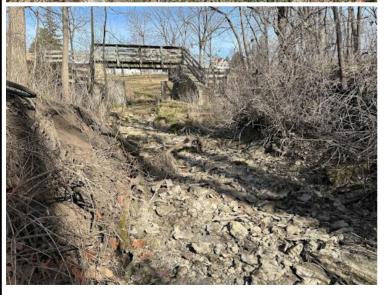
PHOTO NO. 9, bottom: Photo view faces upstream from a point just downstream of the trail bridge.

Observations made along the natural stream channel indicated the stream was dry for a reach of approximately 1000 feet downstream of the bridge, at which point snow melt and small hillside seeps contributed some water to the stream channel.
