June 2026

Draft Cedar and Upper Wapsipinicon Rivers Watershed Restoration and Protection Strategies Report Update 2026

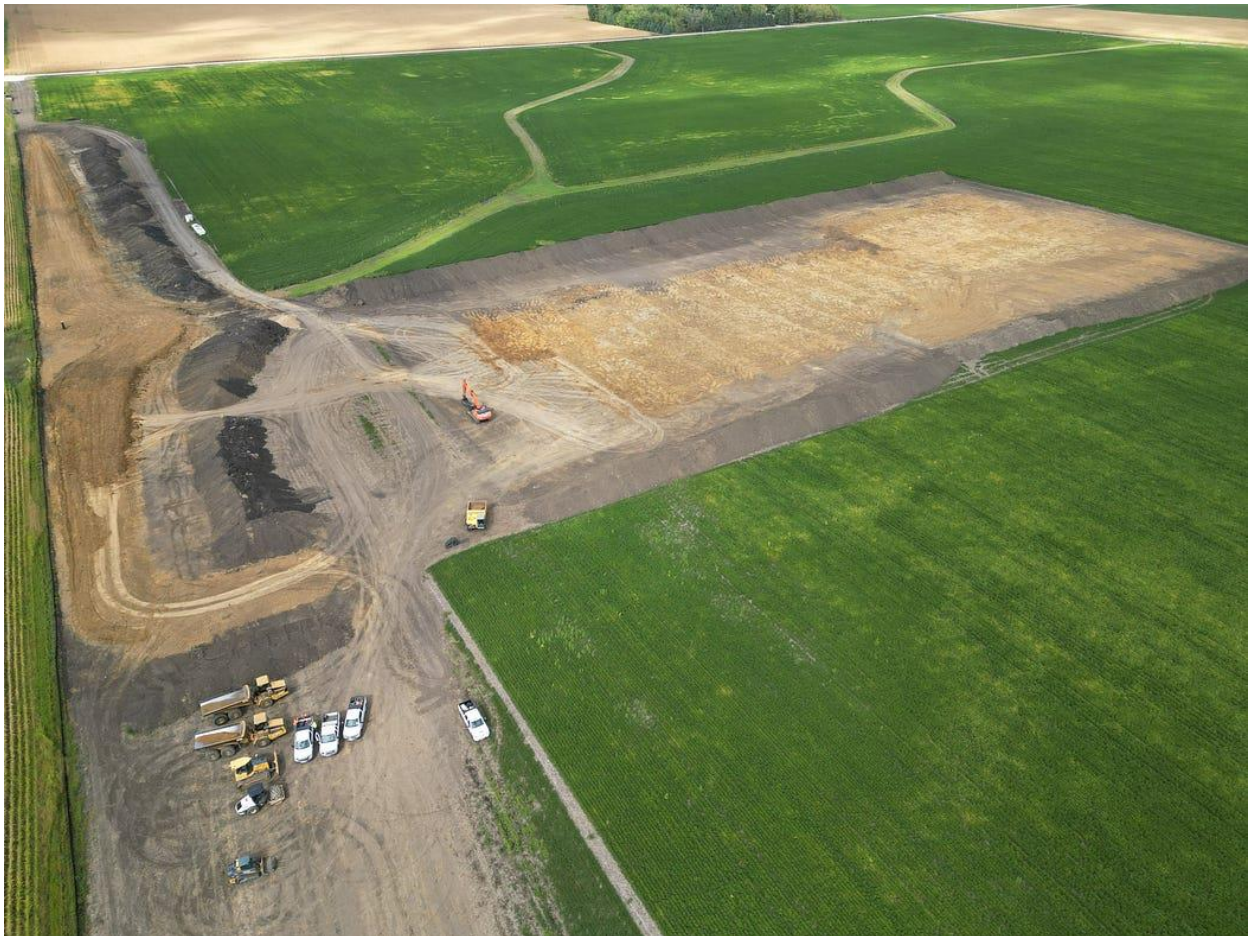
Figure 6: Sept. 7, 2023, berm being built by CRWD in Dobbins Creek.

achieving at least a 10% reduction compared with an 8% target, including completion of a major structure known as the nearly 2,000-foot Dexter 30-Dam 2 berm. Example shown in Figure 6.

The approach continued to expand in 2023 with two additional earthen berms built in the south-branch headwaters of Dobbins Creek in Red Rock Township. Spanning roughly a combined half mile and draining about 467 acres, the new berms were designed to hold back high flows during intense rain and rapid melting events and then release water more gradually, reducing risks such as overtopped roads and streambank erosion. Modeling suggests the added storage would cut peak flows at East Side Lake by about 14% during a 100-year rainfall scenario. At the same time, permanent conservation accelerated on the landscape: in 2025, Mower SWCD approved 457 acres for restoration into native prairies and wetlands through permanent easements, building on a record 407 acres the year before. Together, engineered storage and long-term restoration helped keep water on the land longer while improving habitat and reducing erosion and nutrient runoff across the watershed.

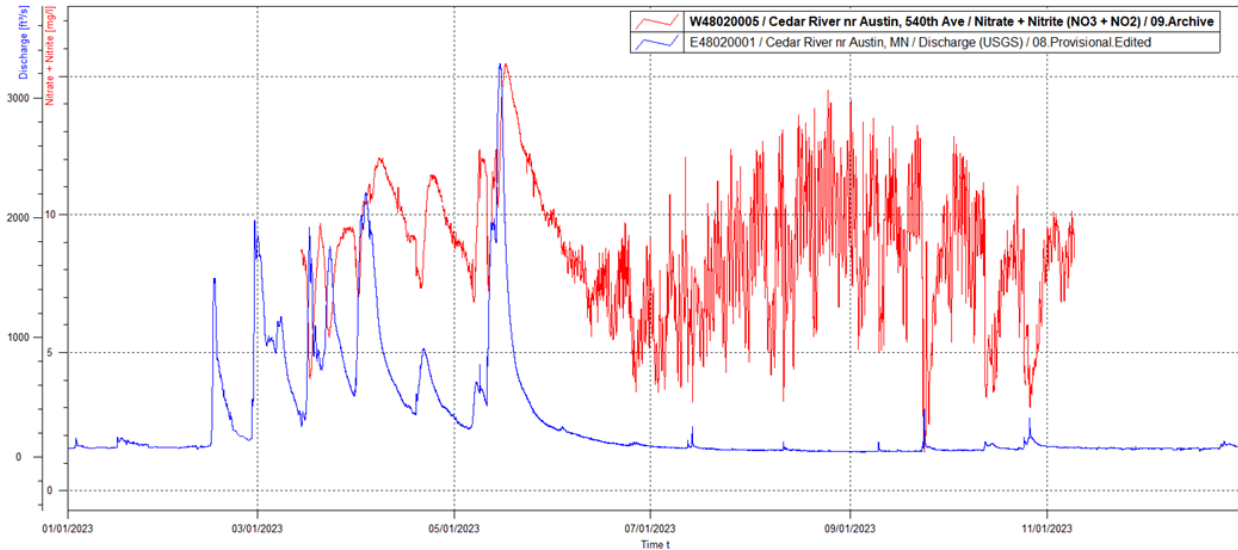
Figure 15: July to October 2023 nitrate + nitrite and flow data at Cedar River E48020001.

Over the period of record, the high-resolution nitrate time series has documented a consistent diel oscillation under low-flow conditions. When discharge falls below approximately 200 cfs, nitrate concentrations typically increase through the morning, peak near midday, and decline through the evening. Although the amplitude and timing of the oscillation vary, there are numerous multi-day periods during which concentrations fluctuate by as much as 3 to 5 mg/L within a 24-hour cycle. See Figure 15 and Figure 16.

During a March 2025 presentation and discussion with the Upper Mississippi River Conservation Committee (UMRCC), participating experts provided opinion and a reference suggesting that in-stream biological processes may be driving the observed pattern (Moraetis et al, 2010). In response, the MPCA staff and partners are deploying additional continuous monitoring probes within the Cedar River to further evaluate the mechanisms underlying this phenomenon.

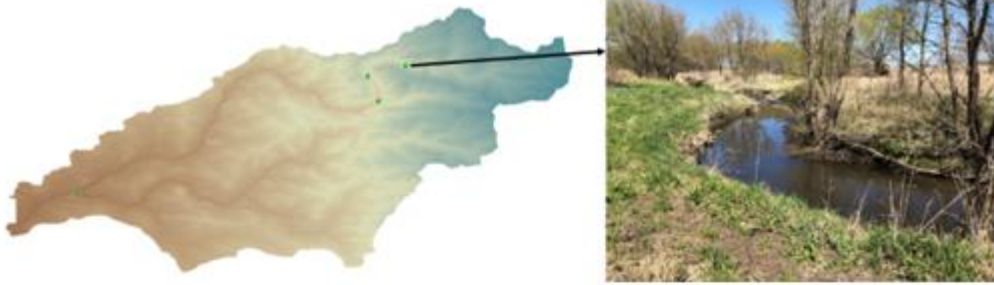
Dobbins Site 1 – WSB Restoration Site

A Dobbins Creek geomorphic survey completed by Minnesota Department of Natural Resources (DNR) and stored in the DNR Stream Geomorphology Survey Database, evaluated geomorphic conditions at four representative reaches of Dobbins Creek to document channel form, stability, erosion potential and floodplain connectivity. This technical work can support restoration planning and future habitat improvement projects. The reaches included an upstream restoration site, a downstream reference reach used to inform that design, a pasture reach with active instability, and a downstream comparison site at Hormel Nature Center as shown in Figure 24. The report reflects work completed over several years rather than a single field season: the pasture site was initially surveyed in 2014 and resurveyed in 2021, the reference reach was surveyed in 2017, and post-project bank erosion assessments at the restoration site were completed in 2021 after implementation.

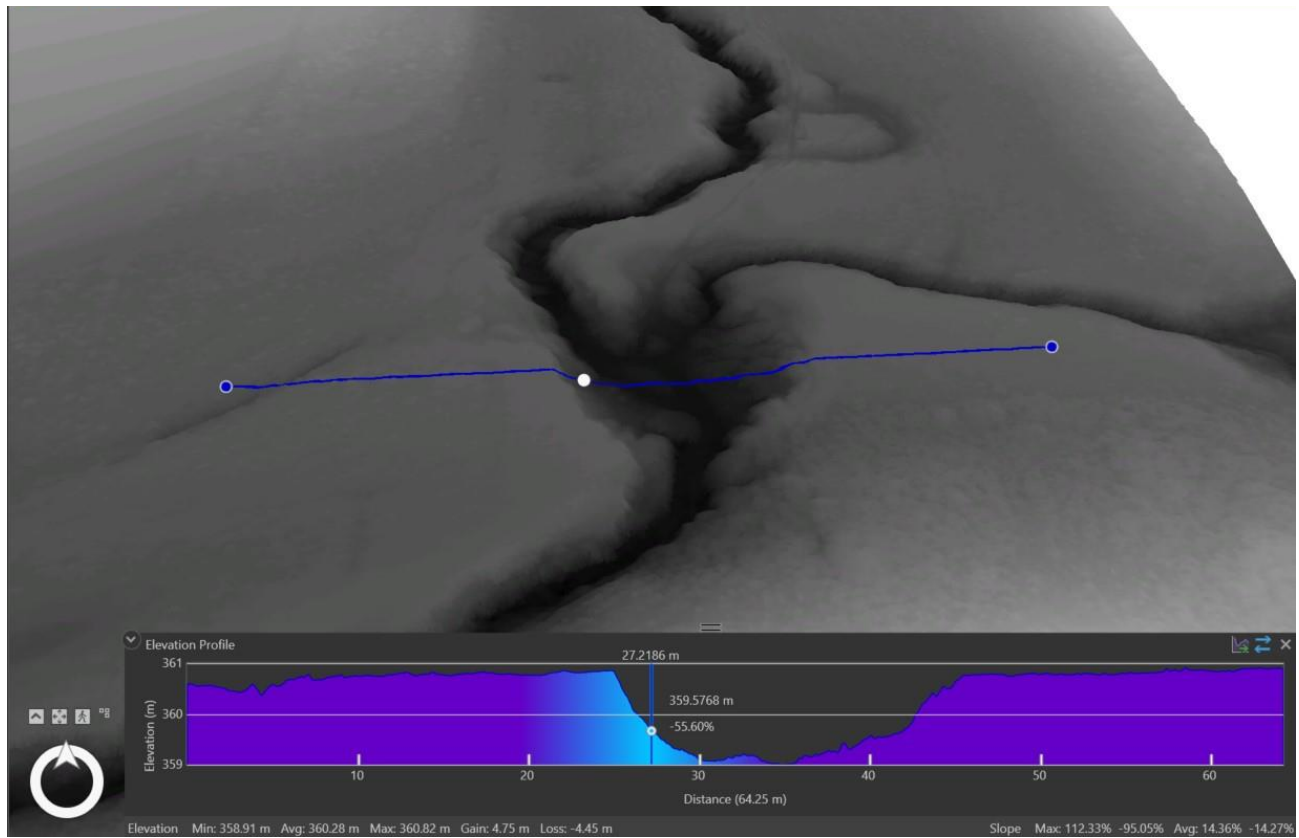
Figure 26: High resolution DEM allowing for accurate stream cross section records over time.

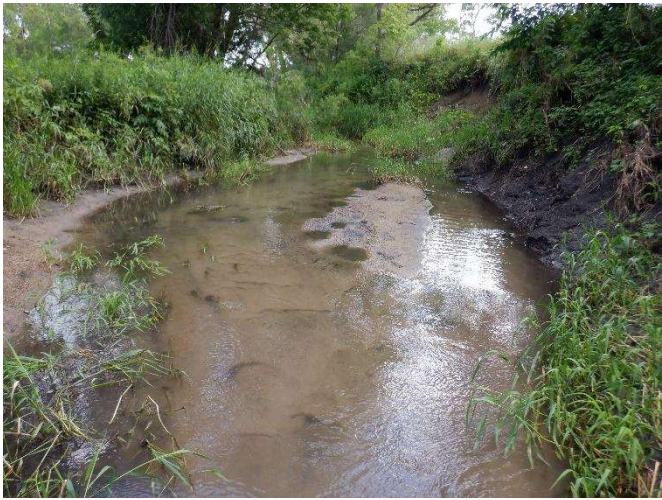
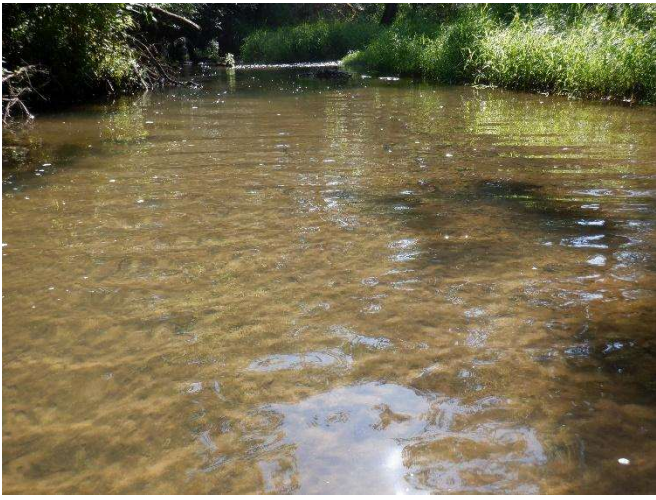
<p>N12.6 -2024: Headwaters of the North Branch. Severe excess sand aggradation, reduced pool depth and smothered spawning gravels. Very high banks on both sides limits riparian flow refuge.</p>	<p>S0.04 -2022:—Near outlet of the South Br. Stream is overwidened with excess sand on bottom, lacks depth variability. Surprisingly, this reach was much improved with far less sand in 2024, possibly moved out during the June flood prior to sampling in late July.</p>

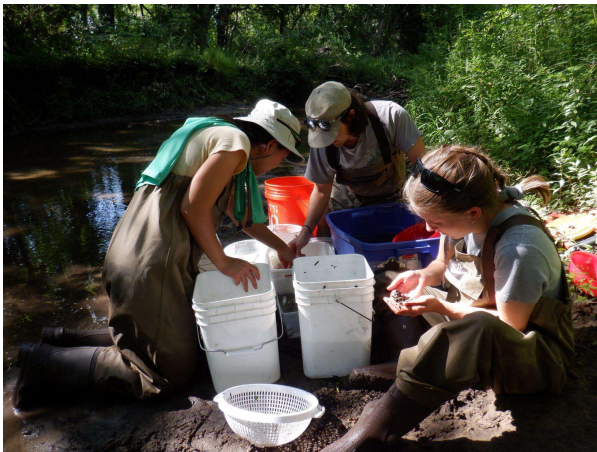
Figure 4.32a: Bucket sorting by species, gravel sorting for smallest fish.

We also attempted to sample during the same week or as near to as possible as was sampled in previous years. There are many young-of-year (YOY) fish that were collected, and mid-July is our start of sampling in order to allow the size to be identifiable and reportable. Fish at the Dobbins Creek monitoring stations are collected from a segment of the stream reach (station) using a Smith-Root LR24 electrofishing backpack. The electrical pulse gently stuns the fish which momentarily stops swimming and then floats on the side or upside down so they can then be easily captured with a pole-handled net. The netted fish are transferred into a large bucket with water until they are brought to the sorting station on the edge of the stream. There, multiple buckets of water are waiting for staff to identify and sort by species each fish sampled. After data is collected, fish are released.

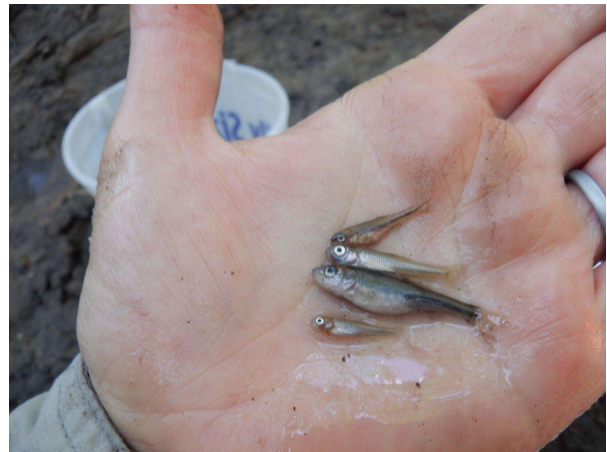
Figure 4.32b: Example of small YOY. Top to bottom: Blacknose Dace, Common Shiner, Creek Chub and a YOY too immature for identification.

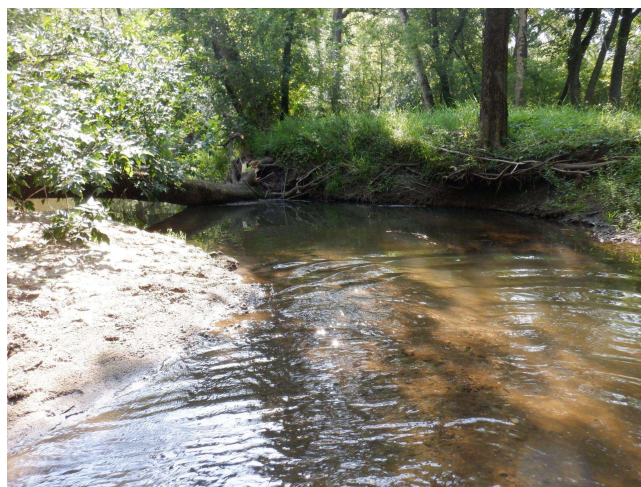
Photo – S0.04 – 2024: Less sand accumulation on bottom, some deposited on point bars. Deeper thalweg and scour pools by downed trees.

S0.04 had the highest MSHA scores, with a lower score in 2022. The MSHA score was lower in 2022 due to the excess sand accumulation in this channel which was extreme (see photo near beginning of report). This caused a lack of depth variability. However, in 2024, after a series of high flow events, the excess sand was removed from the bottom and there was an abundance of sand deposited on point bars that were narrowing the channel (photo below). There were many very deep pools and areas of coarse substrates (gravel/small cobble) that were fairly clean and unembedded. The habitat quality in 2024 was good.

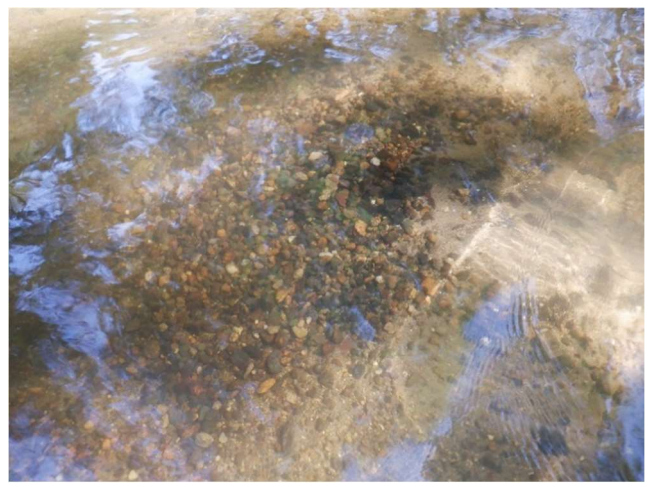
Photo – S1.9 – 2024: Gravel piled up by chubs.

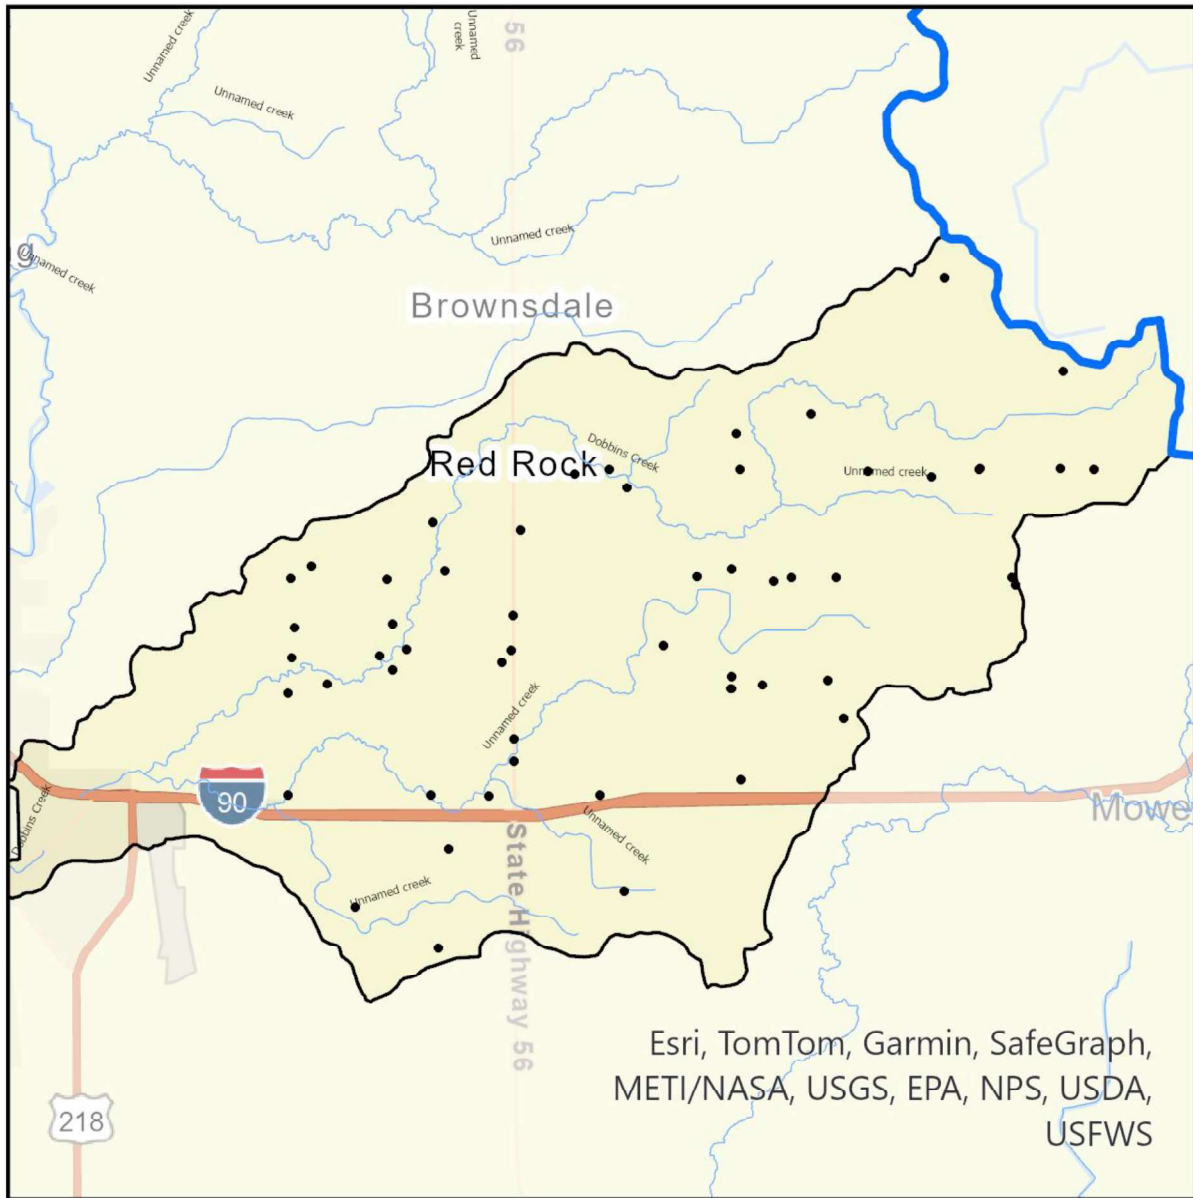
The 27 registered non-CAFO feedlots in the Dobbins Creek subwatershed are mapped in Figure 10. Both active and inactive feedlots are listed. While inactive feedlots no longer have livestock, they have the potential to be a source of historical *E. coli* loading to surface waters.

Figure 10. Registered feedlots in the Dobbins Creek subwatershed (December 2023).
