**ESCUDILLA LANDSCAPE**  
**WATERSHED RESTORATION ACTION PLAN**  
**&**  
**WATERSHED BASED PLAN**

**Prepared by Southwest Native Ecosystems Management,  
Apache-Sitgreaves National Forests,  
Gila National Forest,  
and  
New Mexico Environment Department**

**July 31, 2018**

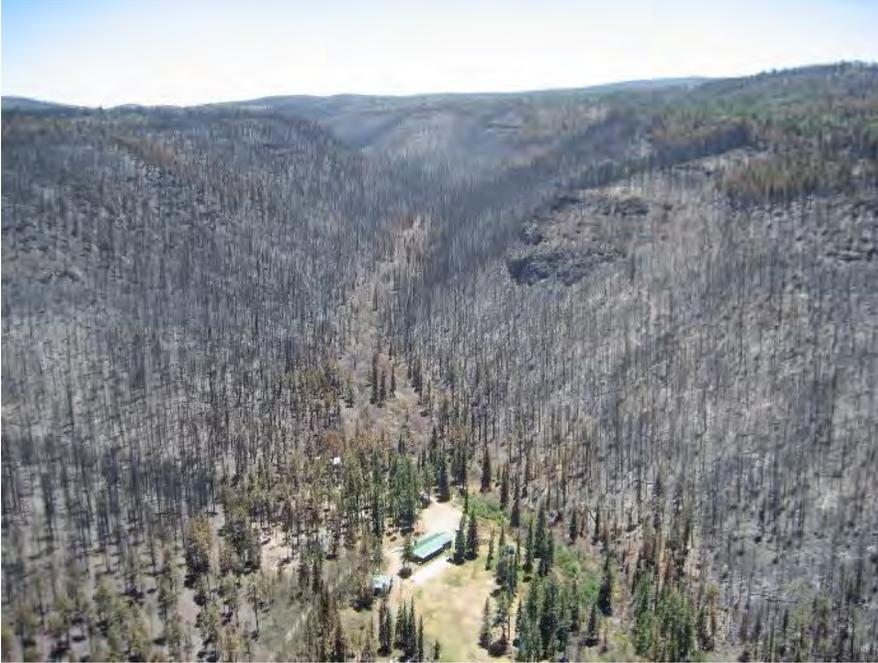
Figure 2. Picture of Wallow Fire

Due to the steep mountainous characteristic of the WRAP Area, the past impacts from historic management activities and the recent Wallow Fire (Figure 2) that left many severely burned areas within the WRAP Area, the Escudilla Landscape 6<sup>th</sup> code watersheds are not considered to be in Properly Functioning watershed condition.

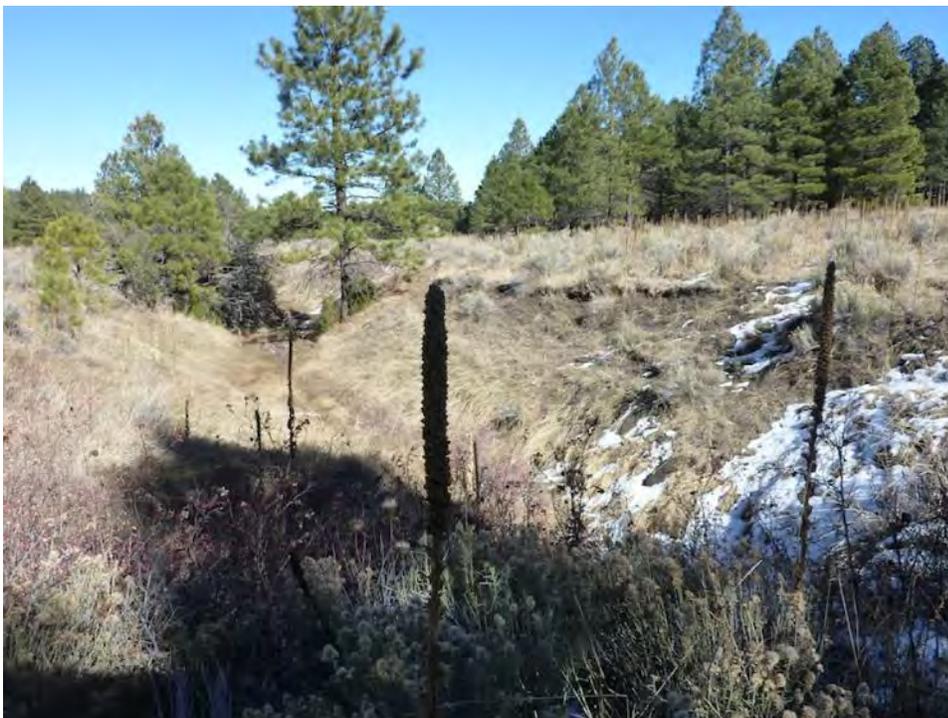
Figure 3. Stream Channel in Valley Bottom that Was Down-Cut Many Years Ago

Early on during the westward expansion period there were many attempts to establish homesteads in the valley bottoms where the productive soils occurred and water was much easier to capture and use to irrigate the land. The many small farms were slowly abandoned during late 1800s and early 1900s as drought and flood events occurred that made living and farming along these flashy Southwest stream/river systems much harder than was originally thought. These early attempts to farm the flood plains substantially changed the geomorphology of many streams/rivers and reduced perennial flows of water due to down cutting, which resulted in deep channels that drained subsurface waters from the floodplains.

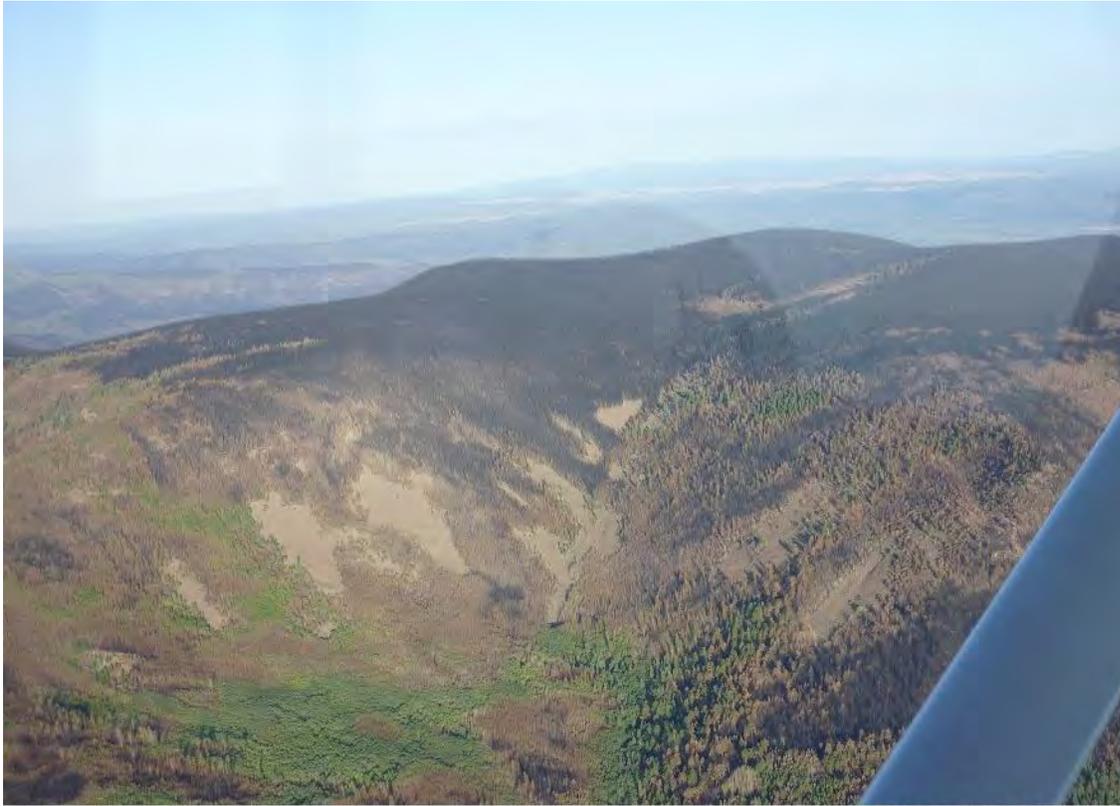
*Wallow Fire on Escudilla Mountain, AZ 07/07/11 0630 hrs. AZ time Photo: D Shamley*

Figure 4. Intense Burn Area on Escudilla Mountain Shortly after Wallow Fire

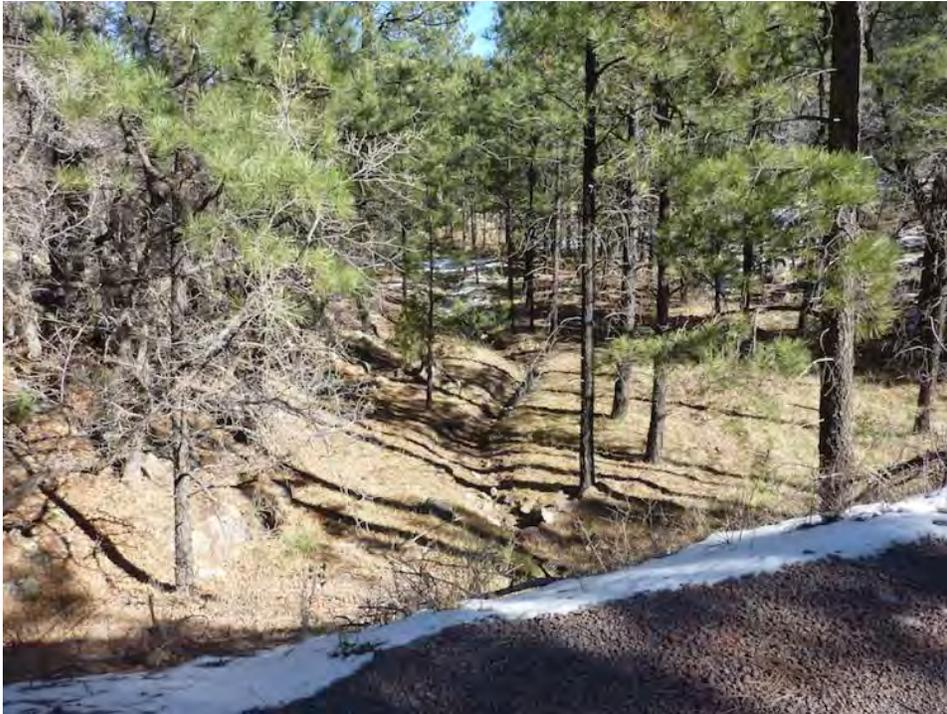
- The invasion of woody species of both trees and shrubs now occupy areas that once supported grassland and savanna ecosystems (Covington & Moore, 1994). Also the tree and shrub density within the woodland and forest ecosystems is much higher than what occurred in the past. The increase in woody plants has reduced herbaceous ground cover, thus degrading watershed health and functionality.

Figure 5. Dense Stand of Low Vigor Ponderosa Pine

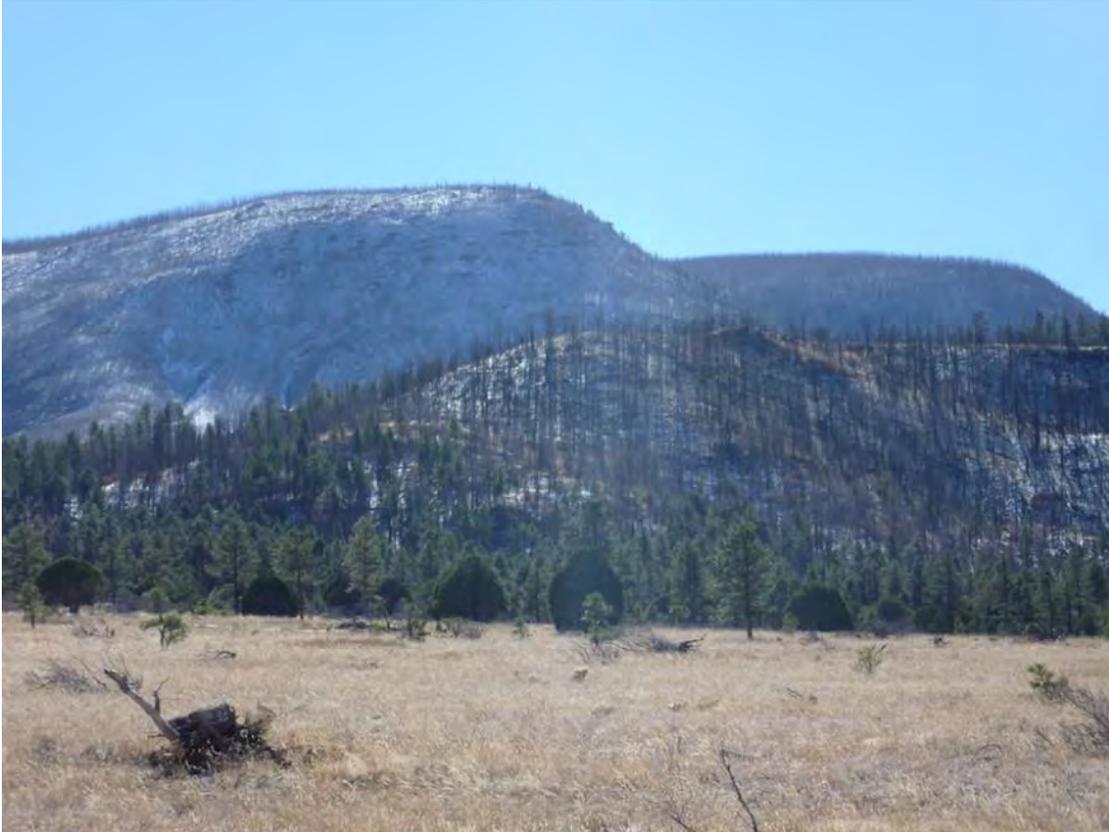
- Severely burned areas that occurred during the Wallow fire need to be monitored and efforts to decrease sheet and gully erosion as well as downstream negative impacts that are resulting from the severely burned areas should be a priority.

Figure 6. Severely Burned Slopes of Escudilla Mountain

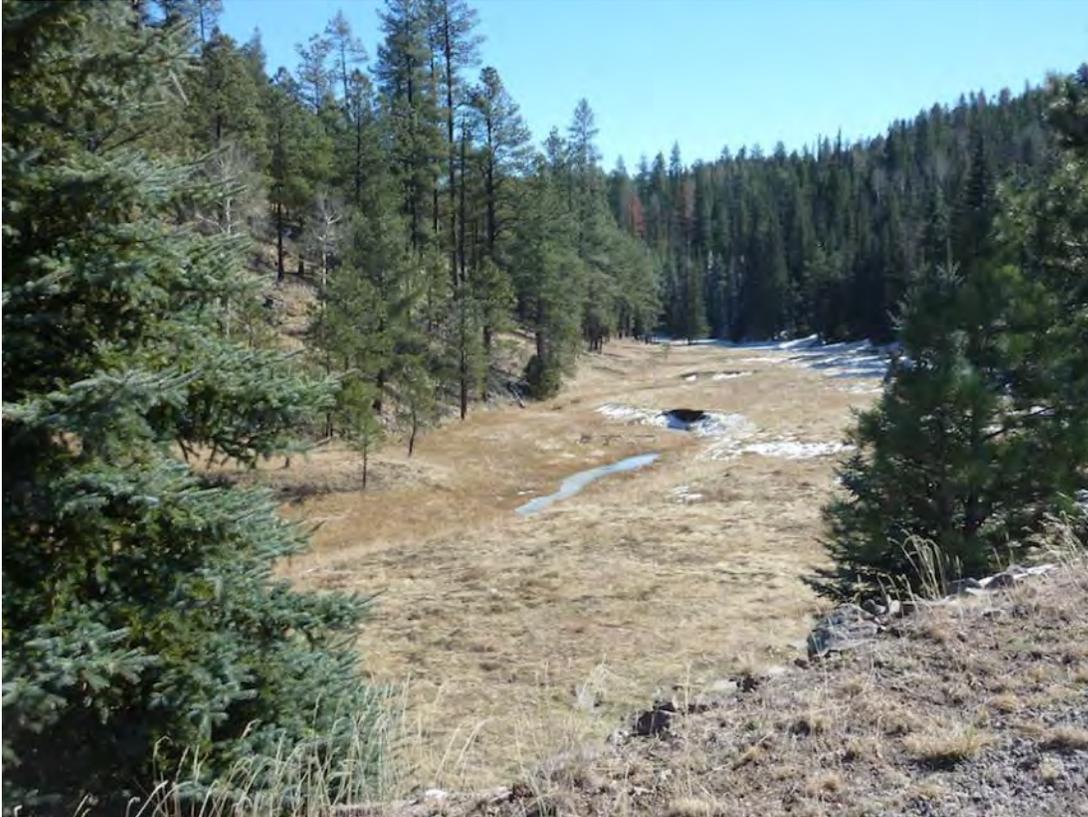
- Head cuts and gullies are still active in many of the streams and ephemeral drainages within the WRAP Area due to effects of past management and uncharacteristic wildfire. These head cuts and eroding stream banks are still releasing tons of sediment into the stream channels. Also the deep gullies and incised channels associated with past management are preventing elevated flow events from accessing the entire floodplain. The ability of many valley bottom floodplains to absorb and store water has been greatly reduced.

Figure 7. Head cut and Eroding Stream Banks in Mountain Meadow

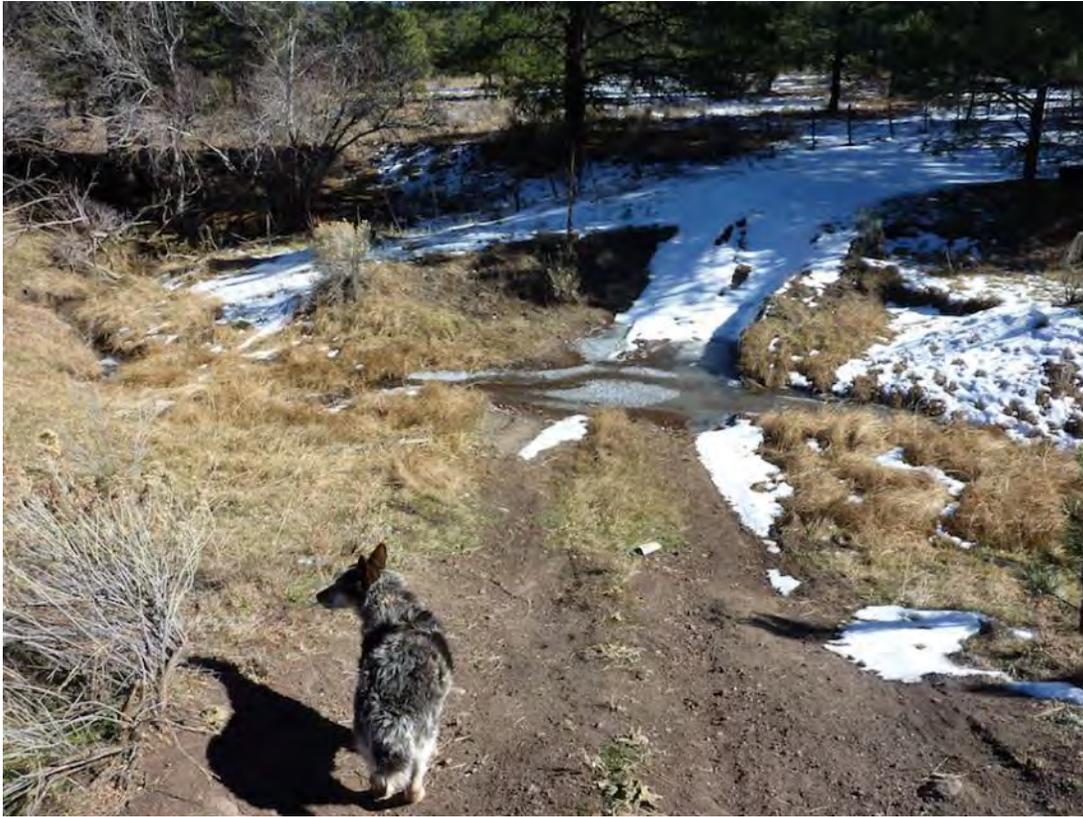
- Channeling of flood water and erosion due to poorly located and improperly constructed roads contribute to the sediment load carried by many streams in the WRAP Area.

Figure 8. Two Track Road Crossing with Down Stream Eroding Banks

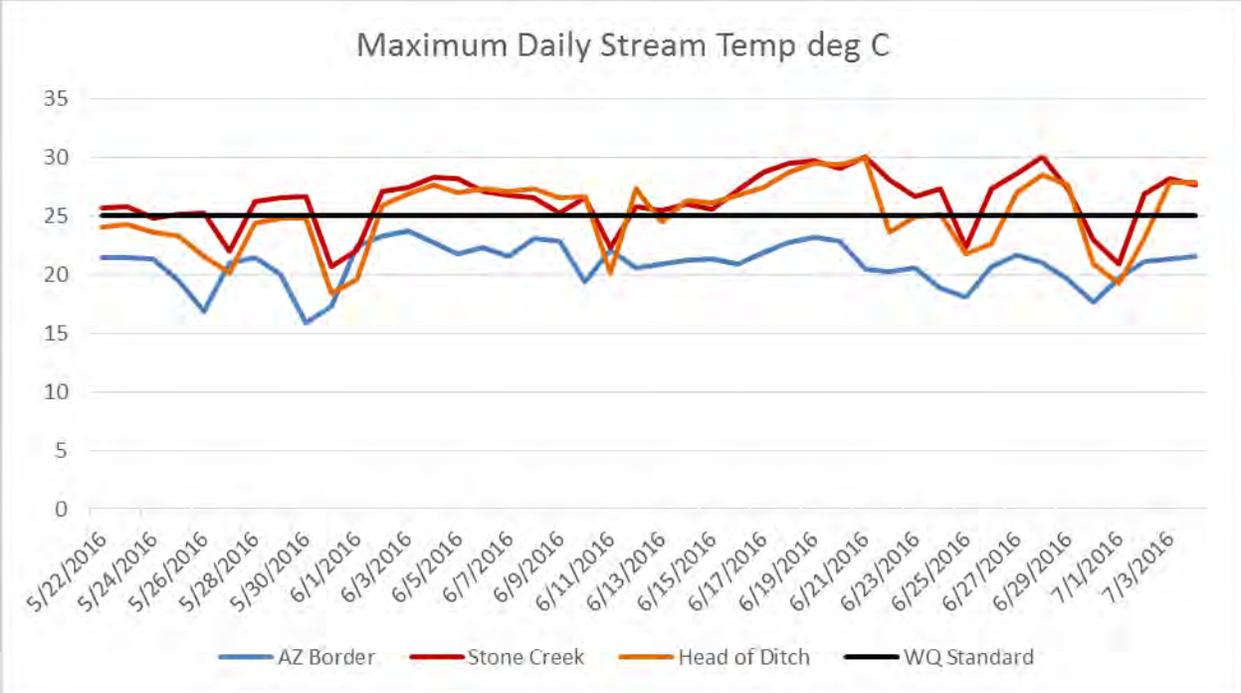
Figure 15. Recent temperature monitoring for San Francisco River and Stone Creek

In this assessed reach of the San Francisco River there is only one perennial tributary, Stone Creek, which flows from Escudilla Mountain in Arizona into New Mexico. Stone Creek is an unassessed perennial tributary to the San Francisco River above the NMED monitoring station near Head of Ditch campground just west of Luna, NM. Water temperature dataloggers deployed in 2016 demonstrated that the average maximum daily high temperature in Stone Creek was 5.4 degrees Celsius warmer than the temperature where the San Francisco River enters New Mexico, and 1.3 degree Celsius warmer than the temperature measured at Head of Ditch Campground. Based on modeling using SSTEMP (USGS Stream Segment Temperature Model), it appears that there is the potential to lower the water temperature inputs from Stone Creek by as much as 6 degrees by increasing the streamside shading from the current <10% to an attainable 60% through the proposed actions of planting and exclusionary fencing (see “essential projects” section below). While Stone Creek is, by volume, a considerably smaller stream, discharging 1- 2 cubic feet per second to the San Francisco River’s 3- 6 cubic feet per second, it would appear that a 6 degree reduction in Stone Creek water temperature could potentially reduce the stream temperature measured at Head of Ditch by as much as 2 degrees Celsius. SSTEMP is also relatively ‘blind’ to the temperature reductions that might be achieved through greater surface to ground water connectivity which would contribute to additional cooling effects by reducing the surface water temperature and increasing the volume of water entering the stream.

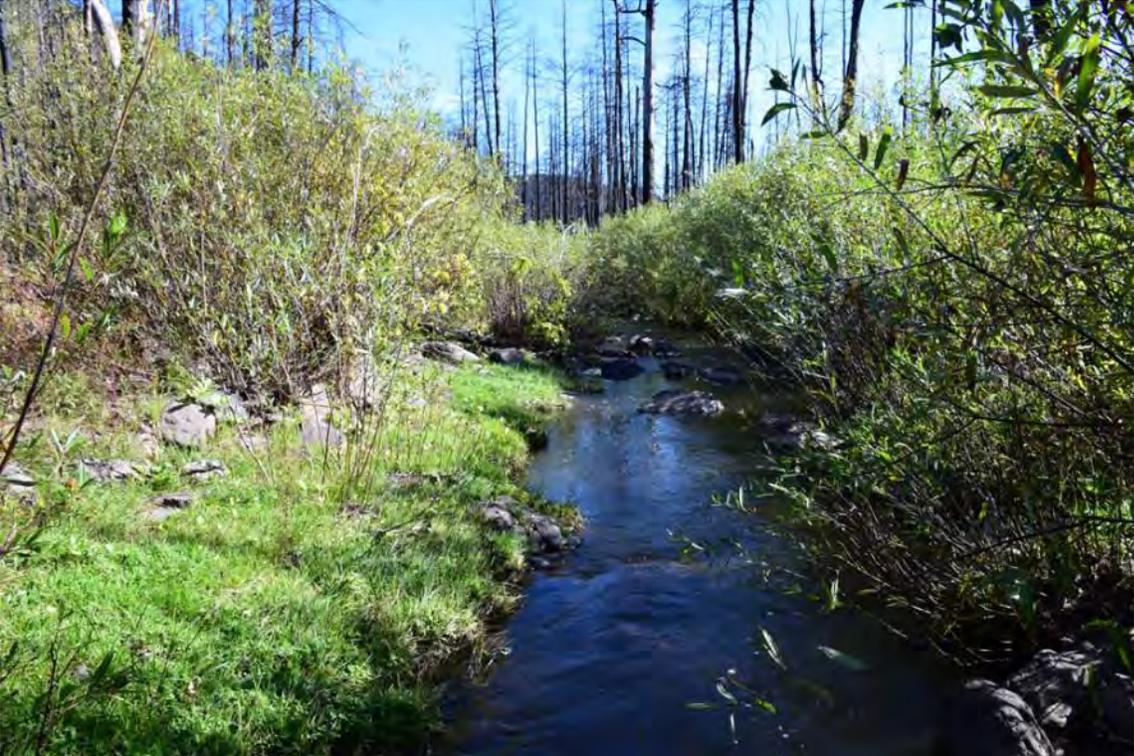
Figure 16. San Francisco River upstream of Stone Creek in New Mexico

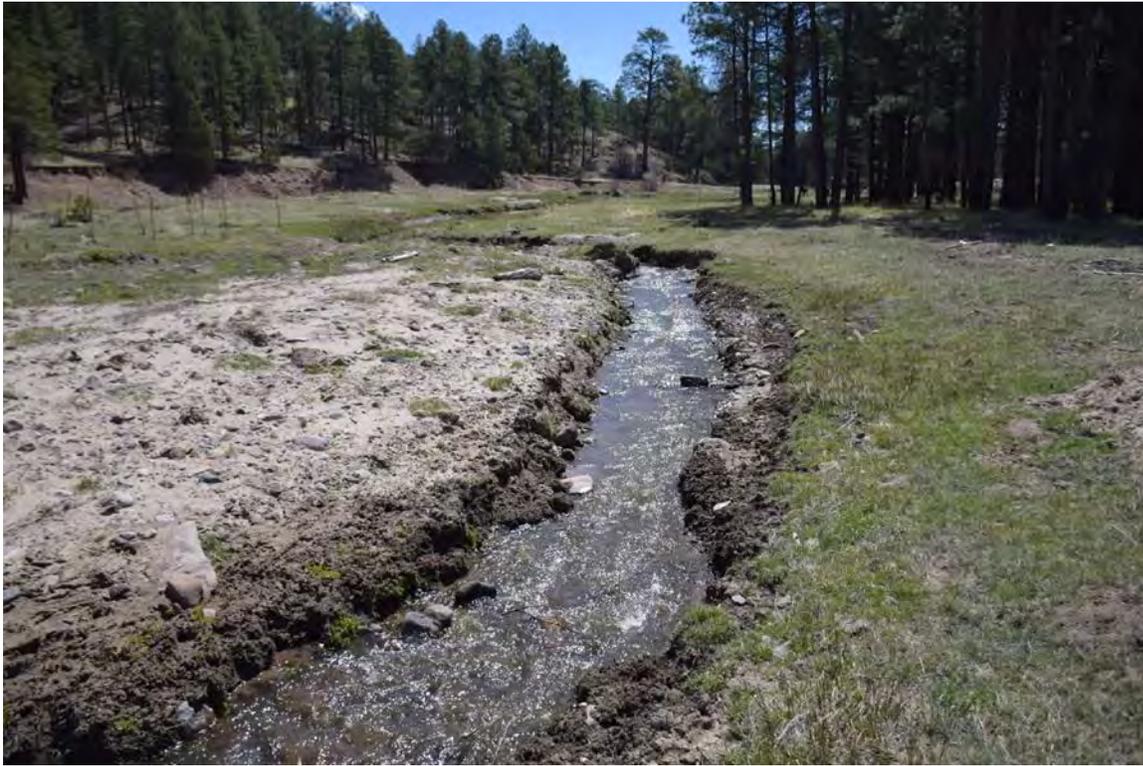
Figure 17. Stone Creek in New Mexico just above San Francisco River confluence

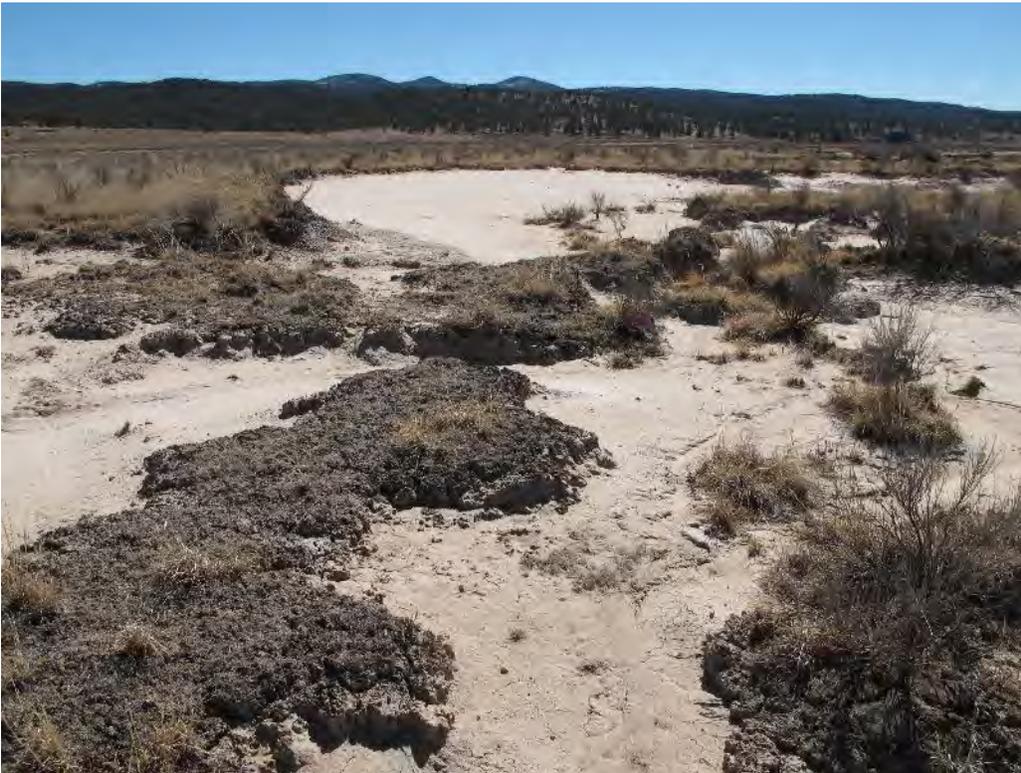
Secondary effects of rangeland grazing are more systemic throughout the Centerfire watershed and can be seen in the gullied and eroded uplands, poorly vegetated streambanks, incised stream channels and encroachment of woody upland species in the riparian zone. The water quality implication of this degradation is that even after an area has been excluded from grazing, the lingering effects of headcuts and bank sloughing continue. The effects are twofold: soils are mobilized which contributes directly to nutrient inputs into the stream, and there is a loss of nutrient removal from the stream as streamside wetlands are lost either to erosion or dewatering during channel incision.

Figure 18. Degraded rangeland condition in Spur Draw

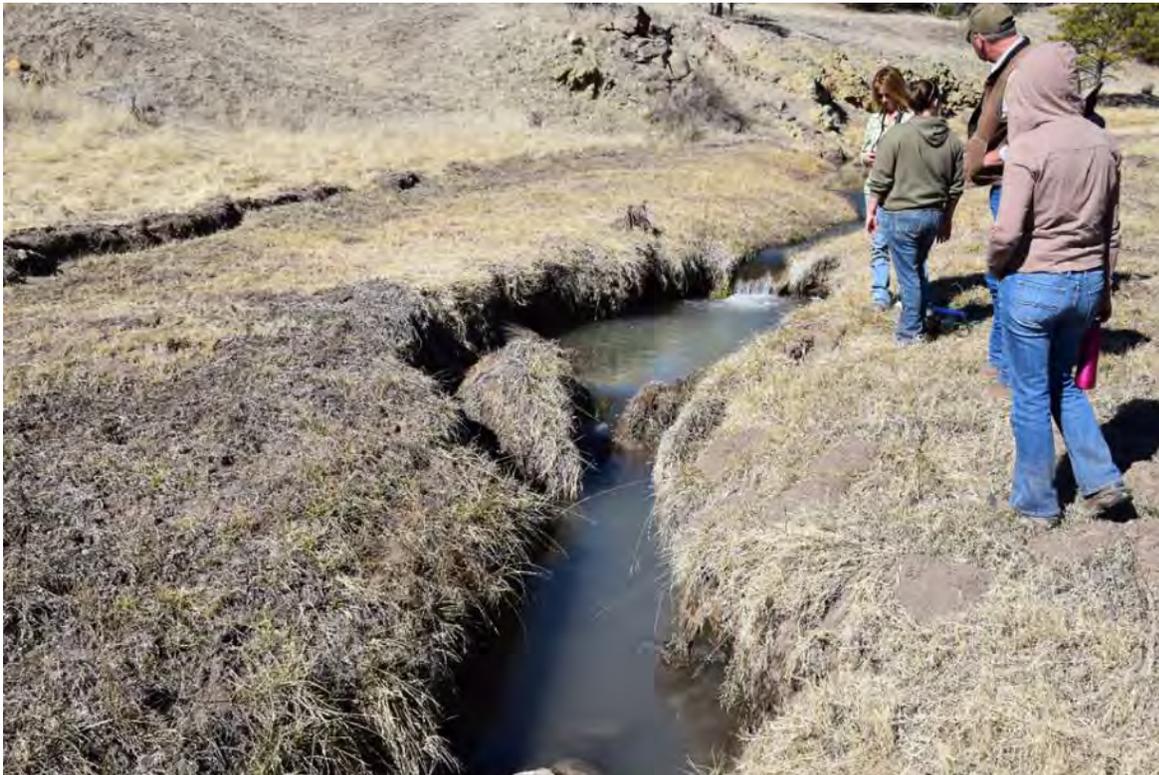
Centerfire Creek has several areas of severe channel instability which is leading to extensive channel widening, bank erosion and headcuts. It has been estimated that at least 6" of bank erosion has been occurring ever year for at least the past 6 years.

Figure 19. Streambank instability in Centerfire Creek
