**CIBOLA NATIONAL FOREST & NATIONAL GRASSLANDS  
MT. TAYLOR RANGER DISTRICT**

**SHUSH KIN FEN RIPARIAN RESTORATION PHASE II**

**Proposed Action**

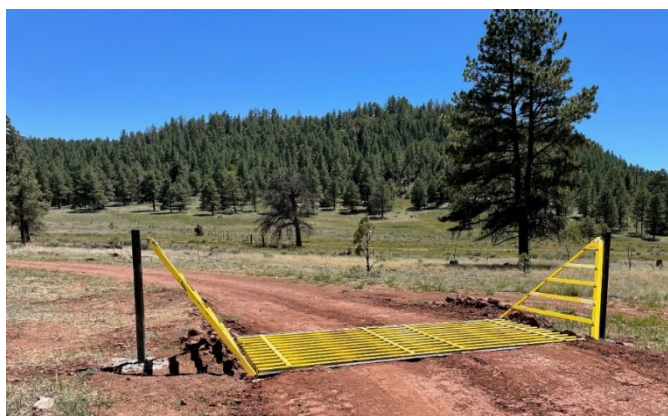
**Figure 2.** New cattleguards installed in 2023 to tie into the new Serna pasture fence.

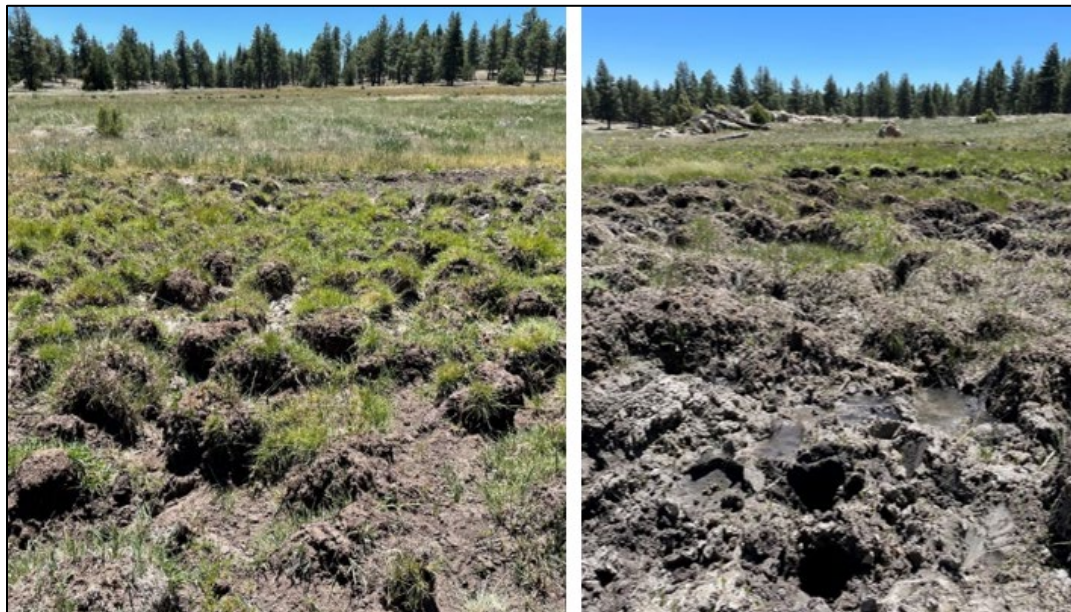
**Figure 3.** Hummocks and evidence of severe hoof action in Shush Kin Fen, July 2023.

The Shush Kin Fen is a perennial spring- and runoff-fed wetland that has been severely degraded from years of overgrazing. There is widespread pedestalling and hummocked soils (root crowns exposed by erosion) with eroding plant communities (herbaceous forbs and grasses). The wetland is underlain by peat but due to historic overgrazing, several channels are forming and the peat is eroding, leading to accelerated soil loss and drying of the wetland. The surface water largely flows at the base of vegetation pedestals 14 – 24 inches lower than the soil surface of the hummocks. Survey and mapping of vegetation indicate that the historical width of the fen was likely more extensive in comparison to its current condition.

Approximately 80% of the fen shows damage from overgrazing as evidenced by livestock/game trails, bare soil, head cuts and incision, and exposed muddy soils from extensive hoof action. Research shows that a healthy high elevation fen should not have more than 5% of the total area with this kind of disturbance (Milford 2023). Recent livestock fencing around the fen is expected to improve vegetation cover but additional restoration interventions are expected to accelerate the ecological recovery of the wetland. Furthermore, native ungulates have not been excluded from the fen and therefore, some grazing pressure and surface disturbance is still present in the fen.

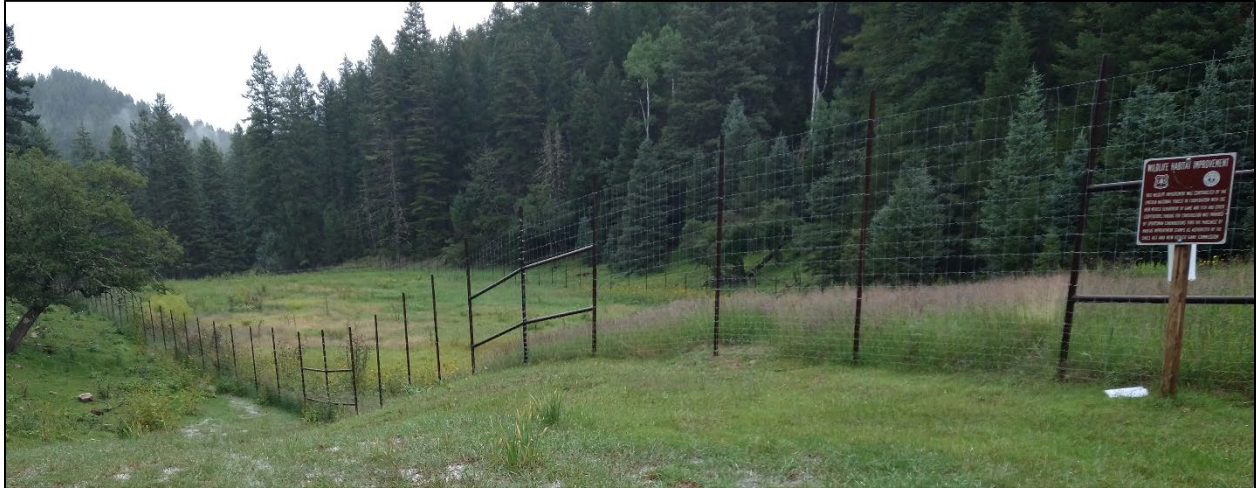
**Figure 6.** Example of native ungulate exclusion fence design.

After the hummock repair and erosion control structures are complete, the Cibola will raise the height of the existing fence to ~10 ft to temporarily exclude native ungulates for a prescribed period of time to allow the instream restoration actions in Phase II to take effect without disturbance by

large native grazers (Example in Figure 6). The extended fence would remain in place for ~2 years or until soil stabilization and riparian vegetation re-establishment is sufficient to withstand or be resilient to some level of native grazing. Environmental compliance for this part of the project is complete (USFS 2021a).
