# **AQUATIC RESOURCE DELINEATION REPORT**

**Project Name:** Shush Kin Fen Wetland Restoration

**Date:** 5/26/2026

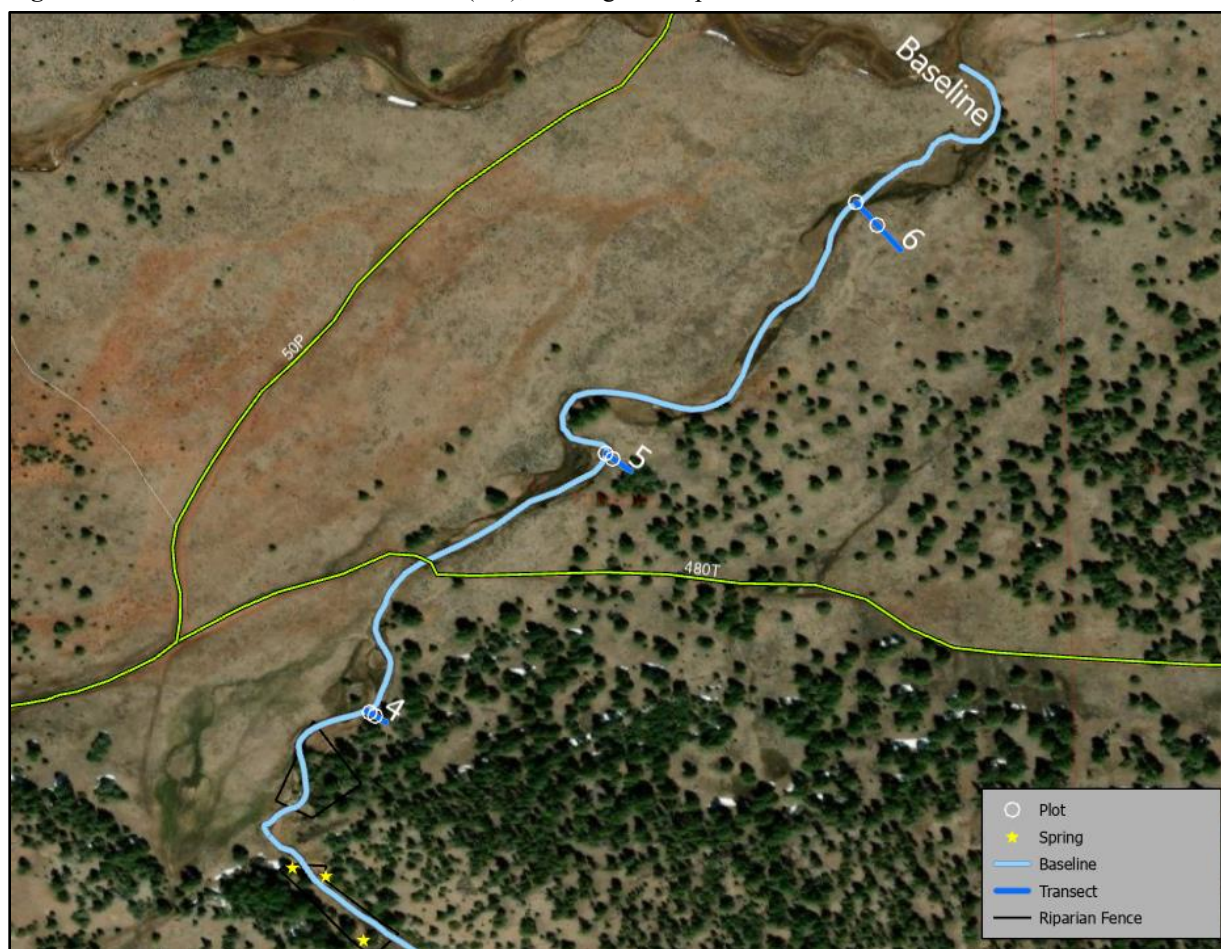
**Figure 3.** Lower Reach baseline, transects (4-6), and vegetation plot locations.

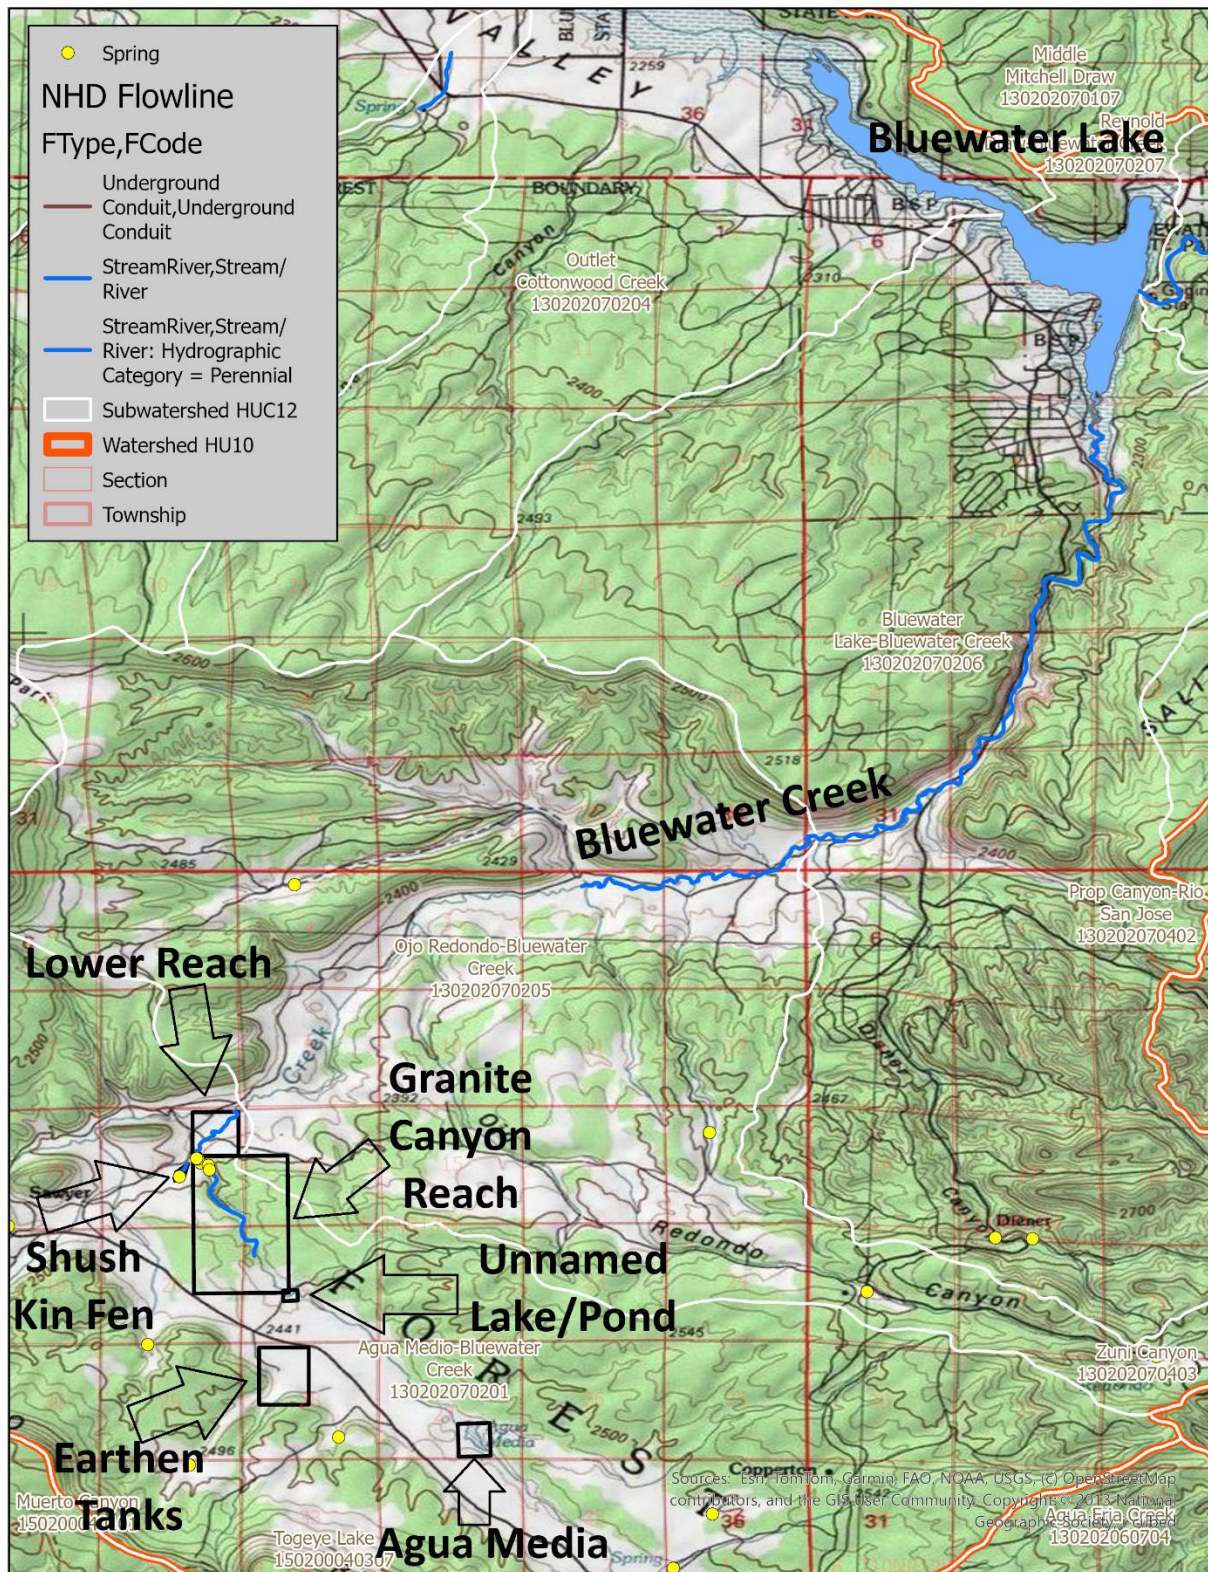
**Figure 10.** Wetland reaches included in this review, shown in context of nearby water bodies.
