The NTSB report for the Genius Star XI Battery Fire

HazMat Cargo Vessel Genius Star XI

Lithium-ion Battery Fires aboard Cargo Vessel Genius Star XI
https://www.ntsb.gov/investigations/Pages/DCA24FM013.aspx

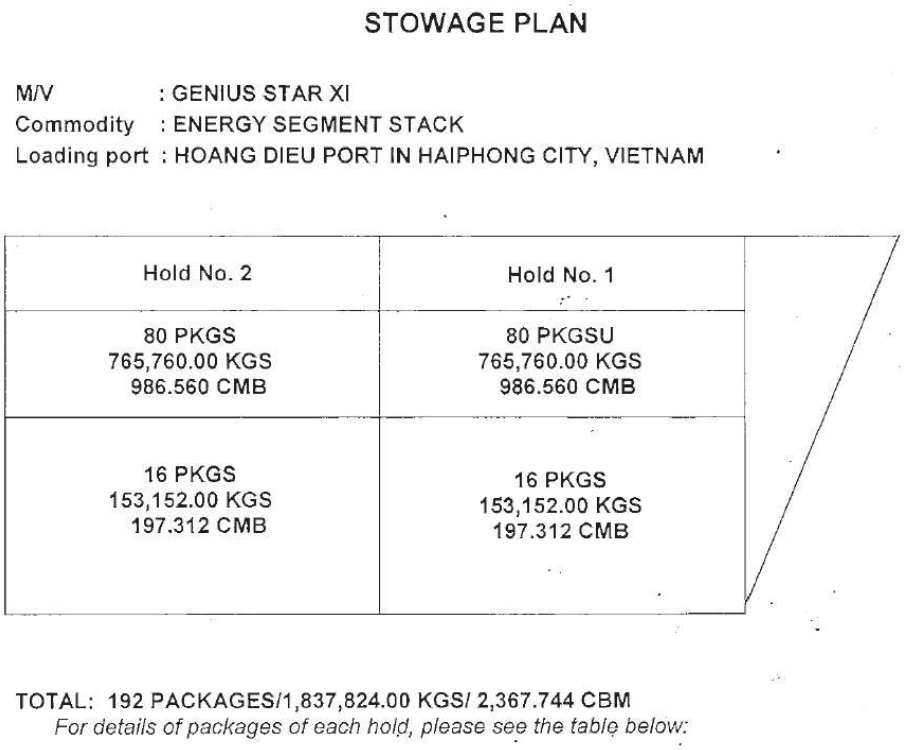
**Figure 1: Stowage Plan of the 192 BESS aboard Genius Star XI**

No. 2 on the tween deck of the vessel.[1] A cargo hatch covered the tween deck while in transportation. Another 32 BESS were arranged below the deck in a two by eight rectangular arrangement in the lower two holds (See Figures 1 and 2). A total of 41 BESS had shifted and broken free from its lashing on the tween deck; there was no evidence that the BESS in the lower holds were damaged. The BESS were lashed individually to the decks as seen in Figure 3:

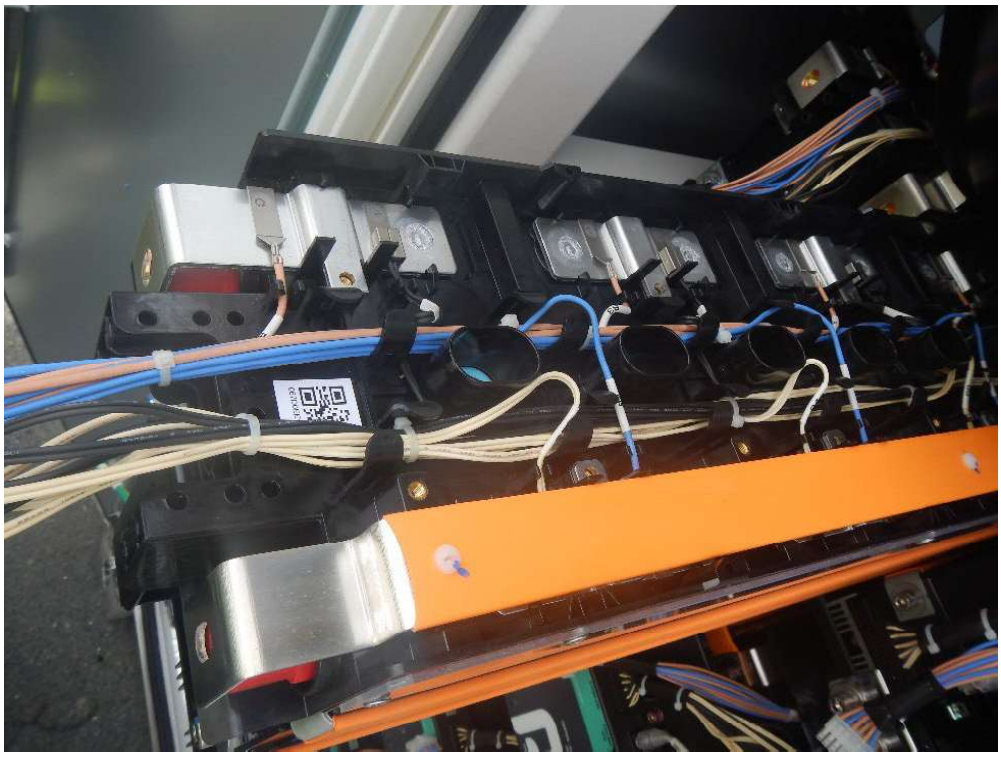
**Figure 5: Single Module showing the laser welded busbars on top on February 25, 2024**

After the modules were assembled, they were transported by truck, and then loaded onto a vessel in a 20-foot container to Vietnam, where the modules were installed in cabinets. The modules consisted of ten prismatic cells that is connected in series with laser-welded busbars made of T2 tool steel (See Figure 5).[13] Each module weighed 68.5 kg (~151 lbs.) and was rated 32 V(DC), 9760 Wh, 305 ampere-hours (Ah).[14] Three modules are then assembled into a battery pack, consisting of 30 cells in total, which are then placed on a shelf. The shelf with the battery pack weighed over 400 pounds.

The battery cells within Powin's BESS did have a venting feature, as seen in Figure 5. The cells were connected in series and each side of the cabinet is in 420-cell series circuit, as seen in Figure 18. However, in transportation, this circuit is broken into smaller circuits of 150, 150, 120-cell series, which reduces the point-to-point voltage potential. [27] String controllers connect the cell strings and have fuses inside.

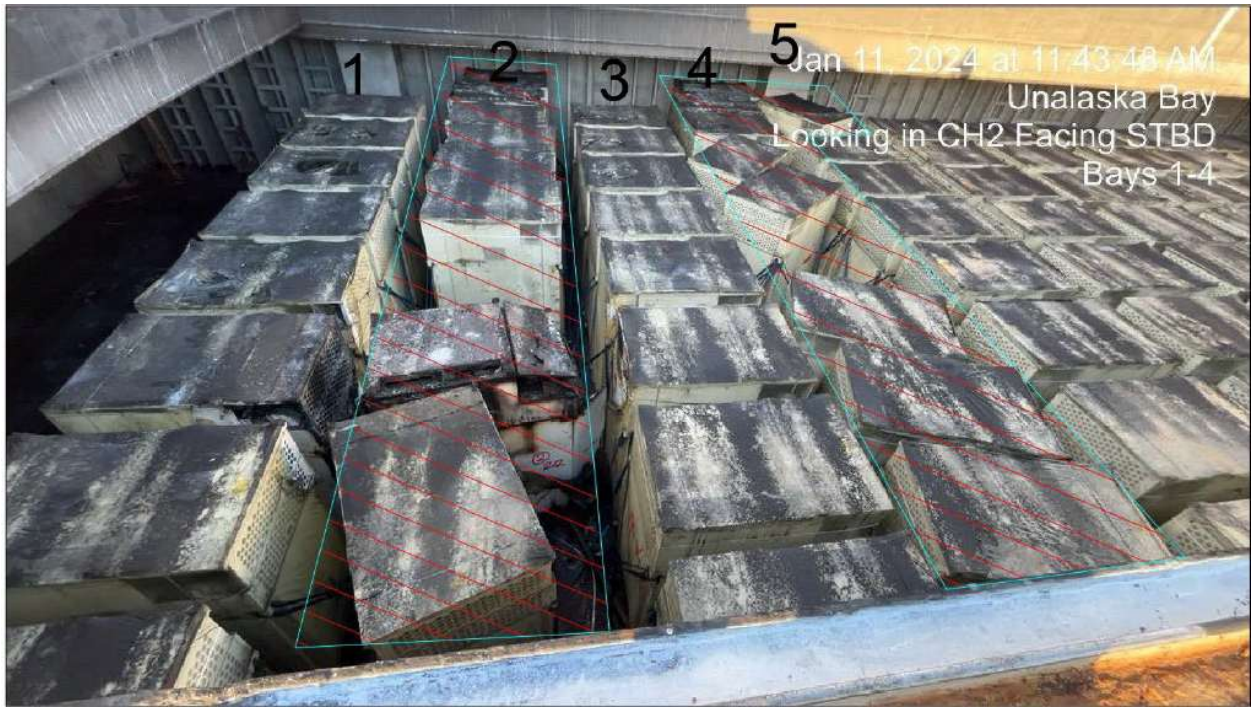
**Figure 10: Photo of shifted cabinets in Hold 2** ***(Image courtesy of Energy Security Agency)***

ESA documented the initial position of the cabinets before conducting the damage assessment and found cabinets that had broken loose from its lashing in both Hold 1 and 2. Those cabinets were found in bays closest "amidship", i.e. center of the ship. Figures 9 and 10 show where the cabinets were positioned post-incident, after the vessel docked in Dutch Harbor. The grid patterns in red identifies cabinets that were physically damaged or had thermal abuse. The teal lines refer to the row numbers.

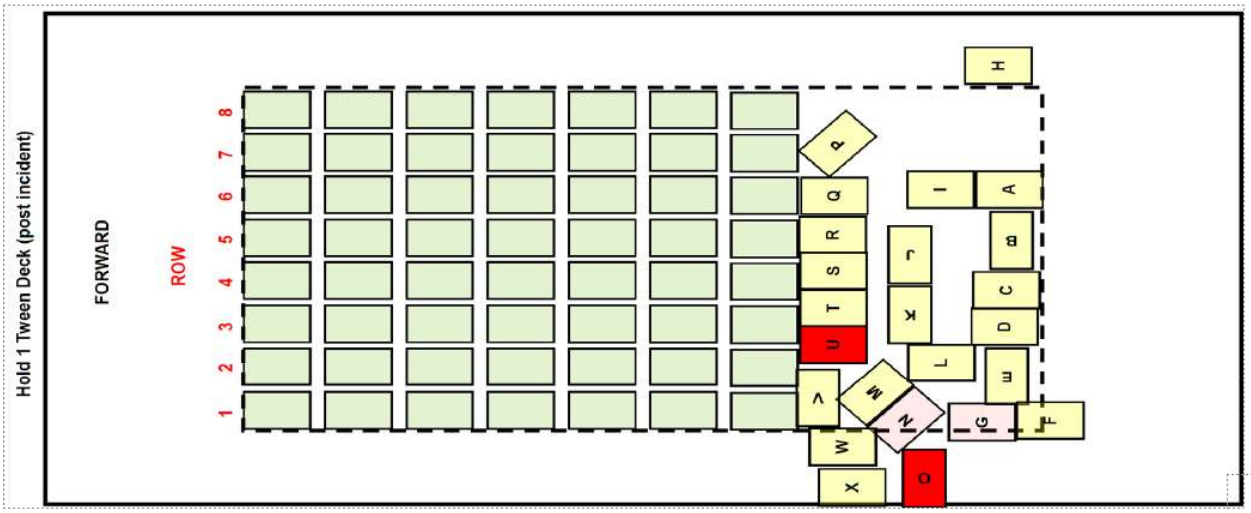
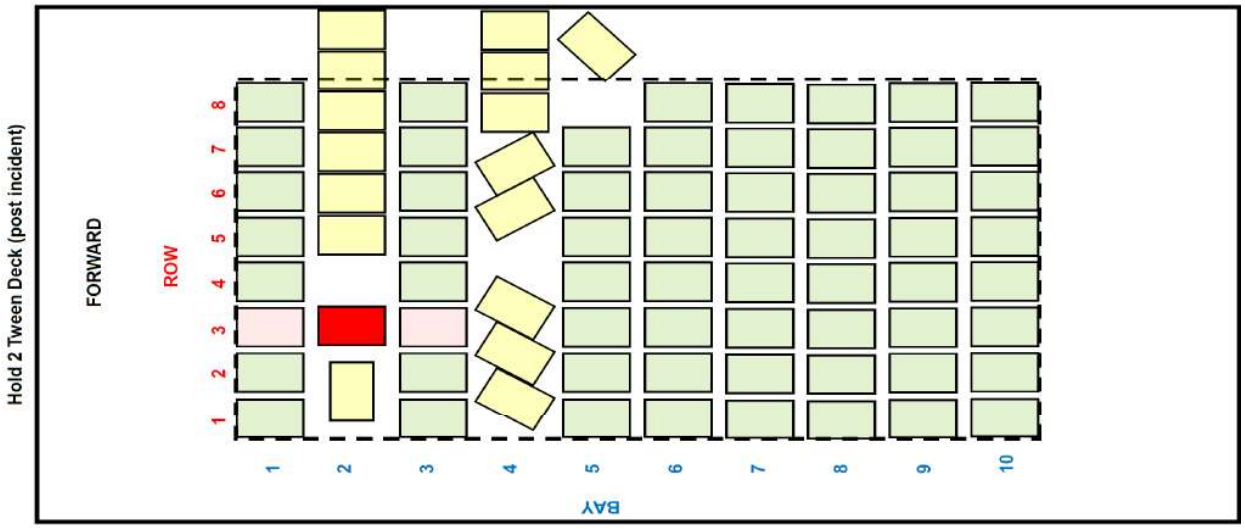
**Figure 11: Mapped positions of the shifted modules aboard the Genius Star XI on tween decks for Holds 1 and 2 *(Image courtesy of Energy Security Agency)***

ESA mapped the movement of the battery cabinets and identified those that went into thermal runaway (red), had severe thermal abuse (pink), or were displaced and shifted and found to have physical damage (yellow) (See Figure 11). The cabinets labeled green had not broken free from its lashing and had no thermal abuse or physical damage. The company examined all the cabinets labeled red, pink, yellow, and then green rows adjacent to yellow or red labeled cabinets.

- A total of 41 BESS shifted; 24 from Hold 1 and 17 from Hold 2
- Rigging and lashing mechanism had failed in both Hold 1 and 2
  - Bays 8 through 10 in Hold 1
  - Bays 2 and 4 in Hold 2
- A total of 3 BESS that broke loose from its rigging and lashing and were observed to have a thermal event that destroyed the entire BESS; two from Hold 1 and one from Hold 2.
- Approximately 8.3 BESS from Hold 1 and 2 were dismantled and the modules were packed into drums. ESA classified these repackaged

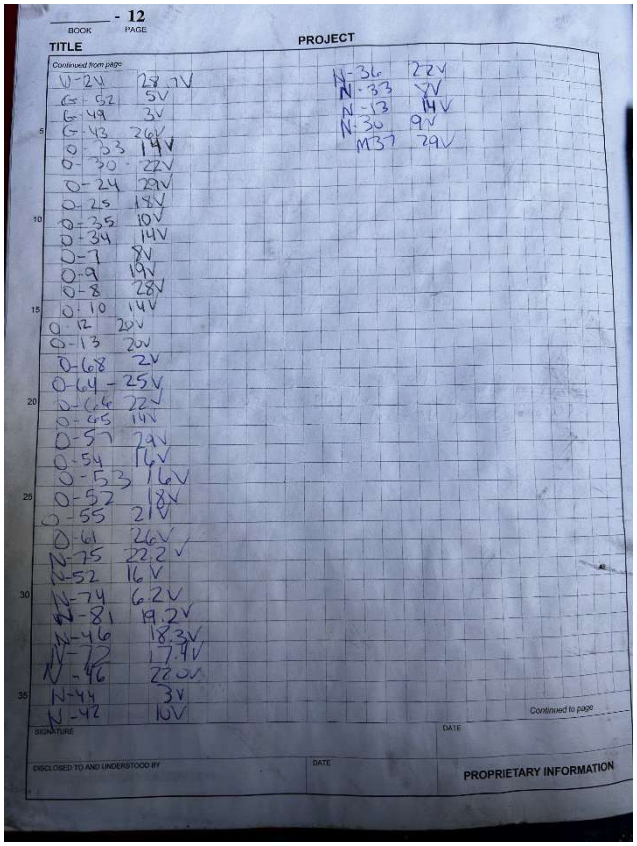
**Figure 17: ESA voltage measurements recorded in Dutch Harbor, AK *(Image courtesy of Energy Security Agency*)**

Powin did not provide the SOC of the BESS when requested by the NTSB. ESA did measure the cell voltage on-scene of several BESS and found that it fell under the nominal voltage of 3.275V, indicating the SOC was below 50% (See Figure 17).

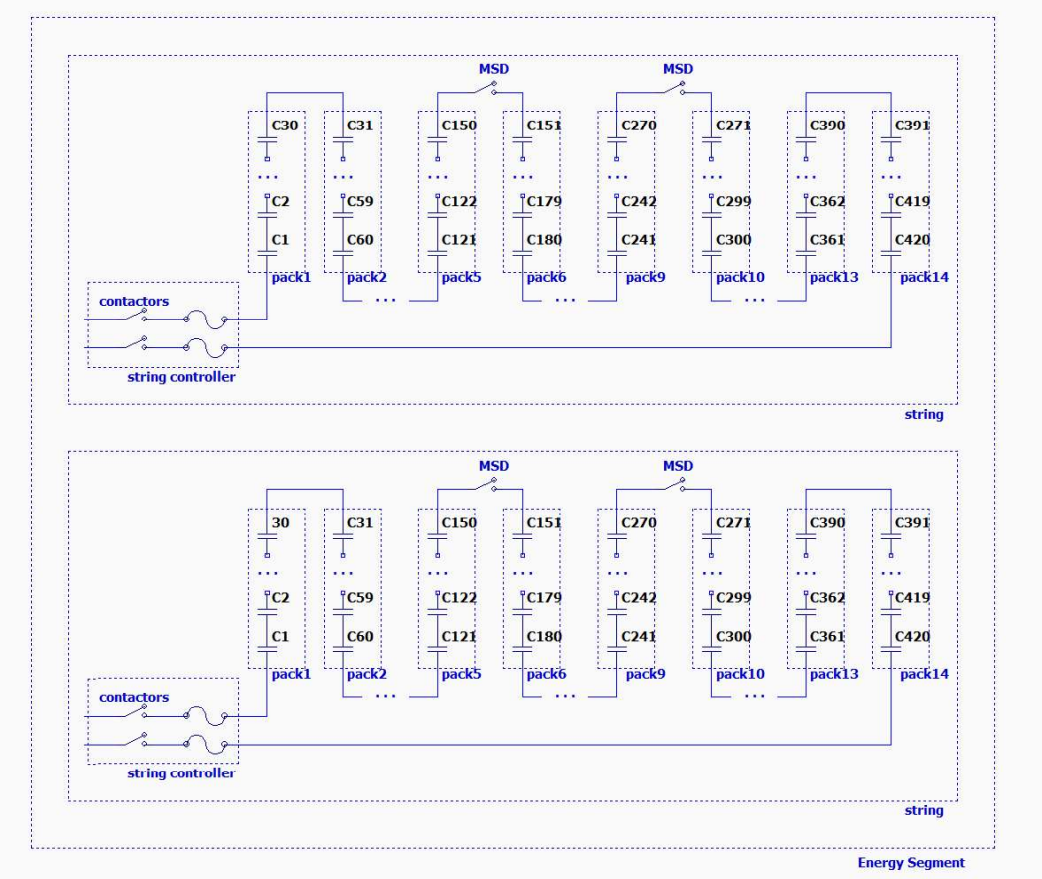
**Figure 18: Schematic of one side of the BESS showing string controllers and disconnected series *(Image courtesy of Powin)***

[27] The BESS features a manual service disconnect (MSD), which is used for maintenance purposes, that physically disconnects the entire 420-cell circuit into smaller circuits of 150, 150, 120. Powin reported that the MSDs are removed while in transportation, leaving series circuit broken into the smaller circuits, reducing the point-to point voltage potential to less than approximately 500 V(DC). See Attachment 10: Powin ATF NTSB USCG Questions.
