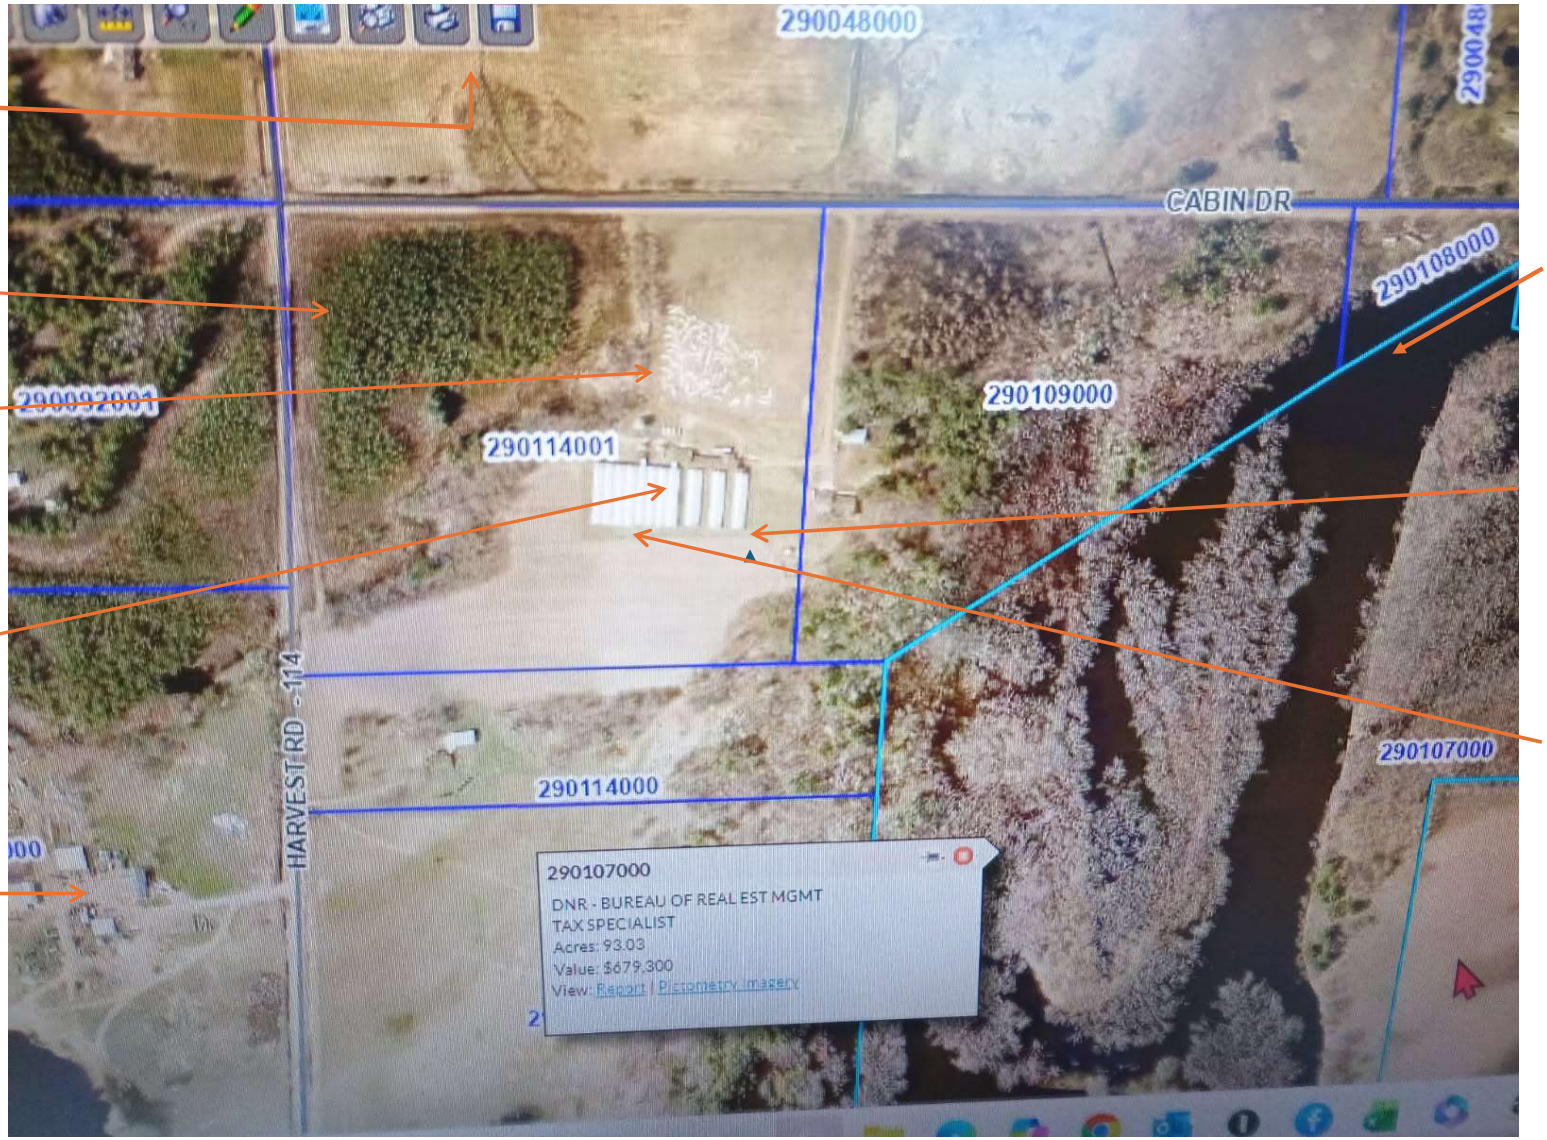
Weis's house north Nitrate 24.8ppm

Swamp wet land always standing water marked on map from DNR

Used fertilized grow bags left on ground to decompose.

Per Erba state document shallow well tested 23 ppm for nitrates

DeGrays well test 48ppm

Light blue line DNR land by Snake River

Greenhouses that had the drip directly into the soil for 28 years 1st 3.

Greenhouses that had a tank that over flowed into the ground because they could only use it 2 rounds before 1. physically too hot from circulation. 2. the fertilizer was off balance so they dumped at the end of the greenhouses in the ground.
