**Steven H. Emerman, Ph.D.**

Specializing in Groundwater and Mining

**Comments on the Draft Supplemental Environmental Impact Statement (DSEIS) for the  
Key Mill Tailings Storage Facility - Filtered Tailings Stack Height Raise**

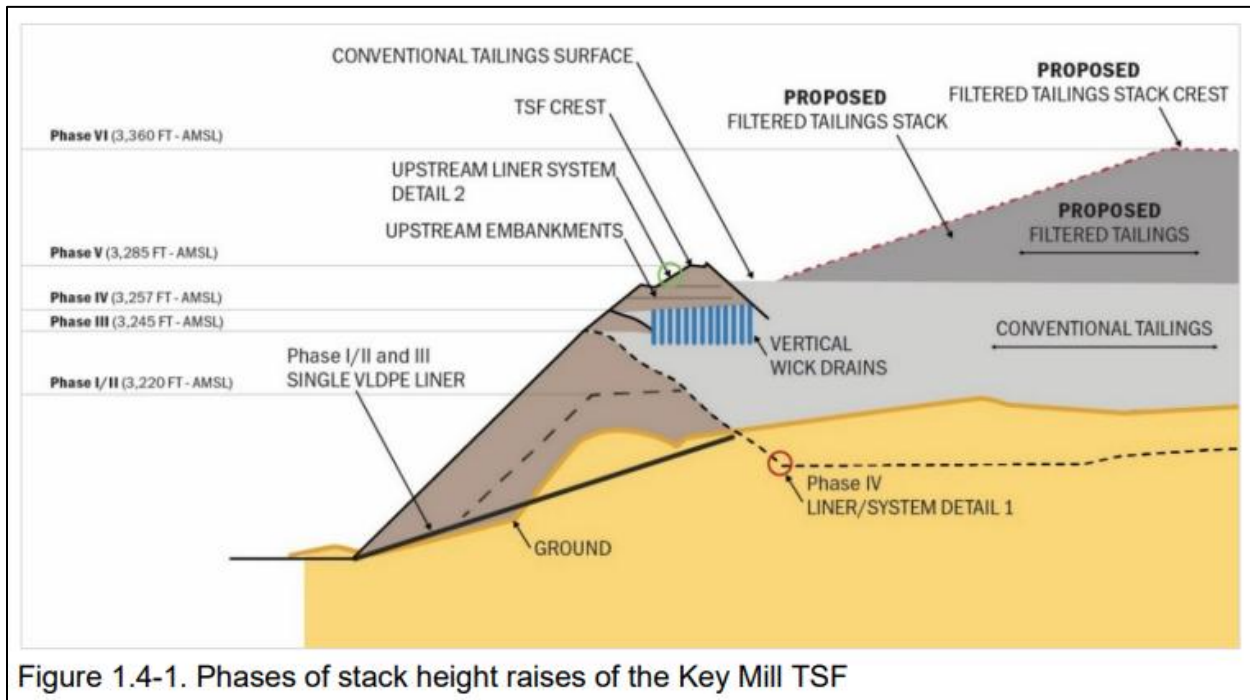
**Figure 2.** The filtered tailings storage facility would be constructed on top of an existing tailings storage facility that was constructed using the upstream method (compare with Fig. 4a). The upstream construction method was known to be unsafe even three decades prior to the use of the method at the Key Mill Tailings Storage Facility. Figure from WSDE (2026, pdf p. 21).

The filtered tailings storage facility would be constructed on top of an existing tailings storage facility that was constructed using the upstream method (see Figs. 1a-b, 2) with the excessively steep slope of 1V:2H (1 meter vertical for two meters horizontal) (see Fig. 3). The upstream construction method was known to be unsafe even three decades prior to the use of the method at the Key Mill Tailings Storage Facility. The construction of outer embankments with such excessively steep slopes was known to be unsafe at the time of construction of these embankments at the Key Mill Tailings Storage Facility.

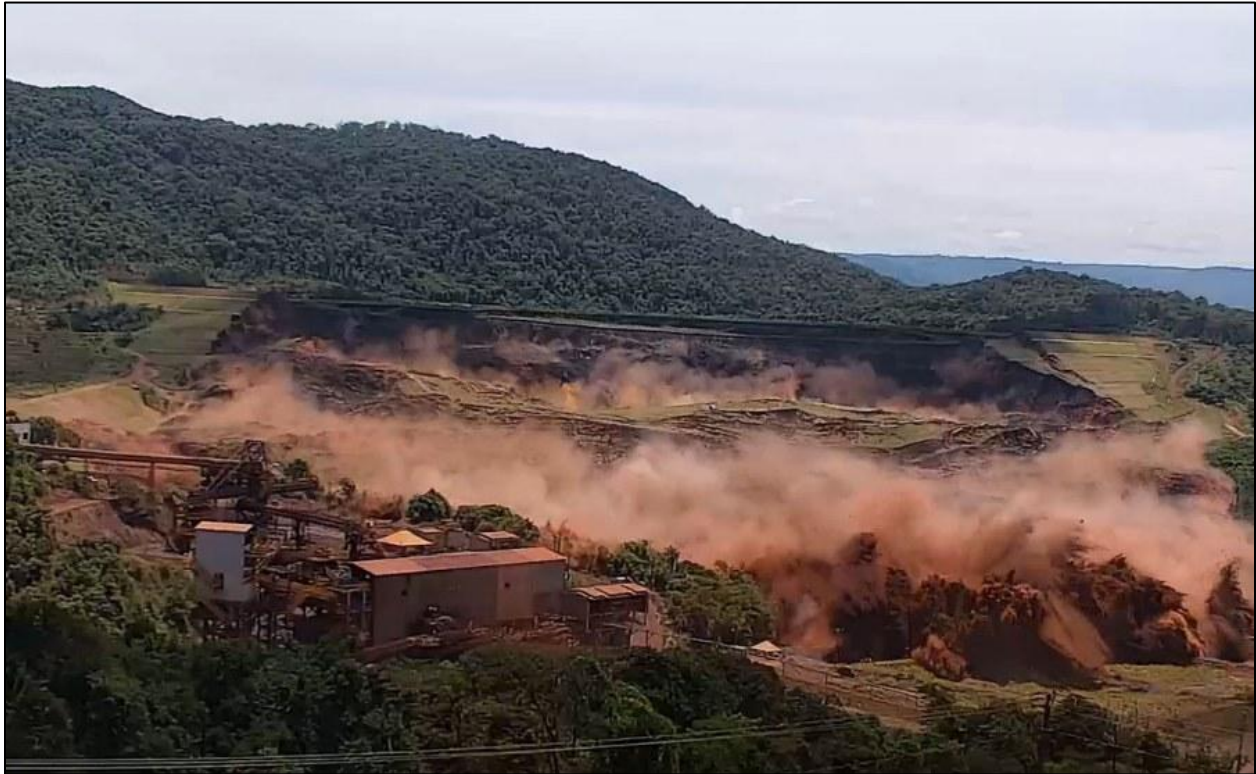
**Figure 5.** The failure of the upstream tailings dam at the Córrego do Feijão mine near Brumadinho, Brazil, on January 25, 2019, which resulted in 272 deaths, including the deaths of 258 mineworkers, was a watershed moment in the global awareness of the danger of the upstream construction method. However, in the five decades preceding the Brumadinho disaster, there were already numerous cautions and prohibitions regarding the use of the upstream method in guidance documents and regulations. Photo from Robertson et al. (2019).

The failure of the upstream tailings dam at the Córrego do Feijão mine near Brumadinho, Brazil, on January 25, 2019, which resulted in 272 deaths, including the deaths of 258 mineworkers (see Fig. 5; Robertson et al., 2019), was a watershed moment in the global awareness of the danger of the upstream construction method. However, in the five decades preceding the Brumadinho disaster, there were already numerous cautions and prohibitions regarding the use of the upstream method in guidance documents and regulations.
