**Re: Okanogan Highlands Alliance (OHA) Comments to the proposed DSEIS for expansion of the Key Mill Tailings Storage Facility – Stack Height Raise**

**Steven H. Emerman, Ph.D.**

Specializing in Groundwater and Mining

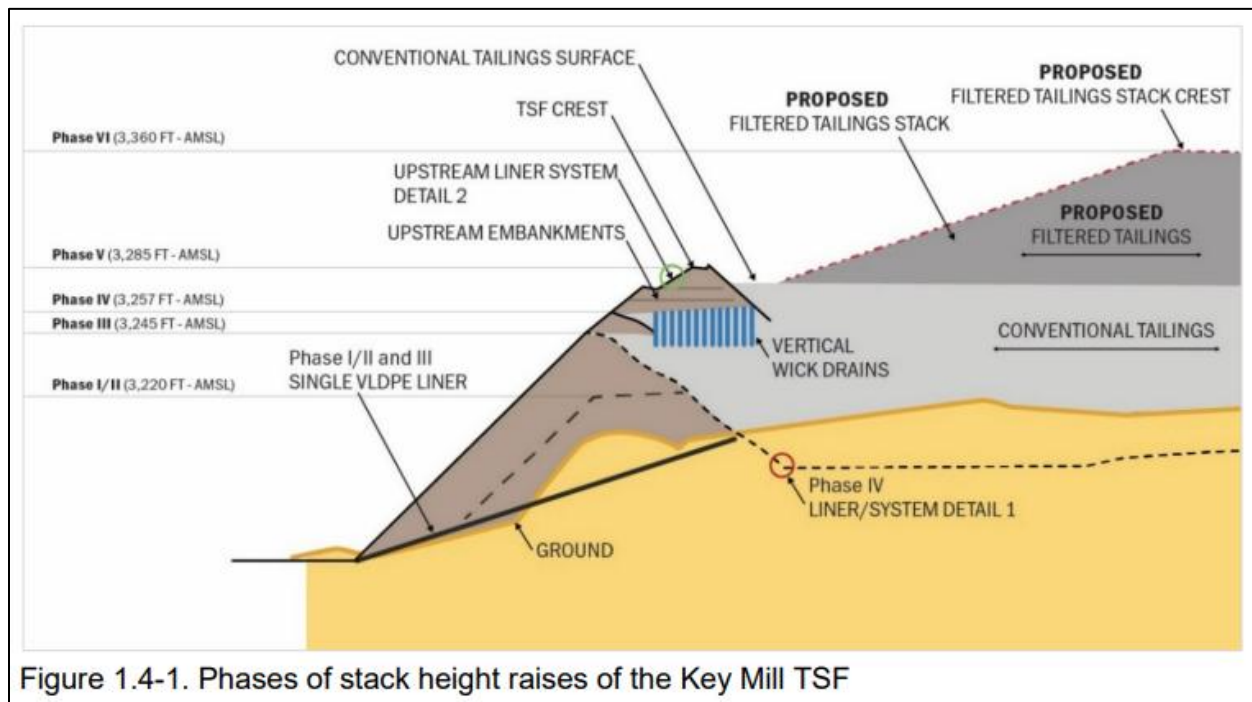
**Figure 2.** The filtered tailings storage facility would be constructed on top of an existing tailings storage facility that was constructed using the upstream method (compare with Fig. 4a). The upstream construction method was known to be unsafe even three decades prior to the use of the method at the Key Mill Tailings Storage Facility. Figure from WSDE (2026, pdf p. 21).

Although the existing tailings storage facility was constructed using unsafe methods, the central assumption of the DSEIS is that the construction of a filtered tailings storage facility on top of the existing facility will improve the stability of the existing facility. The assumption is that weight of the additional tailings would compact the underlying tailings, thus forcing out water that would drain downward through the vertical wick drains that would be constructed (see Fig. 2).

**Figure 1b.** The filtered tailings storage facility would be constructed on top of an existing tailings storage facility that was constructed using the upstream method (compare Fig. 2 with Fig. 4a). The upstream construction method was known to be unsafe even three decades prior to the use of the method at the Key Mill Tailings Storage Facility. See beginning of table in Fig. 1a. Table from WSDE (2026, pdf p. 23).

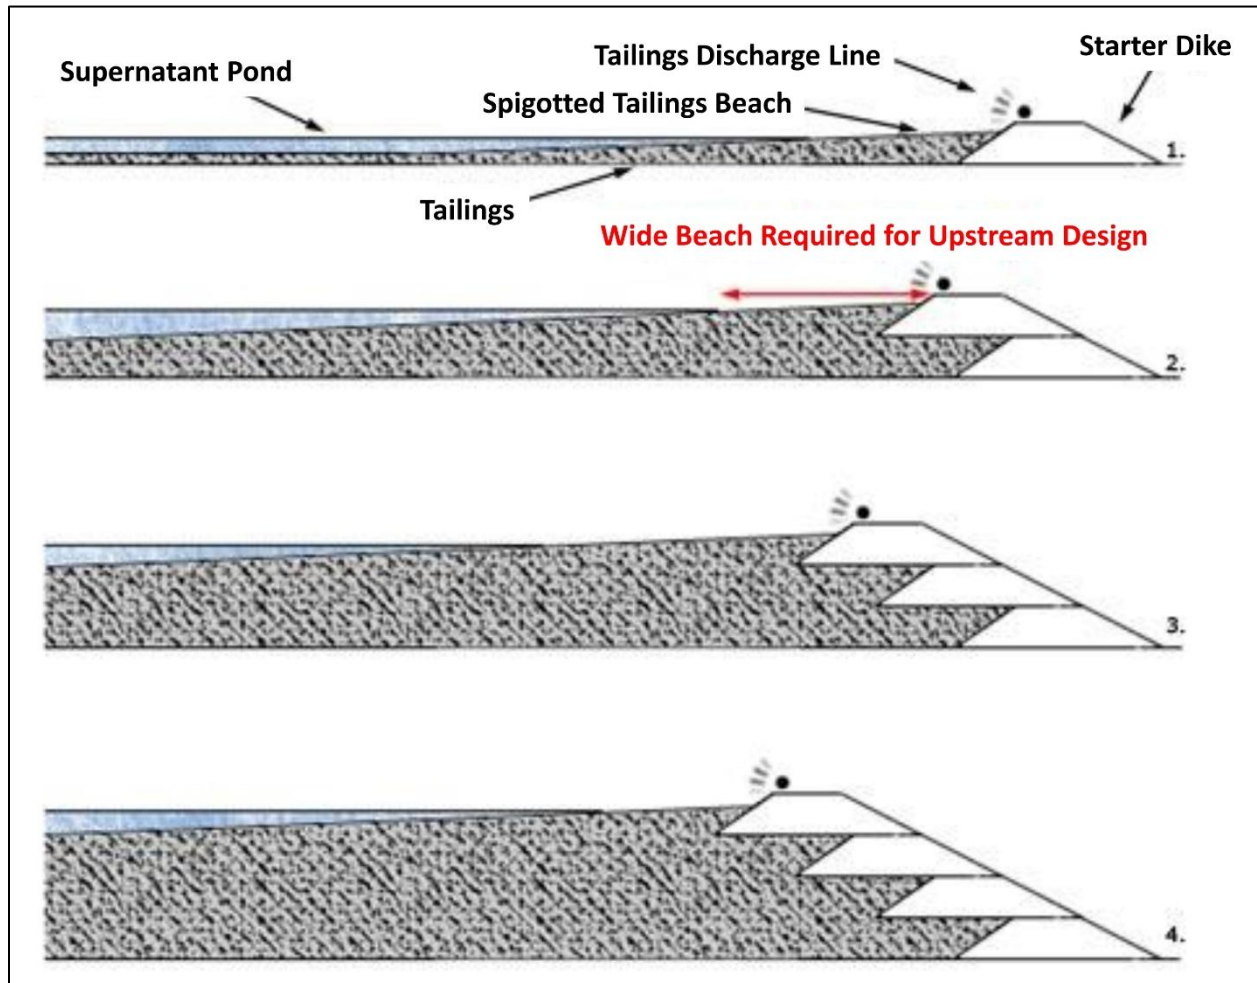
**Figure 4a.** In the upstream construction method, successive dikes are built in the upstream direction as the level of stored tailings increases. Dikes can be constructed with mine waste rock, natural soil, natural rock fill, or the coarser fraction of tailings (with proper compaction). The advantage of the method is its low cost because very little material is required for the construction of the dam. The disadvantage is that the dam is susceptible to failure due to seismic or static liquefaction because the non-compacted wet tailings are below the dam. For this reason, the upstream construction method is illegal in Brazil, Chile, Ecuador and Peru. Dams constructed by this method are also susceptible to flood failure when the beach is too narrow due to an insufficient amount of sand in the discharged tailings or excessive water in the settling pond. Figure from TailPro Consulting (2026).

Each of the three common methods of building tailings dams (upstream, downstream and centerline) begins with a starter dike, which is constructed from natural soil, rockfill, mine waste rock or the tailings from an earlier episode of ore processing (see Figs. 4a). If the starter dike is never raised, then the tailings dam is called a single-stage dam. In the upstream construction method, successive dikes are built in the upstream direction as the level of stored tailings increases. It is most common to build successive dikes from waste rock or the coarser fraction of tailings (typically with appropriate compaction). The advantage of the method is its low cost since very little material is required for the construction of the dam (see Fig. 4a). The downstream construction method is the most expensive since it requires the most construction material (compare Figs. 4a and 4b). In this method, successive dikes are constructed in the downstream direction as the level of stored tailings increases. The centerline construction method is a balance between the advantages and disadvantages of the downstream and upstream construction methods (compare Figs. 4a-c). In this method, successive dikes are constructed by

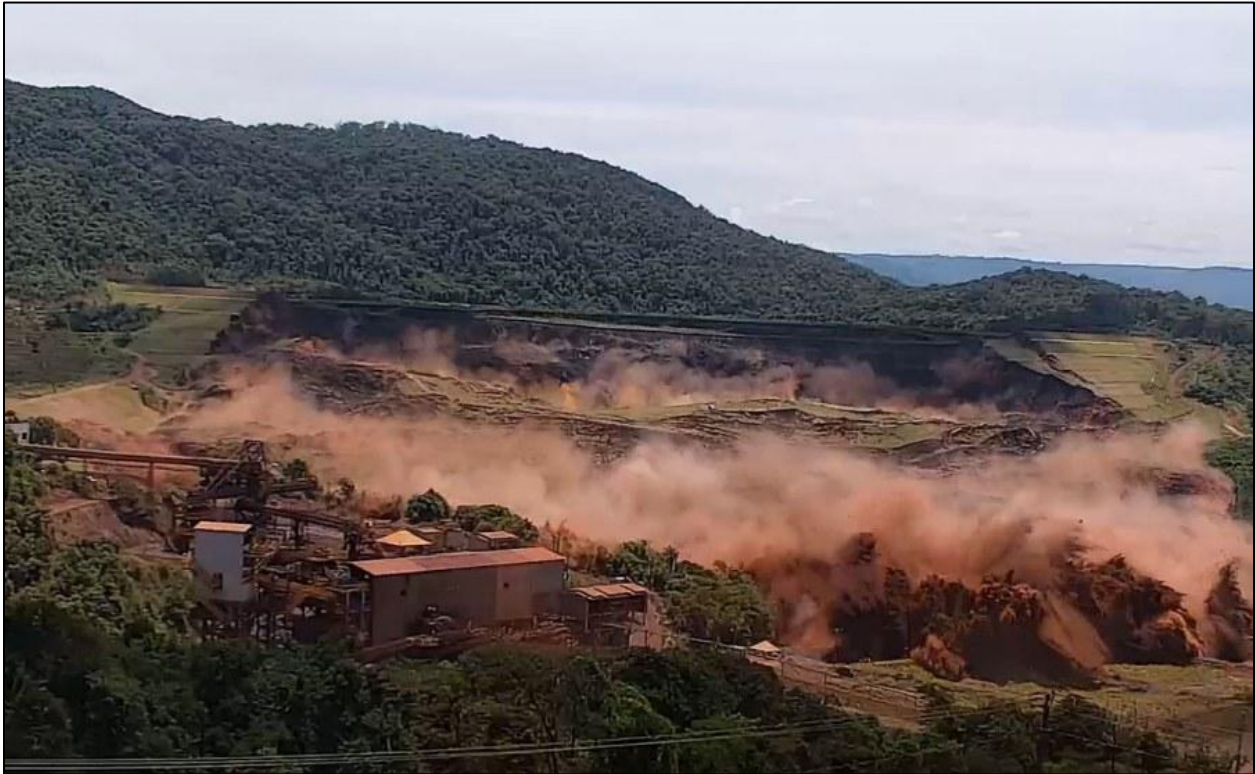
**Figure 5.** The failure of the upstream tailings dam at the Córrego do Feijão mine near Brumadinho, Brazil, on January 25, 2019, which resulted in 272 deaths, including the deaths of 258 mineworkers, was a watershed moment in the global awareness of the danger of the upstream construction method. However, in the five decades preceding the Brumadinho disaster, there were already numerous cautions and prohibitions regarding the use of the upstream method in guidance documents and regulations. Photo from Robertson et al. (2019).
