## Okanogan Highlands Alliance (Sarah Kliegman)

**Re: Okanogan Highlands Alliance (OHA) Comments to the proposed DSEIS for expansion of the Key Mill Tailings Storage Facility – Stack Height Raise**

**Steven H. Emerman, Ph.D.**

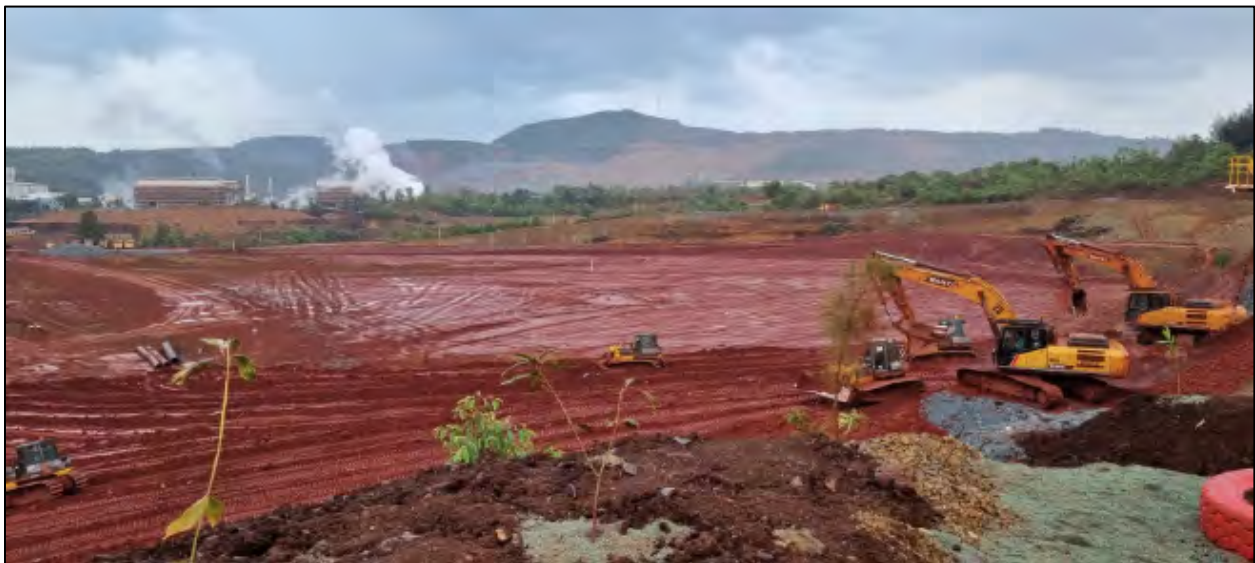
**Figure 4.** Panoramic view of filtered tailings storage facility in Indonesia. The precise location is not stated. Photo from Fisher and Grossl (2023).

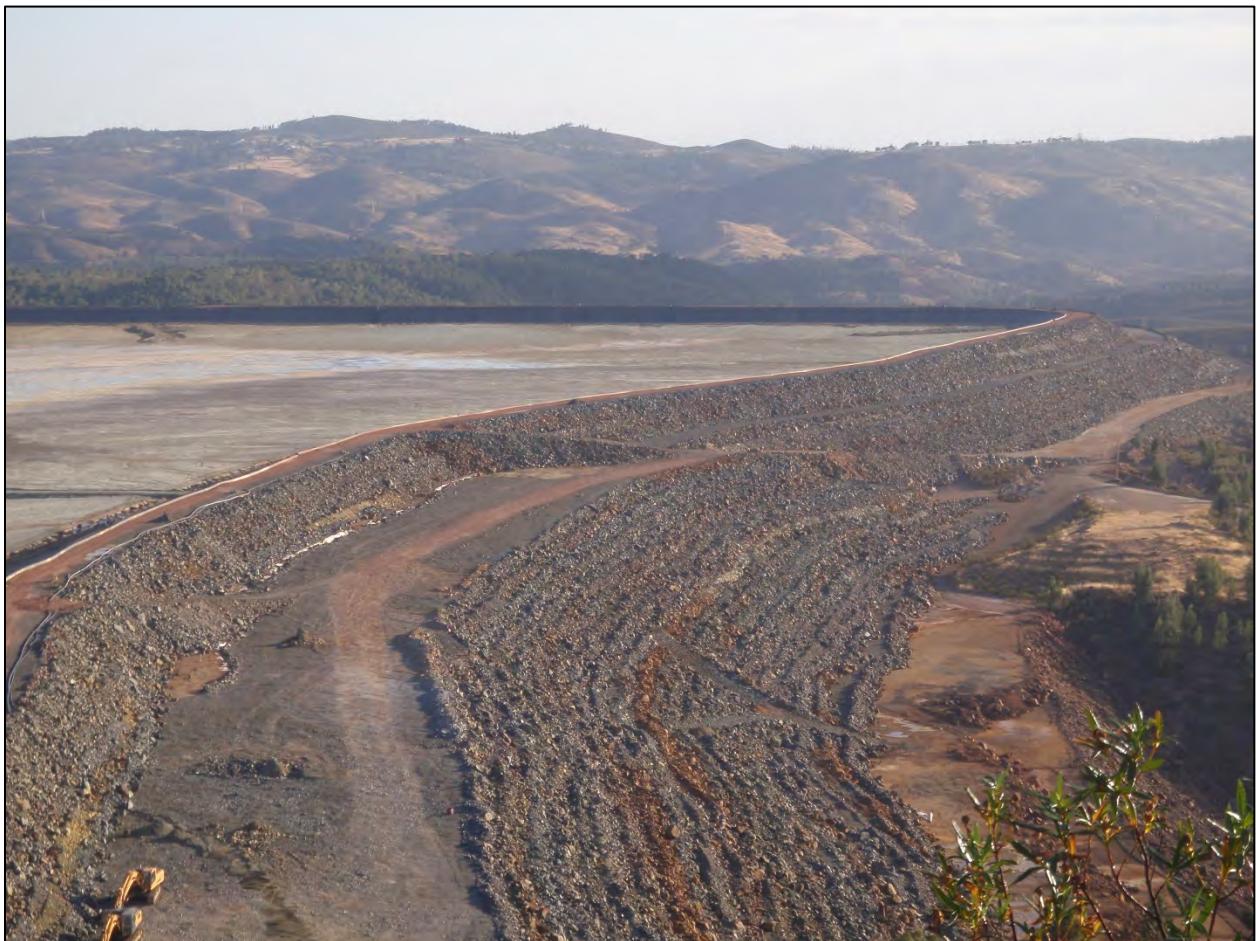
**Figure 7.** In conventional tailings management, wet tailings are permanently stored behind a dam constructed from waste rock, the coarser fraction of the tailings, or rockfill or earthfill that is available on the mine site. Photo of the Aguzadera dam at the Atalaya Mining Riotinto mine in Andalusia, Spain, taken by the author on June 19, 2019.

In summary, the permanent aboveground storage of tailings on land is often the only workable alternative at the present time (see Fig. 7). Despite the fact that it is often the only workable alternative, aboveground tailings storage facilities create the permanent threats of catastrophic collapse of the facilities, as well as the contamination of groundwater and surface

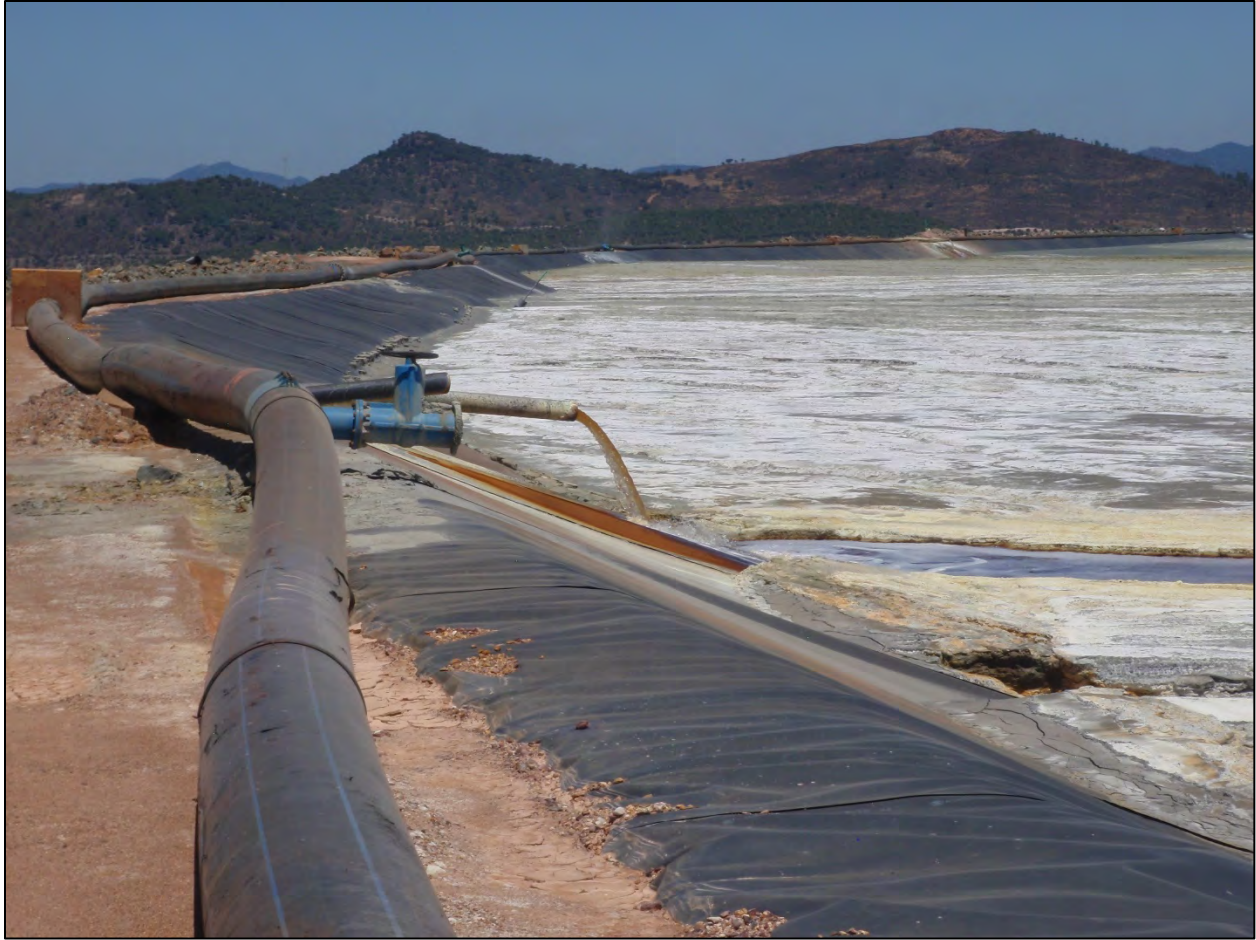
**Figure 8a.** A mixture of water and tailings with a solids content of 35% by mass is hydraulically discharged into the tailings pond from the crest of the Cobre dam at the Atalaya Mining Riotinto mine in Andalusia, Spain (see Fig. 7). Because of the lack of compaction, the loosely-packed tailings are susceptible to liquefaction (see Fig. 10). Photo taken by the author on June 21, 2019.

water by the tailings. Tailings are typically hydraulically discharged behind a dam that is constructed out of waste rock, the coarser fraction of tailings after suitable compaction, or earthfill or rockfill that is available on the mine site (see Figs. 8a-b). Tailings can be divided into two sizes with very different physical properties, which are the coarse tailings or sands (larger than 0.075 mm) and the fine tailings or slimes (smaller than 0.075 mm). The hydraulic discharge results in the separation of the sizes of tailings by gravity. The larger sands settle closer to the dam to form a beach. The smaller slimes and water travel farther from the dam to form a settling pond where the slimes slowly settle out of suspension. Typically, water is reclaimed from the settling pond and pumped back into the mining operation. The hydraulic discharge means that the tailings are too wet to be compacted in the tailings storage facility, the significance of which is discussed in the following subsection on “Liquefaction.”

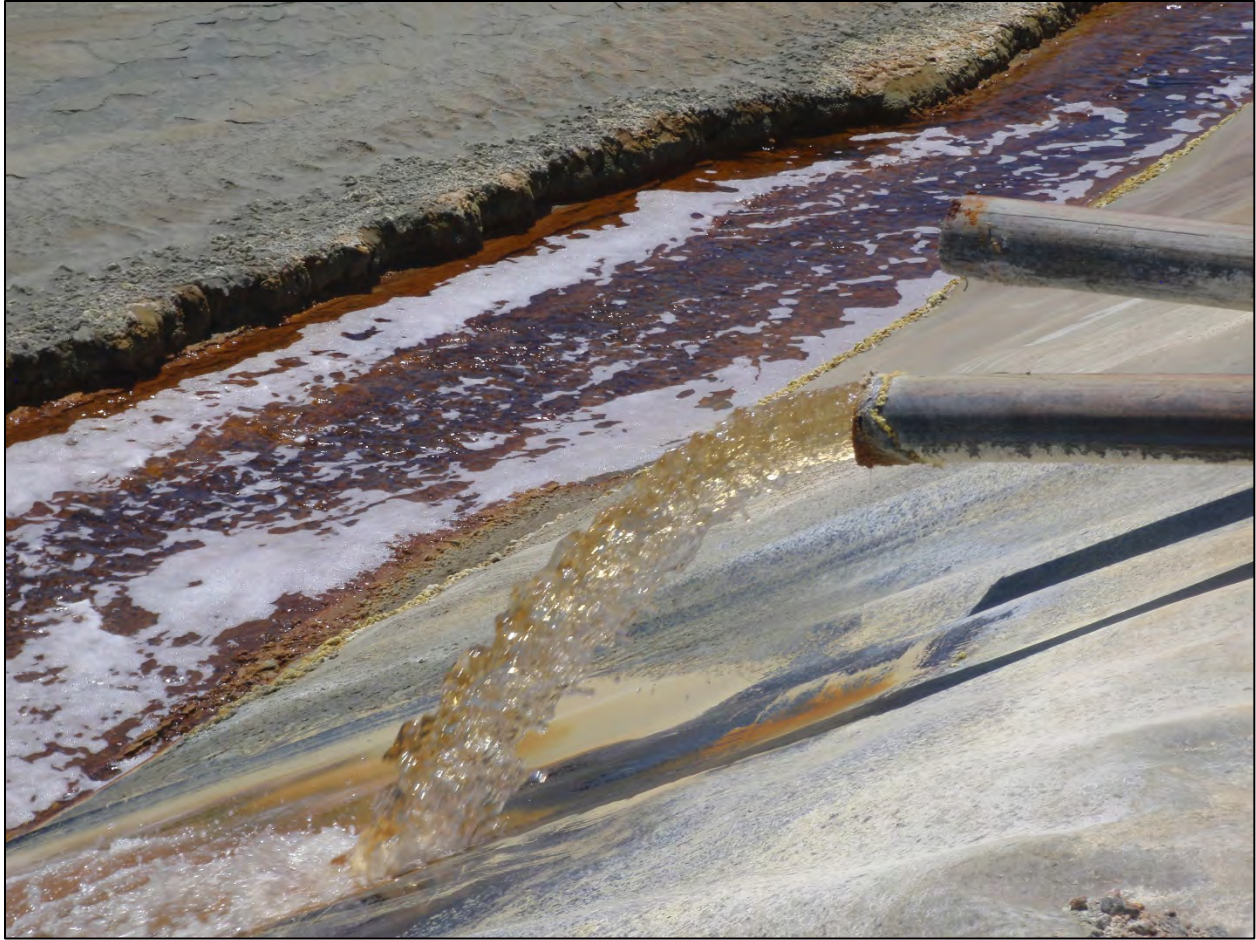
**Figure 8b.** A mixture of water and tailings with a solids content of 35% by mass is hydraulically discharged into the tailings pond from the crest of the Cobre dam at the Atalaya Mining Riotinto mine in Andalusia, Spain (see Fig. 7). Because of the lack of compaction, the loosely-packed tailings are susceptible to liquefaction (see Fig. 10). Photo taken by the author on June 21, 2019.

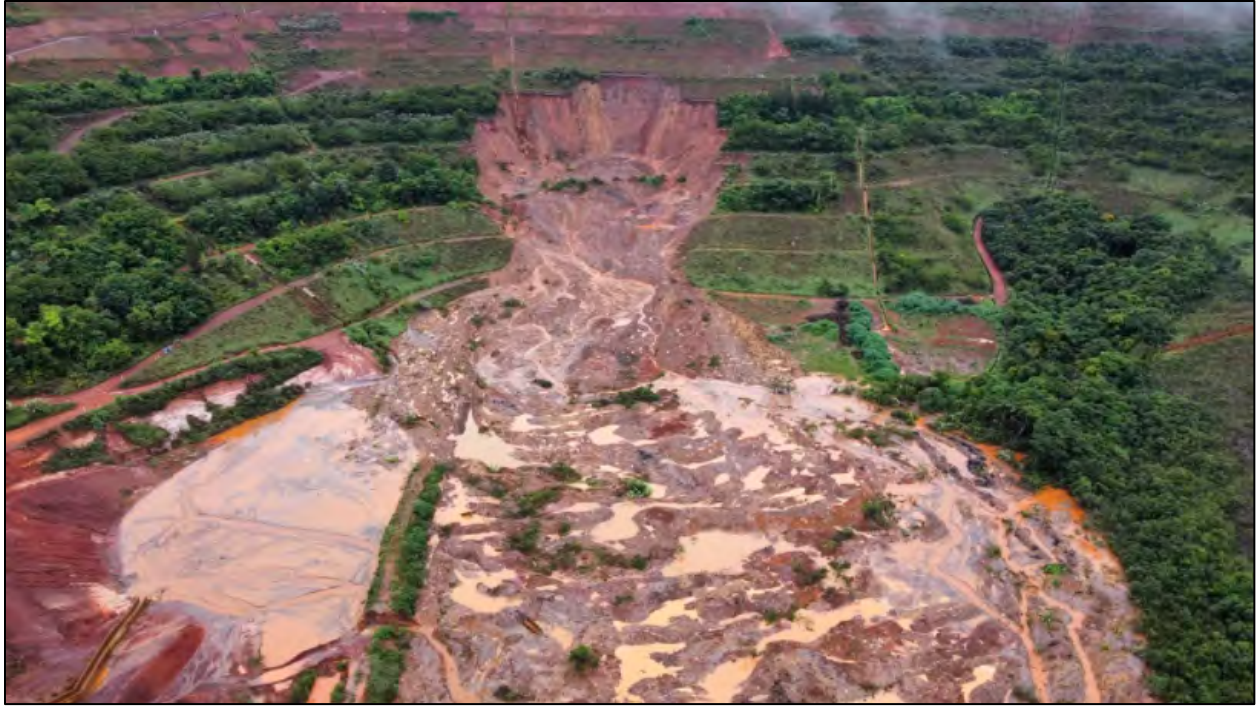
**Figure 14.** A 48-meter-high filtered tailings stack collapsed at the Pau Branco iron-ore mine in Brazil on January 8, 2022. Although filtered tailings are regarded as the Best Available Technology at the present time (Independent Expert Engineering Investigation and Review Panel, 2015; Morrill et al., 2022), the use of filtered tailings technology is not a license to ignore every other aspect of safety. Photo from Angelo (2022).

The strongest argument of all that failure of filtered tailings storage facilities is possible is that, aside from the failures in Indonesia that are documented in this report, at least three catastrophic failures of filtered tailings storage facilities occurred from 2022 to 2024. The first failure was the collapse of the 48-meter-high filtered tailings stack at the Pau Branco iron-ore mine owned by the French company Vallourec in Brazil on January 8, 2022 (see Fig. 14). The resulting slump buried Highway BR-40, but without any fatalities (see Figs. 15a-b). The second failure occurred on September 24, 2024, when the filtered tailings storage facility of the mining company Cuzcatlán SA de CV, a subsidiary of the Canadian company Fortuna Mining, in Oaxaca, Mexico, released contaminated water into the El Coyote river (Desinformémonos, 2024; EDUCA, 2024; see Fig. 16). The contamination extended to the drinking water well that supplies the communities of Magdalena Ocotlán and San Matías Chilazoa. A previous failure with release of contaminated water had reportedly occurred in 2018 (Desinformémonos, 2024). The third failure occurred on December 7, 2024, when a filtered tailings stack collapsed at the Turmalina gold mine again in Brazil, resulting in burial of part of the mining infrastructure, including the emergency escape exit, and the evacuation of 134 community members (Petley, 2024; see Fig. 17).

annual precipitation of 711 mm (see Table 6a and Fig. 25a). The failures of the filtered tailings storage facilities at the Pau Branco and Turmalina mines in Brazil have already been discussed (see Figs. 14, 15a-b, and 17). The filtered tailings storage facility at the Pinos Altos mine in Mexico has also been reported as unstable with no further information (Franks et al., 2021; UNEP et al., 2025). Assigning mean annual precipitations of 1597, 1360, and 1046 mm (Fick and Hijmans, 2017), and tailings storage volumes of 2.85, 0.71, and 5.152 million cubic meters (Agência Nacional de Mineração, 2025; UNEP et al., 2025) for the filtered tailings storage facilities at the Pau Branco, Turmalina, and Pinos Altos mines, respectively, shows that construction even well within the current technological limit is no guarantee of success (see Fig. 25a).

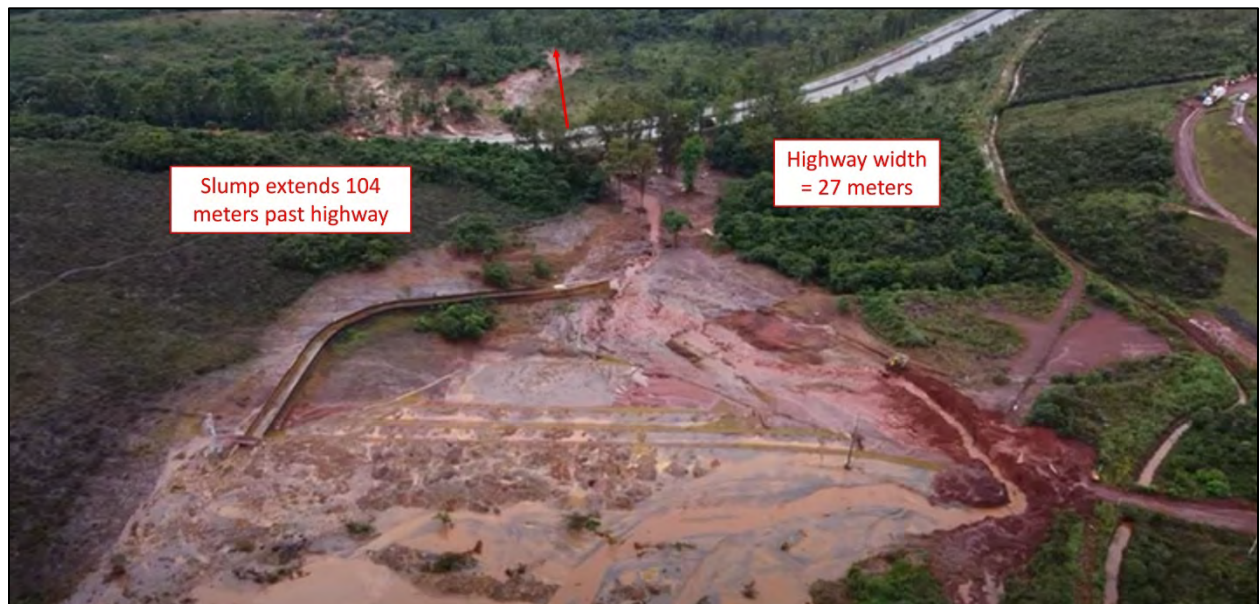
**Figure 15a.** Based on the highway width of 27 meters, the slump at the filtered tailings storage facility at the Pau Branco mine in Brazil on January 8, 2022 (see Fig. 14), extended for 104 meters past Highway BR-40. Highway width was measured from Google Earth image from June 29, 2022 (see Fig. 15b). Still image at 0:38 of drone video (Observatório da Mineração [Mining Observatory], 2022).

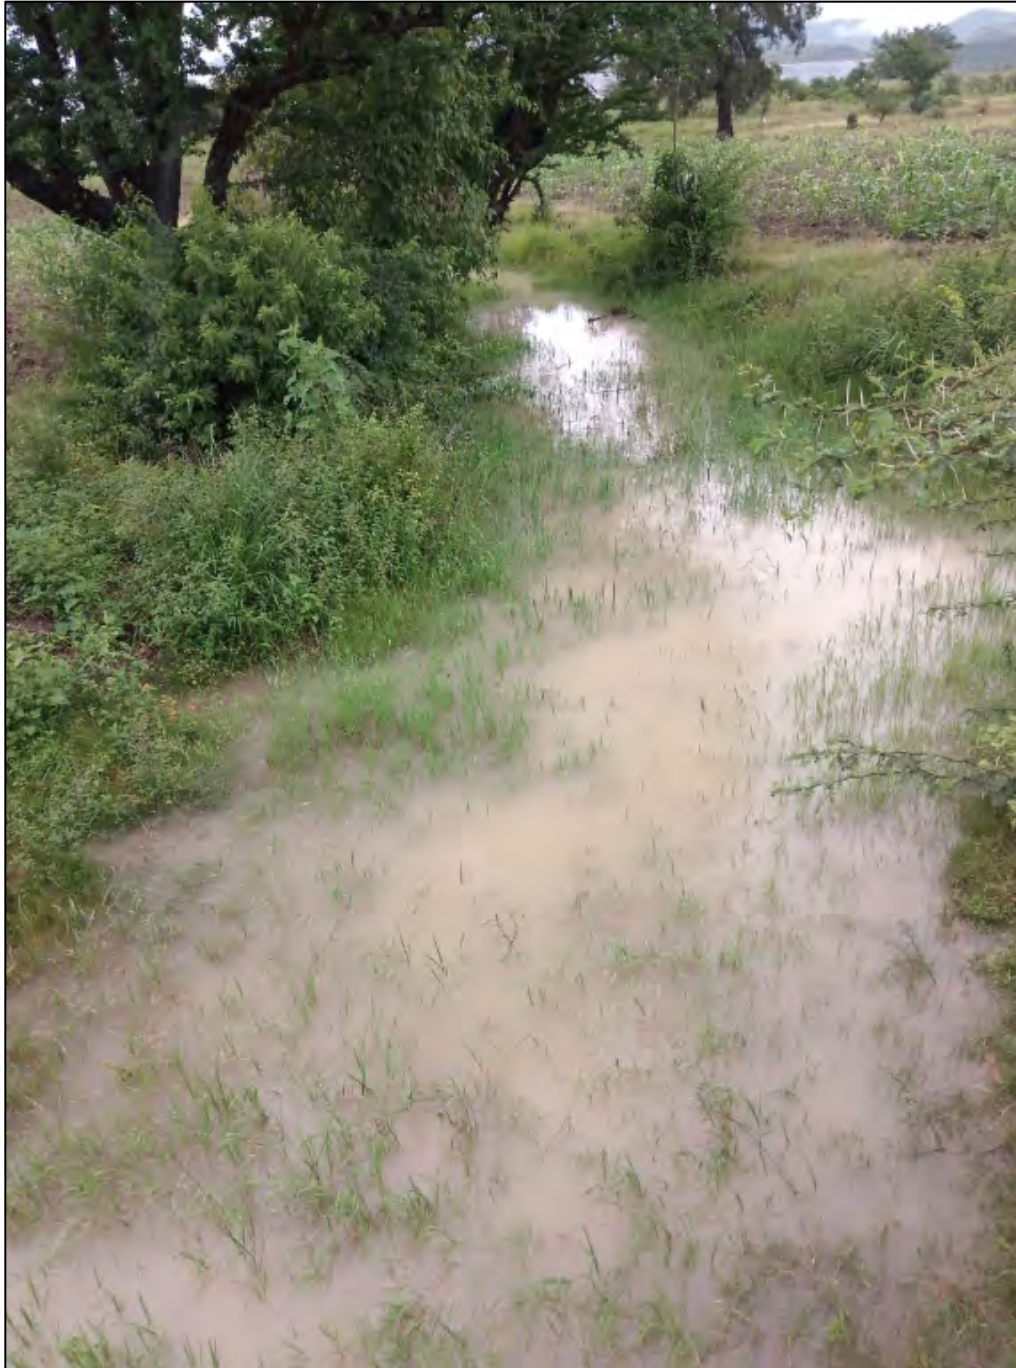
**Figure 16.** On September 24, 2024, a failure of the filtered tailings storage facility of the mining company Cuzcatlán SA de CV, a subsidiary of the Canadian company Fortuna Mining, in Oaxaca, Mexico, released contaminated water into the El Coyote river. The contamination extended to the drinking water well that supplies the communities of Magdalena Ocotlán and San Matías Chilazoa. A previous failure with release of contaminated water had occurred in 2018. Photo from Desinformémonos (2024).

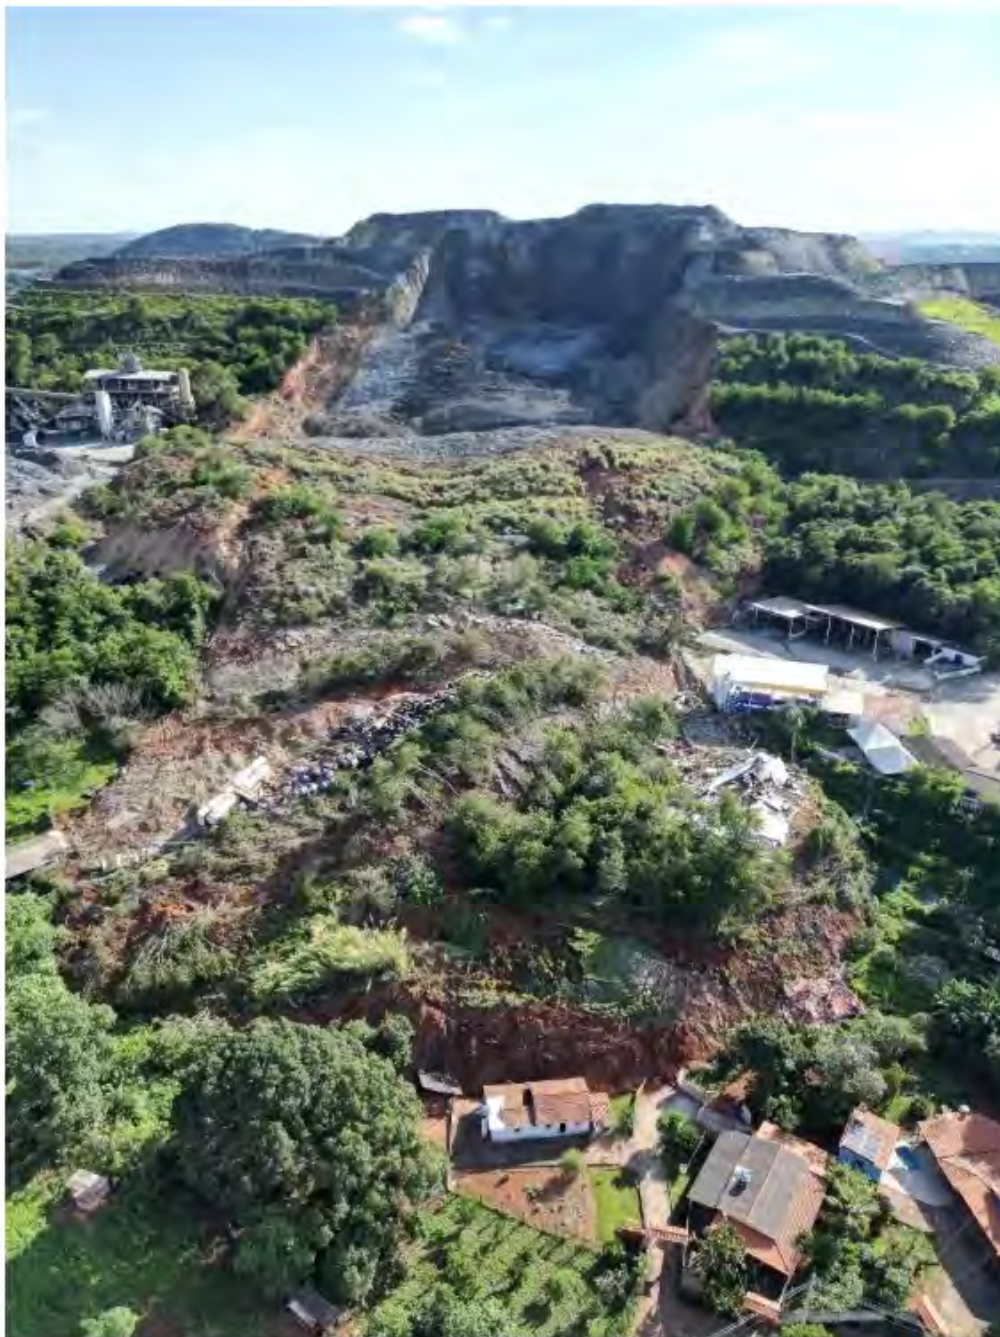
The aftermath of the 7 December 2024 Turmalina Mine landslide in Brazil. Image posted to LinkedIn by Walinton Sousa.

**Figure 17.** A filtered tailings stack collapsed at the Turmalina gold mine in Brazil on December 7, 2024, resulting in burial of part of the mining infrastructure, including the emergency escape exit, and the evacuation of 134 community members. Although filtered tailings are regarded as the Best Available Technology at the present time (Independent Expert Engineering Investigation and Review Panel, 2015; Morrill et al., 2022), the use of filtered tailings technology is not a license to ignore every other aspect of safety. Based on a height of 19 meters (Agência Nacional de Mineração, 2025) and runout of 400 meters, the tailings slump extended for 21 times the height, which is similar to the height-runout relation for the collapse at the Pau Branco mine (see Figs. 15a-b). Photo from Petley (2024).

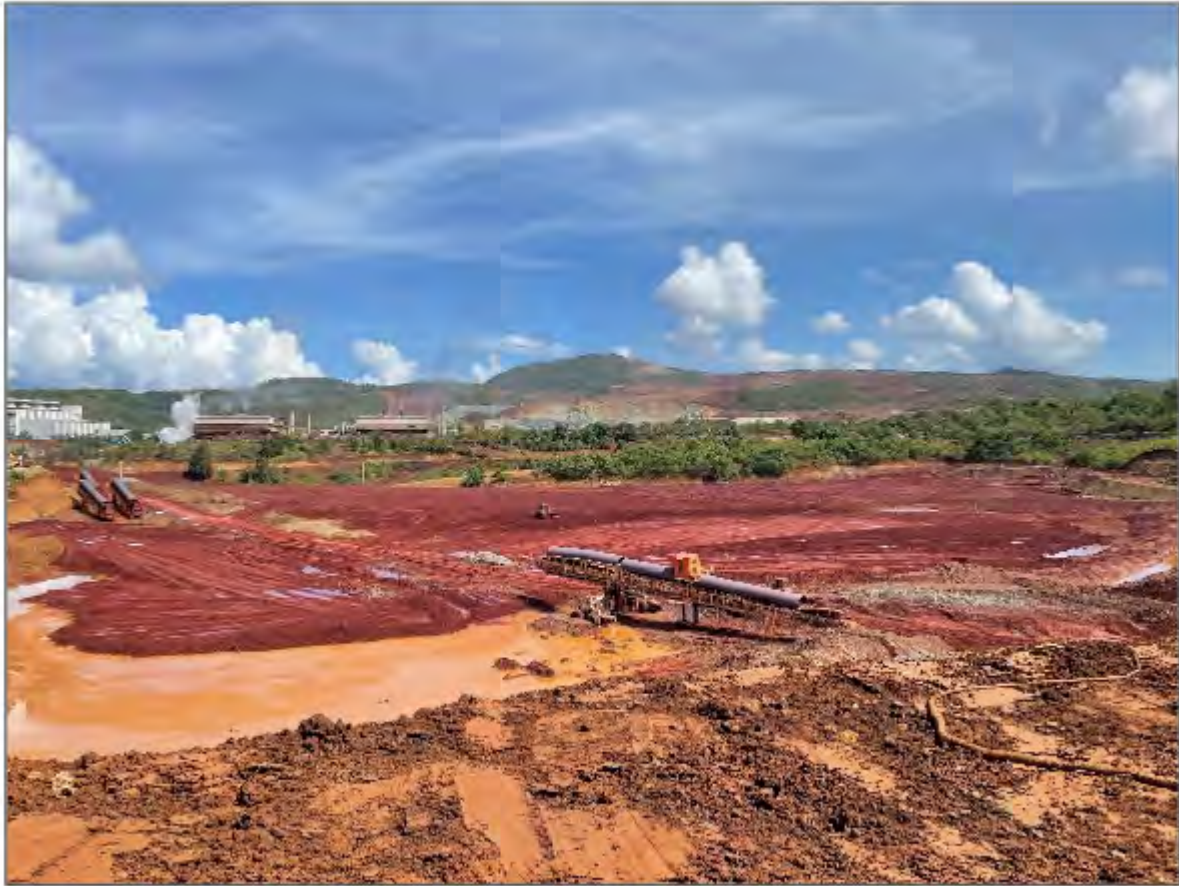
**Figure 9-11: View of DSTF area with significant water ponding**

**Figure 35a.** The first revision of the 2022 report by SRK Consulting (2022b) included a large photo with the heading “View of DSTF area with significant water ponding.” Surface ponding is a very serious problem for a filtered tailings storage facility because the ponded water can lead to erosion and washouts (gully formation) of the filtered tailings stack and because the ponded areas are not trafficable. Moreover, ponding raises the possibility that the entire stack might be saturated and liquefiable, while the surface water would promote flow behavior if a collapse did occur. According to SRK Consulting (2022b), **“During the site visit, some issues with water ponding and poor drainage appeared to be present (Figure 9-11) ...** The design considered that the compaction imposed on the tailings would be sufficient to prevent liquefaction; however, it is SRK’s opinion that given the height of the facility (57 m), the lack of quality control in the placement of tailings, **and the observed surface water issues,** further study is required to assess the risk for the tailings to exhibit contractive behaviour during undrained shearing” (emphasis added). A simple way to assess whether the entire stack might be saturated would be to inquire as to the persistence of surface ponding after the cessation of rainfall. SRK Consulting did not include information on the persistence of water ponding in their 2022 report. Photo from SRK Consulting (2022b). Photo from SRK Consulting (2022b).

The purpose of this subsection is to provide further evidence for the imminent catastrophic failure of the DSTF, as well as examples of the actions that SRK Consulting took to dramatically minimize the evidence of serious problems with the DSTF. Revision 1 of the 2022 report by SRK Consulting (2022b) included a large (half-page) photo with the heading “View of DSTF area with significant water ponding” (see Fig. 35a). SRK Consulting (2022b) interpreted the surface ponding as a significant risk for liquefaction. According to SRK Consulting (2022b), **“During the site visit, some issues with water ponding and poor drainage appeared to be present (Figure 9-11) ... The design considered that the compaction imposed on the tailings would be sufficient to prevent liquefaction; however, it is SRK’s opinion that given the height of the facility (57 m), the lack of quality control in the placement of tailings, and the observed surface water issues, further study is required to assess the risk for the tailings to exhibit contractive behaviour during undrained shearing”** (emphasis added). The above photo was gradually reduced in size, while the heading and interpretation were completely eliminated through the sequence of revisions (see Figs. 35b-e). Before reviewing the edits made to a series of report drafts that minimize the issues with the DSTF, it is important to discuss why surface ponding matters.

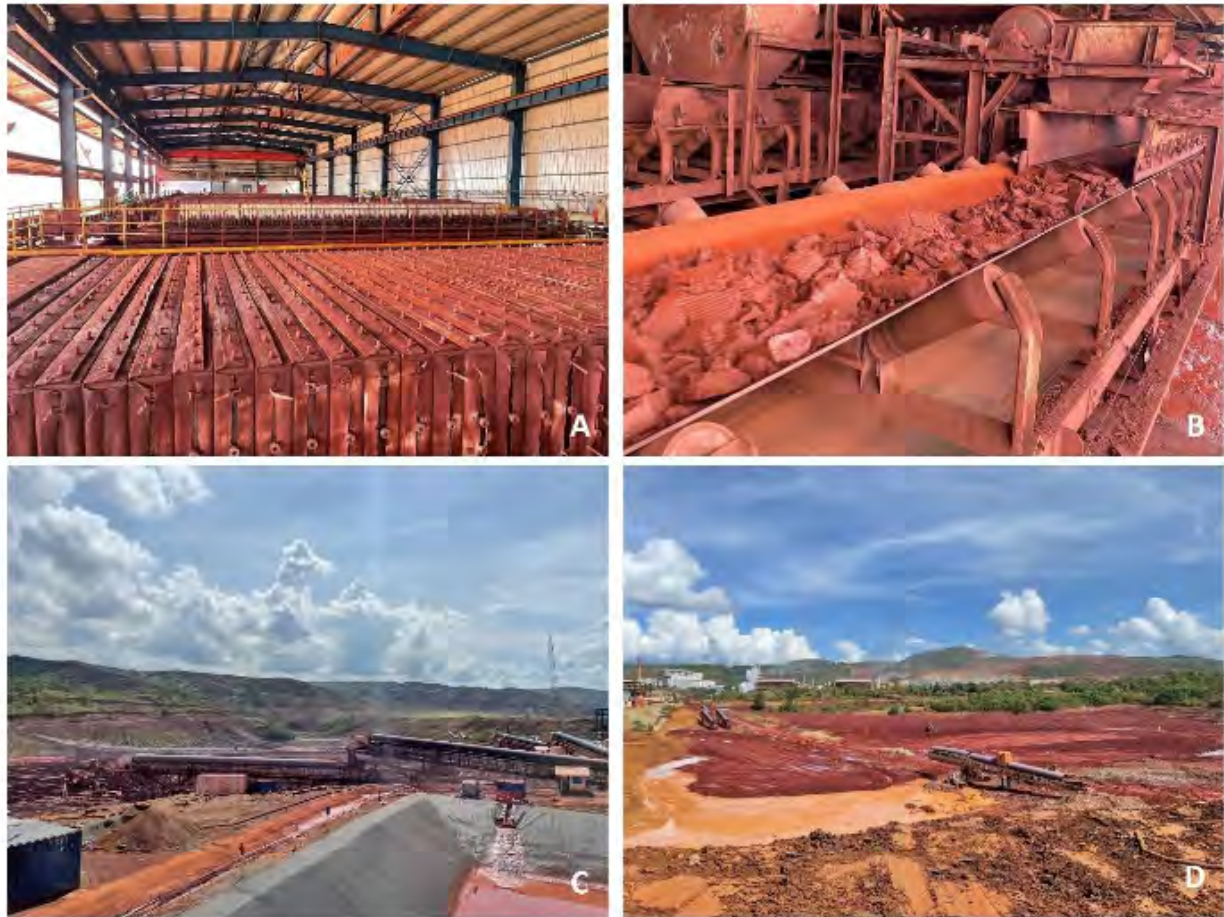
**Figure 8-6: DSFT operation**

Note: A: filter presses, B: Conveyor belt with filtered material, C: View of conveyors and earthmoving plant and D: View of DSTF area with water ponding issue

**Figure 35b.** The large photo with the heading “View of DSTF area with significant water ponding” in the first revision of the 2022 report by SRK Consulting (2022b) was made much smaller in a follow-up to the first revision (SRK Consulting, 2022c) and the caption was changed to “View of DSTF area with water ponding issues.” Otherwise, the photo is identical. The follow-up to the first revision still states, “**During the site visit, some issues with water ponding and poor drainage appeared to be present** ... The design considered that the compaction imposed on the tailings would be sufficient to prevent liquefaction, however it is SRK's opinion that given the height of the facility (57 m), the lack of quality control in the placement of tailings, **and the observed surface water issues**, a further study is required to assess the risk for the tailings to have contractive behaviour during undrained shearing” (emphasis added). The above photo, caption, and quote in SRK Consulting (2022c) are unchanged through Revision 8 (SRK Consulting, 2022e), except that “DSTF” was changed to “dry stack tailings facility” in the photo caption and “poor drainage” was changed to “drainage” in the quote. Photo from SRK Consulting (2022c).

Given the available information, it does not appear that SRK Consulting determined the cause or causes of the surface ponding. SRK Consulting did observe the significant ponding and poor drainage issues, but successive drafts of their report removed key language, minimizing the risks these issues pose to the DSTF. In the follow-up to Revision 1 (called Rev1\_Draft) (SRK Consulting, 2022c), the large photo of surface ponding in Revision 1 (see Fig. 35a) was reduced to a one-quarter of its previous size (see Fig. 35b). The heading “View of DSTF area with significant water ponding” (SRK Consulting, 2022b; see Fig. 35a) was softened to the caption “View of DSTF area with water ponding issues” (SRK Consulting, 2022c; see Fig. 35b). Otherwise, the photo is identical between the two versions (compare Figs. 35a-b). The follow-up to Revision 1 still states, “**During the site visit, some issues with water ponding and poor drainage appeared to be present ...** The design considered that the compaction imposed on the tailings would be sufficient to prevent liquefaction, however it is SRK’s opinion that given the height of the facility (57 m), the lack of quality control in the placement of tailings, **and the observed surface water issues**, a further study is required to assess the risk for the tailings to have contractive behaviour during undrained shearing” (emphasis added) (SRK Consulting, 2022c). The above photo, caption, and quote in SRK Consulting (2022c) were unchanged

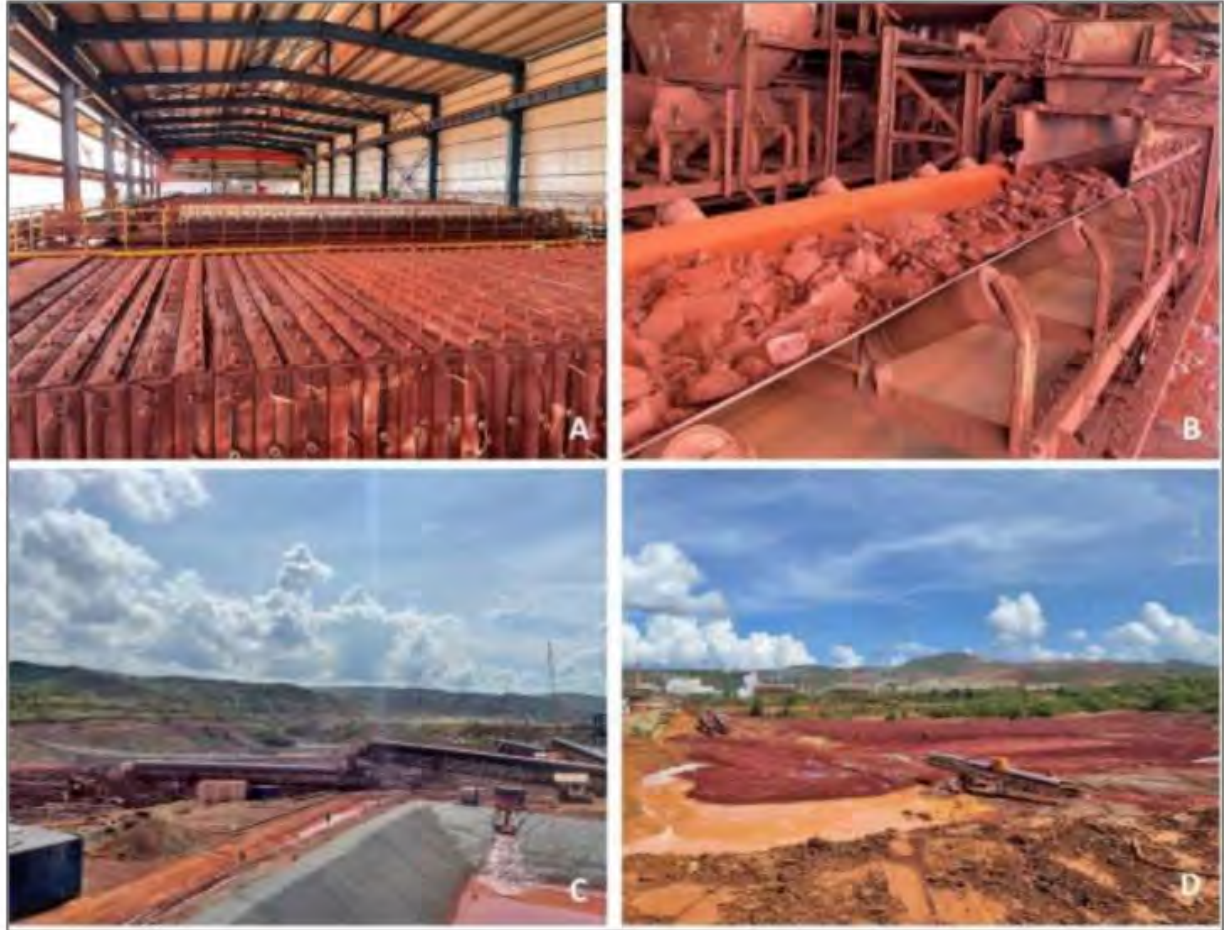
**Figure 7-6: Dry stack tailings facility operation**

**Note:** A: filter presses, B: Conveyor belt with filtered material, C: View of conveyors and earthmoving plant and D: View of dry stack tailings facility area

**Figure 35c.** In Revision 8A, the photo caption of the previous revisions that stated, “View of DSTF area with water ponding issues” or “View of dry stack tailings facility area with water ponding issues” (see Fig. 35b) was changed to “View of dry stack tailings facility area” with no change in the photo. In the quote from Revision 8 that stated, **“During the site visit, some issues with water ponding and drainage appeared to be present ...** The design considered that the compaction imposed on the tailings would be sufficient to prevent liquefaction, however it is SRK’s opinion that given the height of the facility (57 m), the lack of quality control in the placement of tailings, **and the observed surface water issues,** a further study is required to assess the risk for the tailings to have contractive behaviour during undrained shearing” (emphasis added) (SRK Consulting, 2022e), the sentence “During the site visit, some issues with water ponding and drainage appeared to be present” was removed, as well as the phrase “and the observed surface water issues,” which actually left the last sentence grammatically incorrect. The photo, caption, and quote were unchanged through the final revision (SRK Consulting, 2022a), except that the quote was fixed to be grammatically correct: “The design considered that the compaction imposed on the tailings would be sufficient to prevent liquefaction; however, it is SRK’s opinion that given the height of the facility (57 m) and the lack of quality control in the placement of tailings, further study is required to assess the risk for the tailings to exhibit contractive behaviour during undrained shearing.” Photo from SRK Consulting (2022f).

The significant change occurred in the transition from Revision 8 (SRK Consulting, 2022e) to Revision 8A (SRK Consulting, 2022f). In Revision 8A, the photo caption of the previous revisions that had stated “View of DSTF area with water ponding issues” (SRK Consulting, 2022c; see Fig. 35b) or “View of dry stack tailings facility area with water ponding issues” (SRK Consulting, 2022e) was changed to “View of dry stack tailings facility area” (SRK Consulting, 2022e; see Fig. 35c) with no change in the photo. Thus, the observation of surface ponding was eliminated entirely. In the quote from Revision 8 that stated, **“During the site visit, some issues with water ponding and drainage appeared to be present ...** The design considered that the compaction imposed on the tailings would be sufficient to prevent liquefaction, however it is SRK's opinion that given the height of the facility (57 m), the lack of quality control in the placement of tailings, **and the observed surface water issues,** a further study is required to assess the risk for the tailings to have contractive behaviour during undrained shearing” (emphasis added) (SRK Consulting, 2022e), the sentence “During the site visit, some issues with water ponding and drainage appeared to be present” was removed, as well as the phrase “and the observed surface water issues,” which actually left the last sentence grammatically incorrect. Thus, all mention of the observation of surface ponding, as well the significance of surface ponding, was removed from Revision 8A (SRK Consulting, 2022e). The full quote in Revision 8A states, “The design considered that the compaction imposed on the tailings would be sufficient to prevent liquefaction; however it is SRK's opinion that given the height of the facility (57 m), the lack of quality control in the placement of tailings, a further study is required to assess the risk for the tailings to have contractive behaviour during undrained shearing” (SRK Consulting, 2022e). Figs. 35d-e shows the Track Changes version of Revision 8A (SRK Consulting, 2022g) that clarifies the critical deletions that were made in the transition from Revision 8 to Revision 8A.

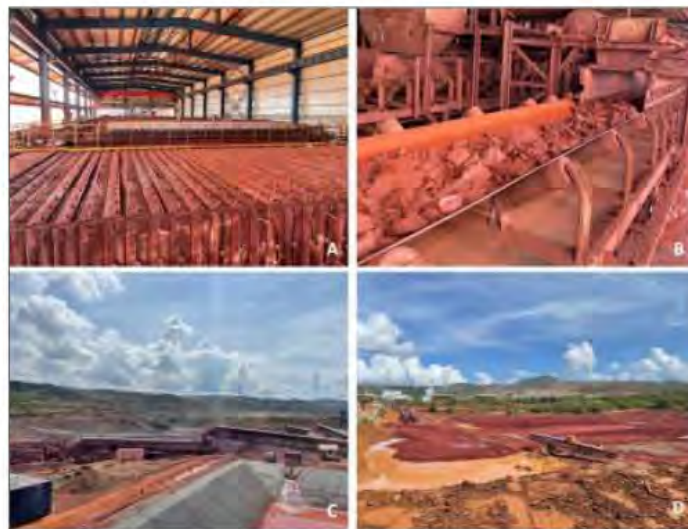
Figure 7-6: Dry stack tailings facility operation

Note: A: filter presses, B: Conveyor belt with filtered material, C: View of conveyors and earthmoving plant and D: View of dry stack tailings facility area.

**Figure 35d.** The Track Changes version that compares Revision 8A with Revision 8 clarifies the changes that were made. First, the phrase “with water ponding issue” was removed from the photo caption. See additional change in Fig. 35e. Photo with changes from SRK Consulting (2022g).

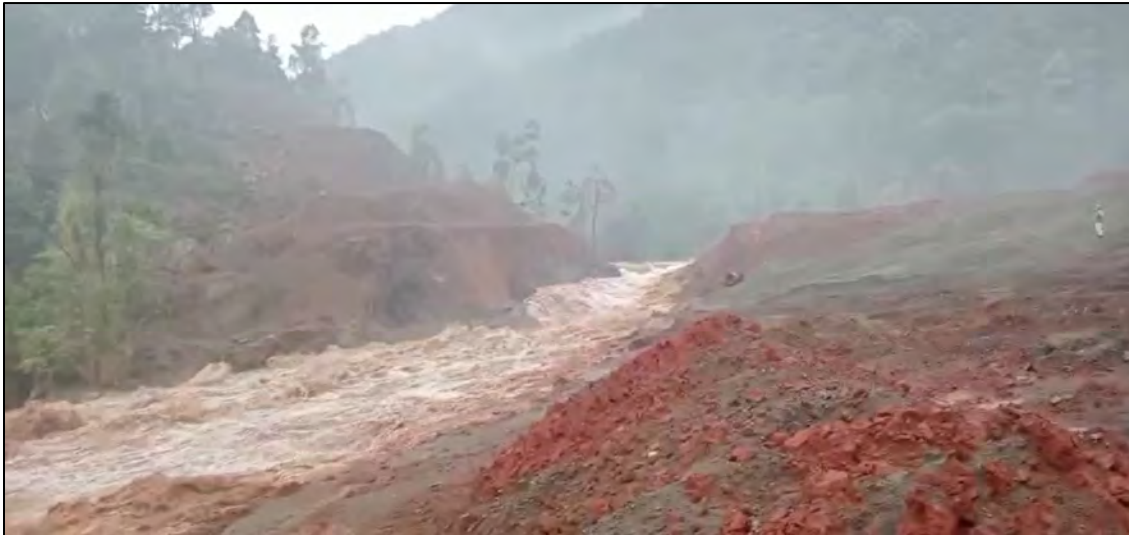
**Figure 40a.** Liquefied tailings flow through a breach of the filtered tailings storage facility of PT Huayue Nickel Cobalt (HYNC) in the Indonesia Morowali Industrial Park (see Figs. 3, 24, and 41a-b) on March 16, 2025. Still image at 0:00 of 9-second video by mineworker at PT HYNC. Photo also available in Business & Human Rights Resource Centre (2025a) and Moore (2025).

On March 16, 2025, the filtered tailings storage facility of PT Huayue Nickel Cobalt (HYNC) failed by liquefaction (see Fig. 40a), which was the first documented case of liquefaction of a filtered tailings stack. According to Asnawi (2025), “*Morowali yang memiliki curah hujan tinggi menjadikan dried tailing berubah menjadi lumpur dan membelah dinding tanggul*” [Morowali, which has high rainfall, causes dried tailings to turn into mud and split the embankment walls]. From the PT HYNC tailings facility, the released tailings flowed approximately two kilometers eastward to reach the Bahodopi River, from where the tailings flowed northwestward toward the Banda Sea with overflow onto the site of PT Fajar Metal Industry (FMI) (see Figs. 24, 40b-c, and 41a) (Bhawano, 2025; Business & Human Rights Resource Centre, 2025a; Da Costa, 2025; Kabar Sulteng, 2025b; Media Alkhairaat, 2025a-b; Moore, 2025; Morrill, 2025; TribunPalun.com, 2025; Yayasan Tanah Merderka (YTM), 2025a). According to TribunPalun.com (2025), “*Persitiwa banjir tersebut diduga berhubungan dengan jebolnya tanggung di area Fasilitas Penyimpanan Tailing PT Huayue Nickel Cobalt*” [The flood incident is thought to be related to the collapse of the embankment in the PT Huayue Nickel Cobalt Tailings Storage Facility area]. Google Earth imagery from January 3, 2025, shows a clearly-defined landslide from the filtered tailings storage facility operated by PT HYNC with clearly-defined channels for tailings to travel to the Bahodopi River (see Figs. 41a-b) (Media

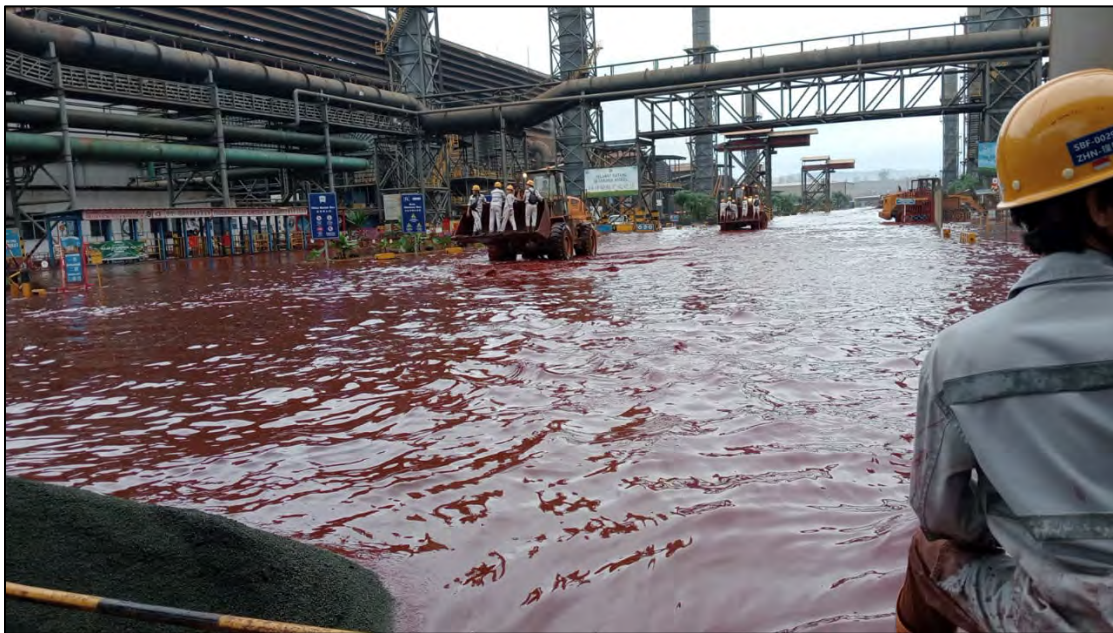
**Figure 40b.** Tailings released by a collapse on March 16, 2025, of the filtered tailings storage facility of PT Huayue Nickel Cobalt (HYNC) in the Indonesia Morowali Industrial Park (see Figs. 3, 23, 24, and 41a-b) flow down the Bahodopi River. Photo by mineworker at PT HYNC and available in Business & Human Rights Resource Centre (2025a) and Moore (2025). Similar photos are available in Bhawano (2025), Pristiandaru (2025), Teraskabar.id (2025), and Wikaksono (2025).

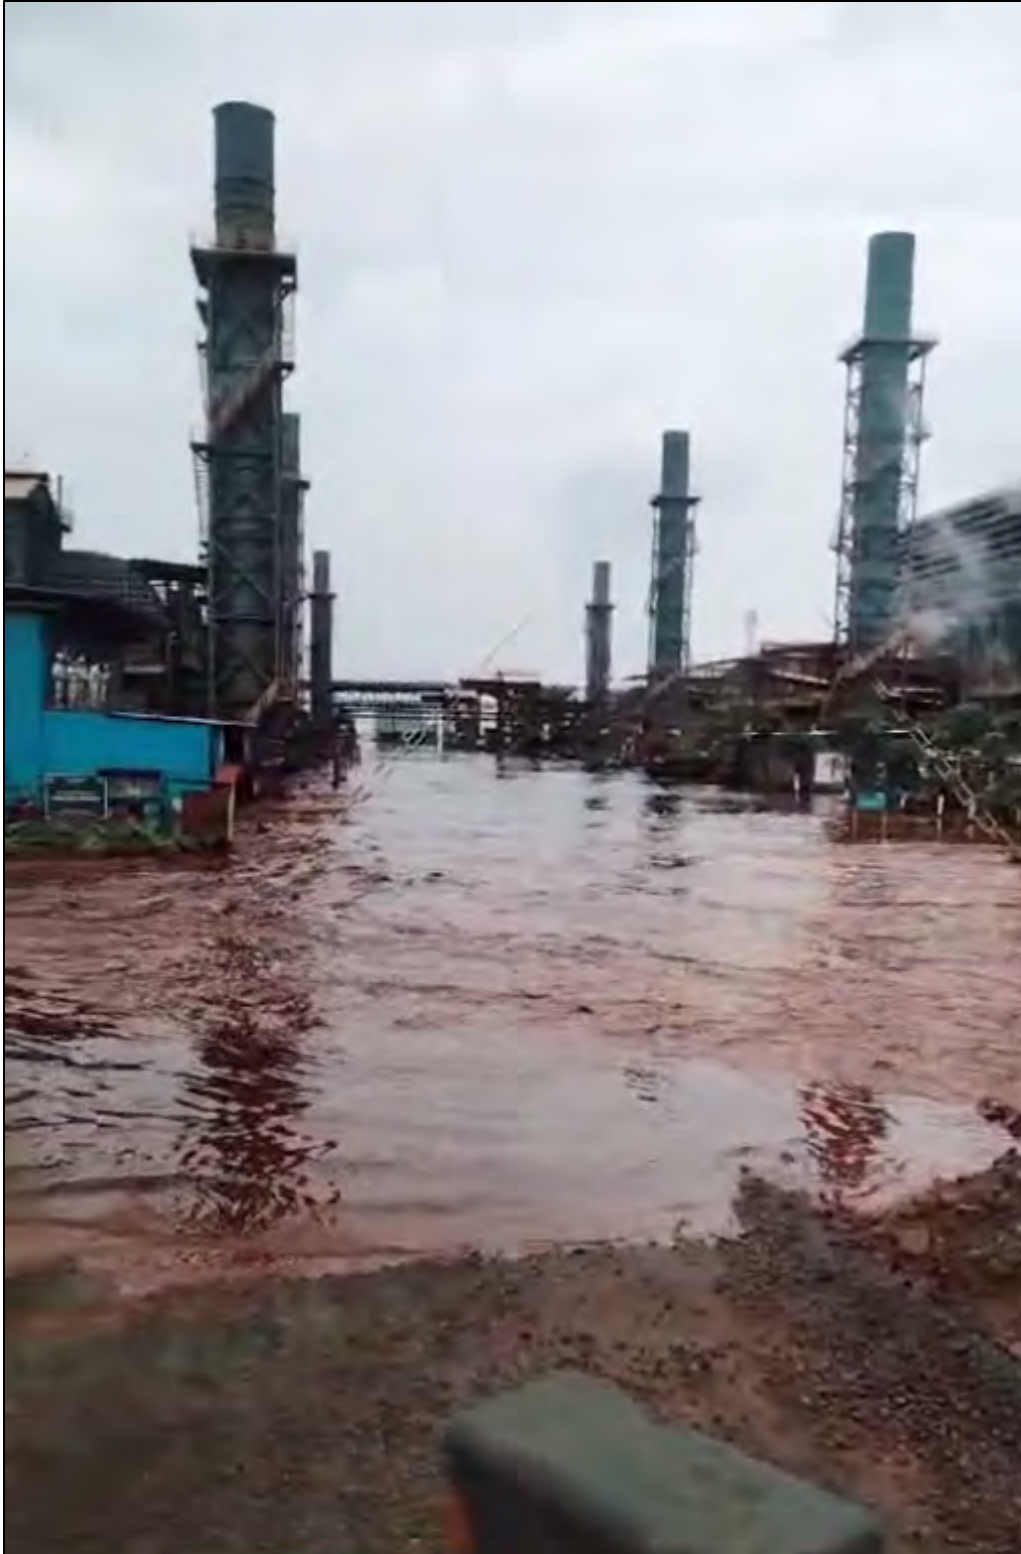
**Figure 40c.** Liquefied tailings from the failure of the filtered tailings storage facility of PT HYNC plus flood water from the Bahodopi River (see Figs. 40a-b) overflow onto the site of PT Fajar Metal Industry (FMI) on March 16, 2025 (see Figs. 23-24). Still image at 0:03 of 10-second video by mineworker.

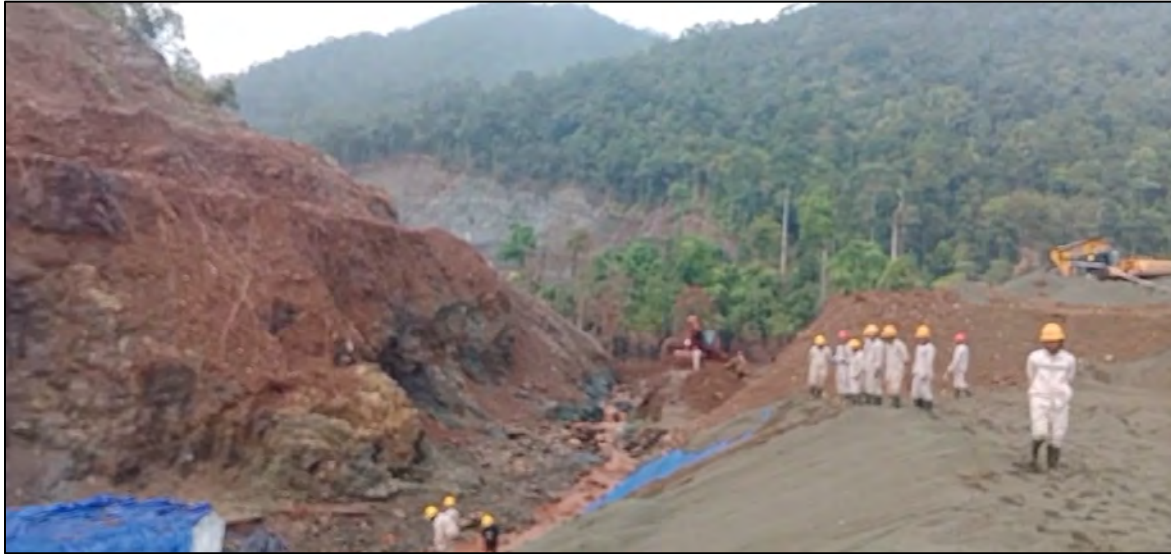
**Figure 42a.** The collapse of the filtered tailings storage facility of PT Qing Mei Bang (QMB) New Energy Materials in the Indonesia Morowali Industrial Park (see Figs. 3, 23, 24, and 41a) on March 21, 2025, resulted in the burial of four workers with three fatalities and one survivor. The four workers were employees of PT Morowali Investasi Konstruksi Indonesia (MIKI), which is a contractor of PT QMB New Energy Materials. Because of the similarity with Fig. 40a, it is not clear as to whether the filtered tailings storage facilities of PT HYNC and PT QMB are actually separate facilities. Still image at 0:12 from video shared by mineworker.

Tragedy struck only five days later, on March 21, 2025, when a landslide at the PT QMB tailings facility buried four mineworkers (see Figs. 42a-b). Some reports have stated the date as March 22 with the clarification that the landslide occurred shortly after midnight local time. One worker was excavated alive, while two bodies were recovered. The last body was never located, so that the official death toll stood at three. All four workers were employees of PT Morowali Investasi Konstruksi Indonesia (MIKI), which is a contractor of PT QMB. The catastrophic failure of the PT QMB tailings facility was widely reported in the Indonesian, Chinese, and English-language media (Asnawi, 2025; Bhawano, 2025; Business & Human Rights Resource Centre, 2025a; Da Costa, 2025; Hamdam, 2025; Harian Sulteng, 2025; Jakarta Post, 2025; Kabar Sulteng, 2025a-b; Man in Indonesia, 2025; Media Alkhairaat, 2025a; Moore, 2025; Morrill, 2025; Prihatini and Jatmiko, 2025; TribunPalun.com, 2025; Yayasan Tanah Merdeka (YTM), 2025a-b).
