## Okanogan Highlands Alliance (Sarah Kliegman)

**Re: Okanogan Highlands Alliance (OHA) Comments to the proposed DSEIS for expansion of the Key Mill Tailings Storage Facility – Stack Height Raise**

**Steven H. Emerman, Ph.D.**

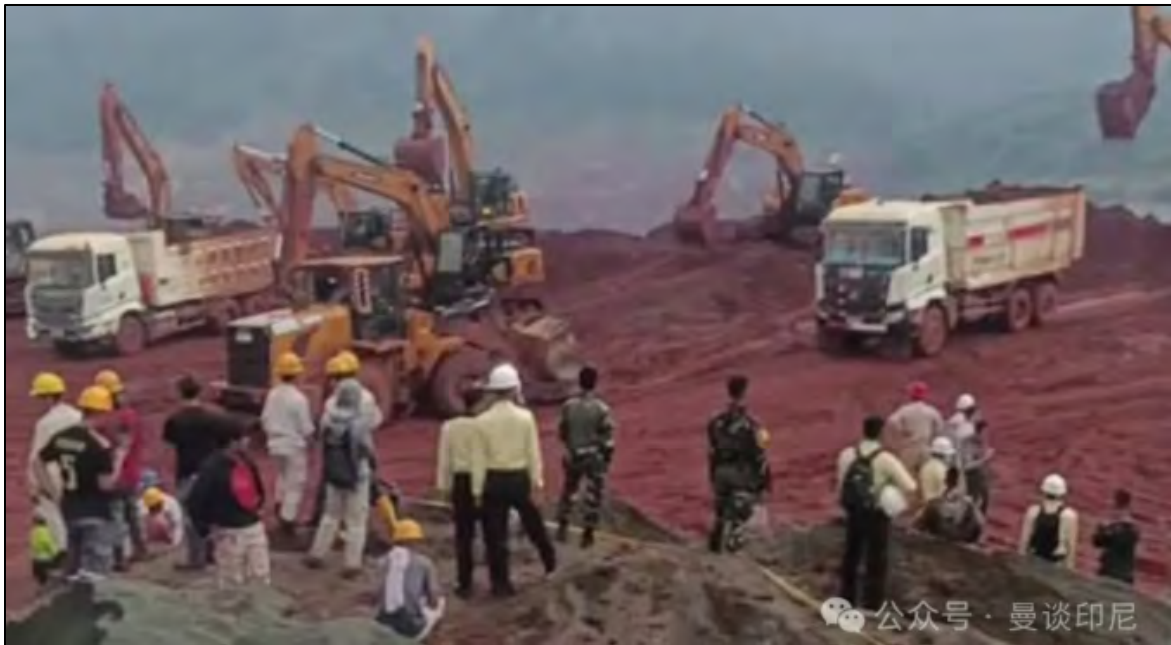
**Figure 42b.** On March 22, 2025, excavators search for four buried workers from the collapse on the previous day of the filtered tailings storage facility of PT Qing Mei Bang (QMB) New Energy Materials in the Indonesia Morowali Industrial Park (see Figs. 3, 23, 24, and 41a). The four workers were employees of PT Morowali Investasi Konstruksi Indonesia (MIKI), which is a contractor of PT QMB New Energy Materials. Photo from 曼谈印尼 [Man in Indonesia] (2025).

Photos published in local media of the use of excavators to locate the four buried workers on March 22 show a pond, even though no pond is visible in satellite imagery of the PT HYNC/PT QMB filtered tailings storage facility (see Figs. 24 and 41a). According to mineworkers, a pond had been infilled to construct the filtered tailings storage facility. As the excavators dug below the water table, the pond re-formed at its previous location. One of the dead mineworkers was found at the bottom of the pond. Construction on an infilled pond is a questionable practice because it could result in a high water table within the filtered tailings storage facility. For example, according to the SME Tailings Management Handbook, “Do not site [filtered tailings storage facilities] where ‘blinding off’ groundwater discharge areas” (Davies et al., 2022). Thus, the filtered tailings storage facility apparently collapsed at its weakest spot where the water table was highest.

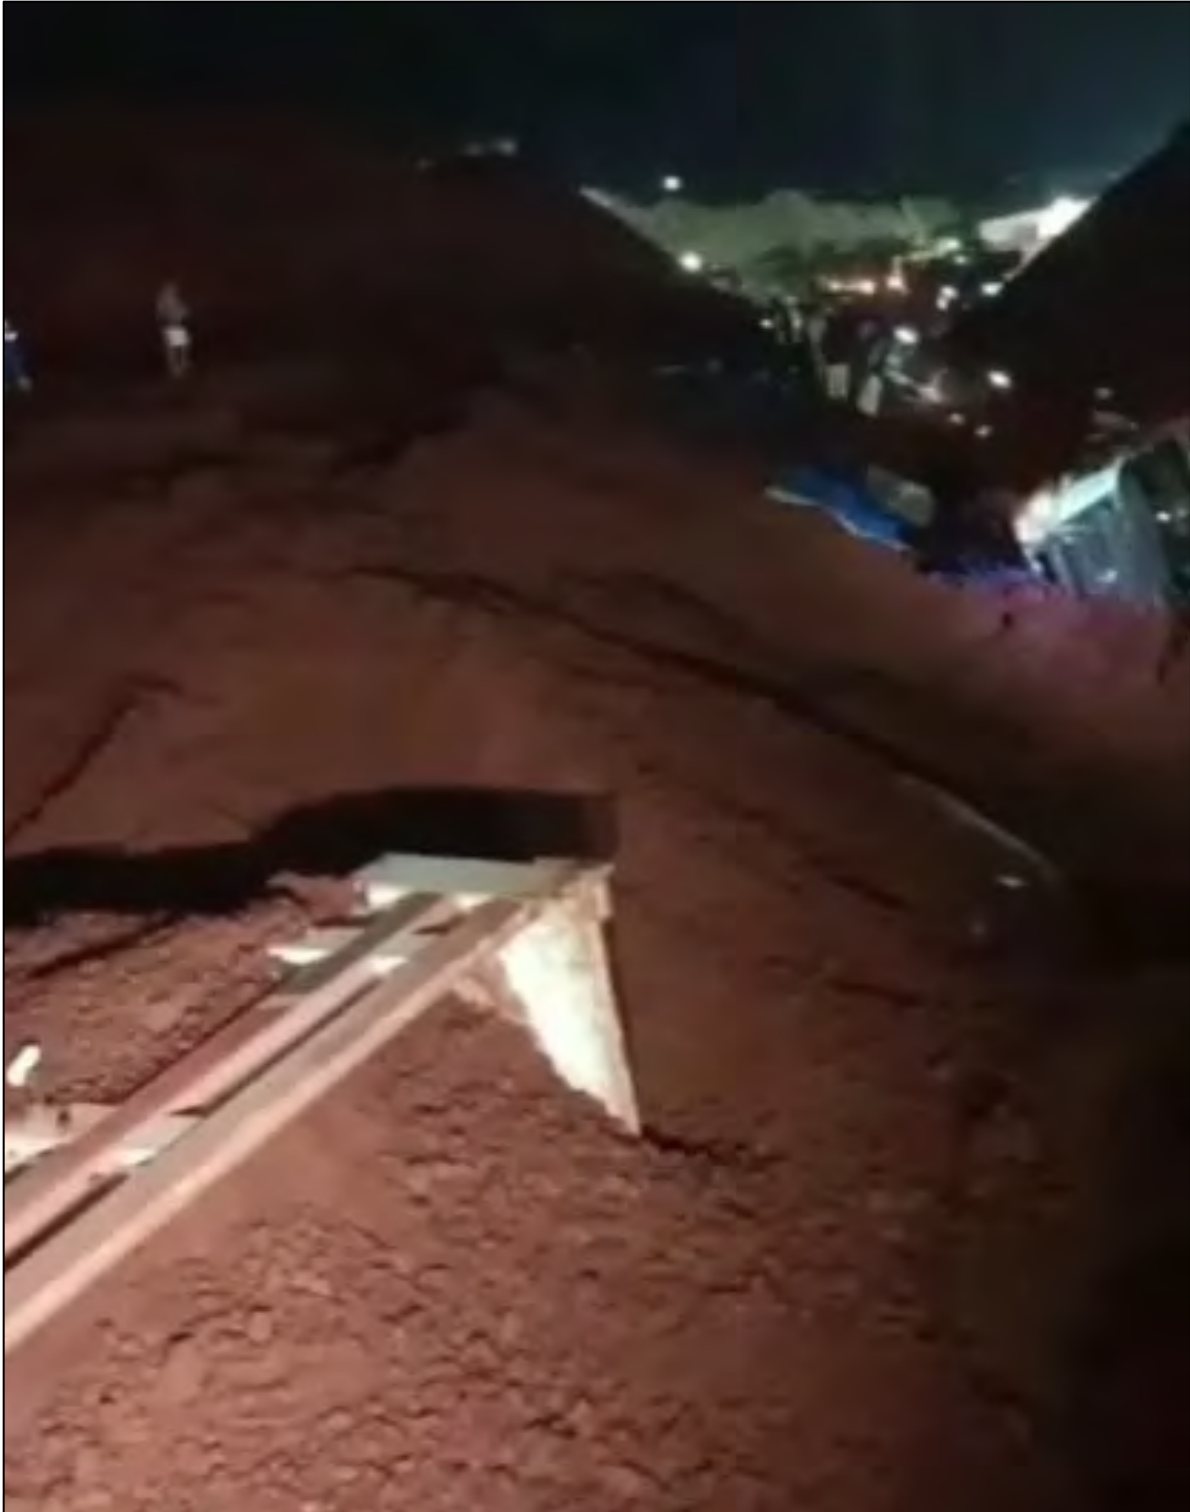
**Figure 43.** On March 27, 2025, an ore stockpile collapsed at the PT Qing Mei Bang (QMB) New Energy Materials project in the Indonesia Morowali Industrial Park (see Figs. 3 and 23), resulting in the burial of heavy equipment. The location of the ore stockpile is not known. Still image at 0:13 from video shared by mineworker.

On March 27, 2025, an ore stockpile collapsed at the PT Qing Mei Bang (QMB) New Energy Materials project, resulting in the burial of heavy equipment, but no fatalities (Business & Human Rights Resource Centre, 2025a; Moore, 2025; Petley, 2025b; see Fig. 43). The incident has not been reported in the Indonesian media and is known only through photos and videos by mineworkers (Destination954; 2025; Pakiding, 2025a-b). The location of the PT QMB ore stockpile is not known. Although an ore stockpile is not a tailings storage facility, the repeated collapses of mine material draw serious questions regarding the quality of geotechnical engineering at the Indonesia Morowali Industrial Park.

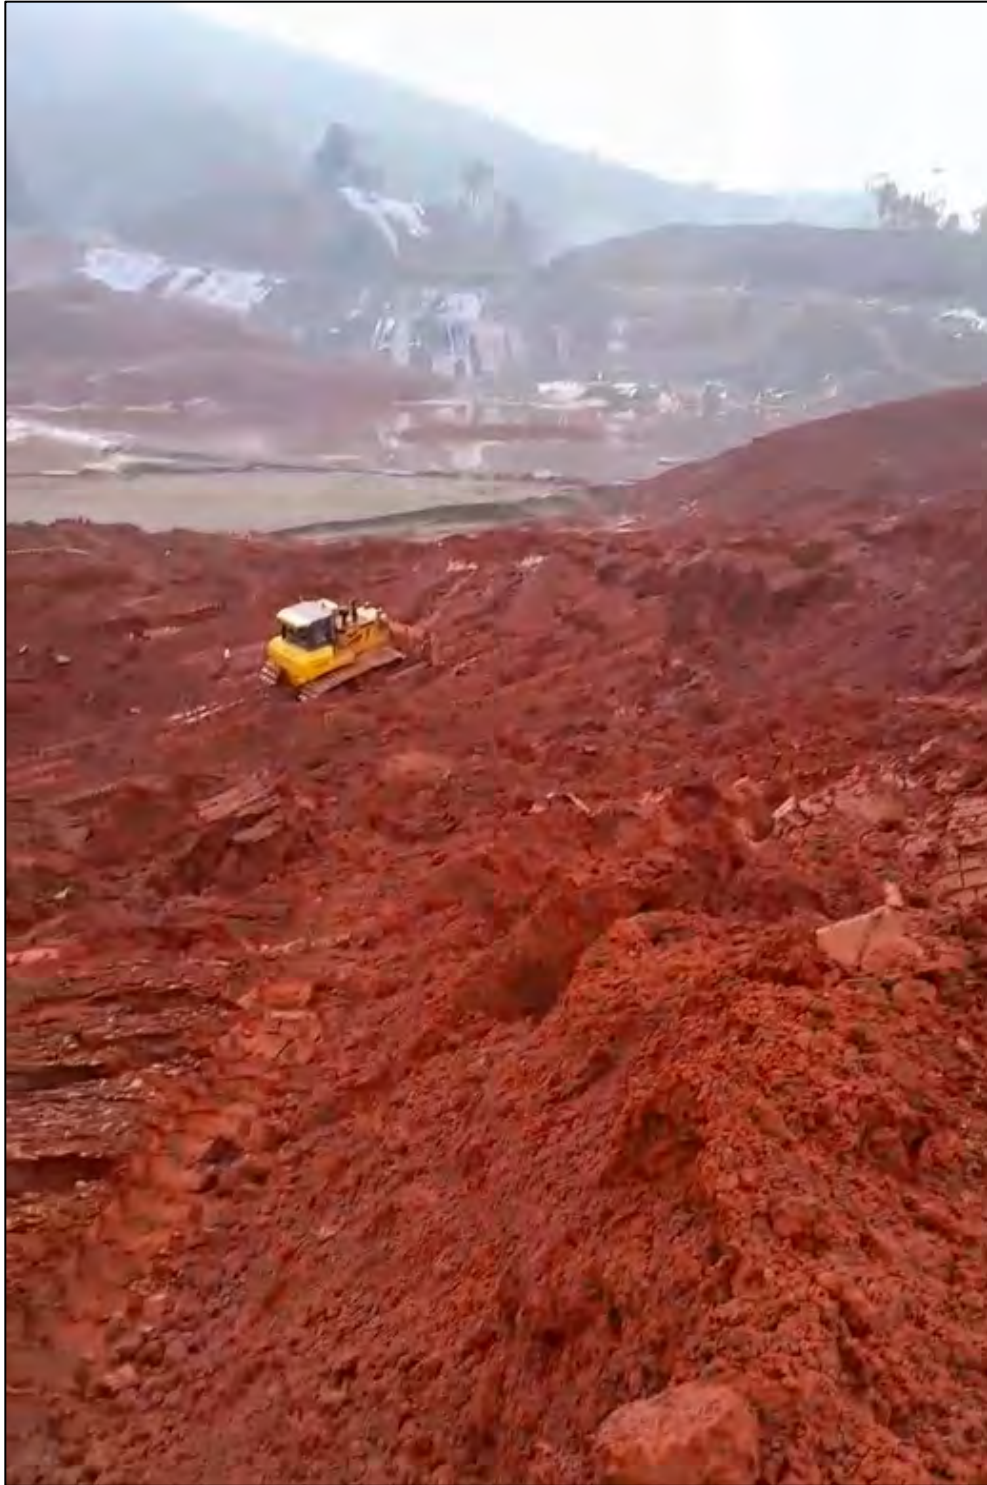
**Figure 44.** On April 30, 2025, a landslide occurred at the filtered tailings storage facility of PT Qing Mei Bang (QMB) New Energy Materials project in the Indonesia Morowali Industrial Park (see Figs. 3, 23, and 24), Still image at 0:12 of 30-second video by mineworker.

The most recent landslide at the PT QMB tailings facility occurred on April 30, 2025 (see Fig. 44). The landslide is known only from photos and videos distributed by mineworkers and has not been reported by any media. An earlier video posted by a mineworker shows a bulldozer being completely engulfed by a landslide at an unidentified filtered tailings storage facility in September 2023 (Petley, 2025b; see Fig. 45). It has already been mentioned that satellite imagery shows at least one major landslide from the PT HYNC tailings facility prior to January 3, 2025 (see Figs. 41a-b).

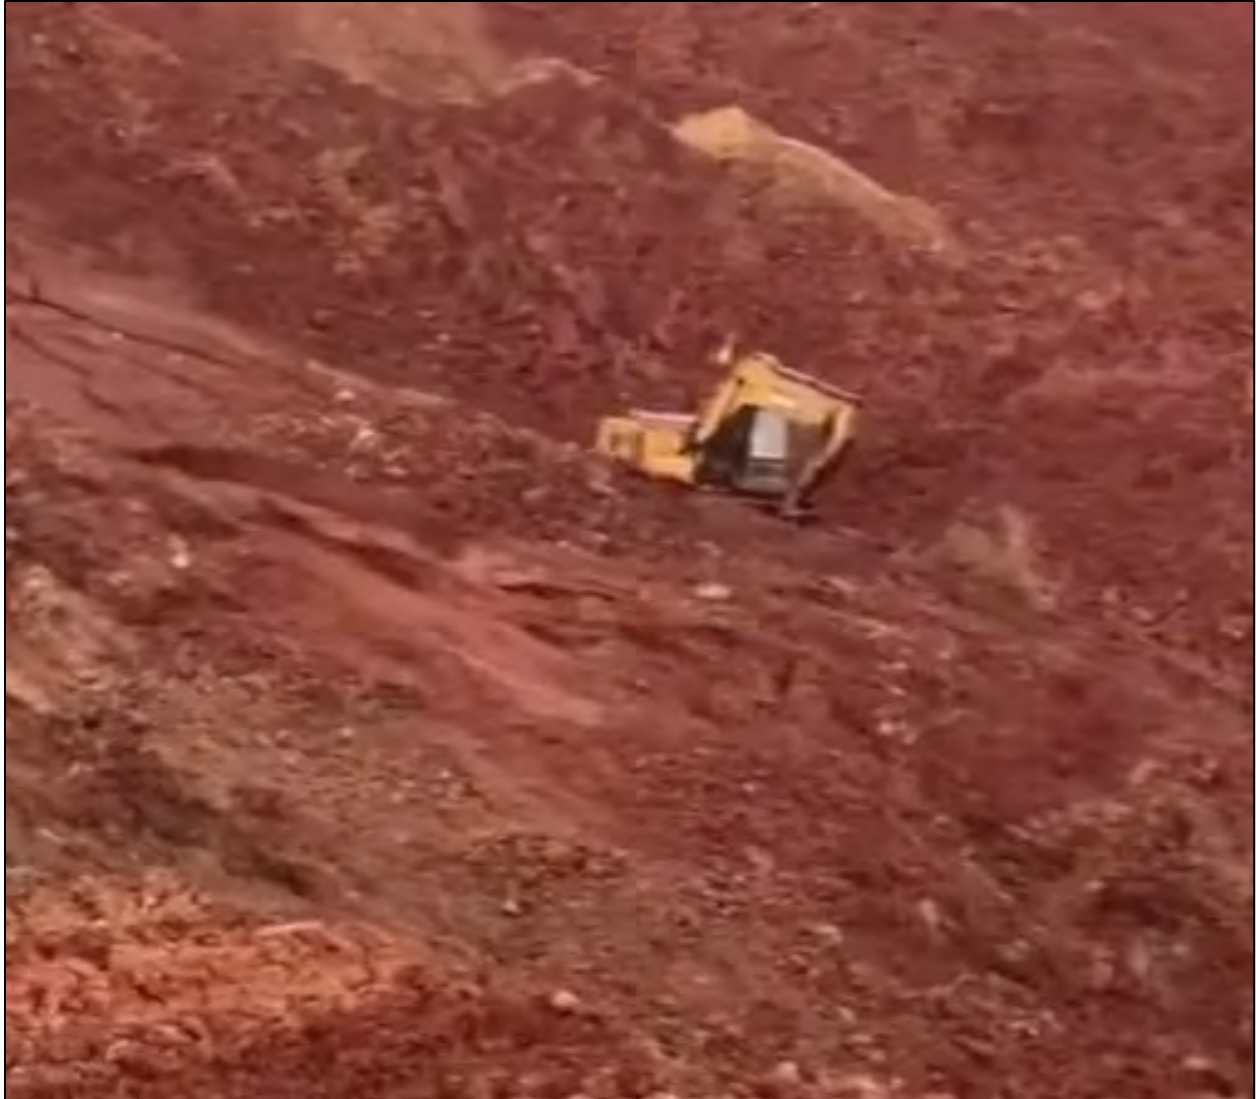
**Figure 45.** A bulldozer was engulfed by a landslide at a filtered tailings storage facility of the Indonesia Morowali Industrial Park (see Figs. 3 and 23) in September 2023. Still image at 0:03 from Kuli Tambang Random [Random Mineworker] (2023).

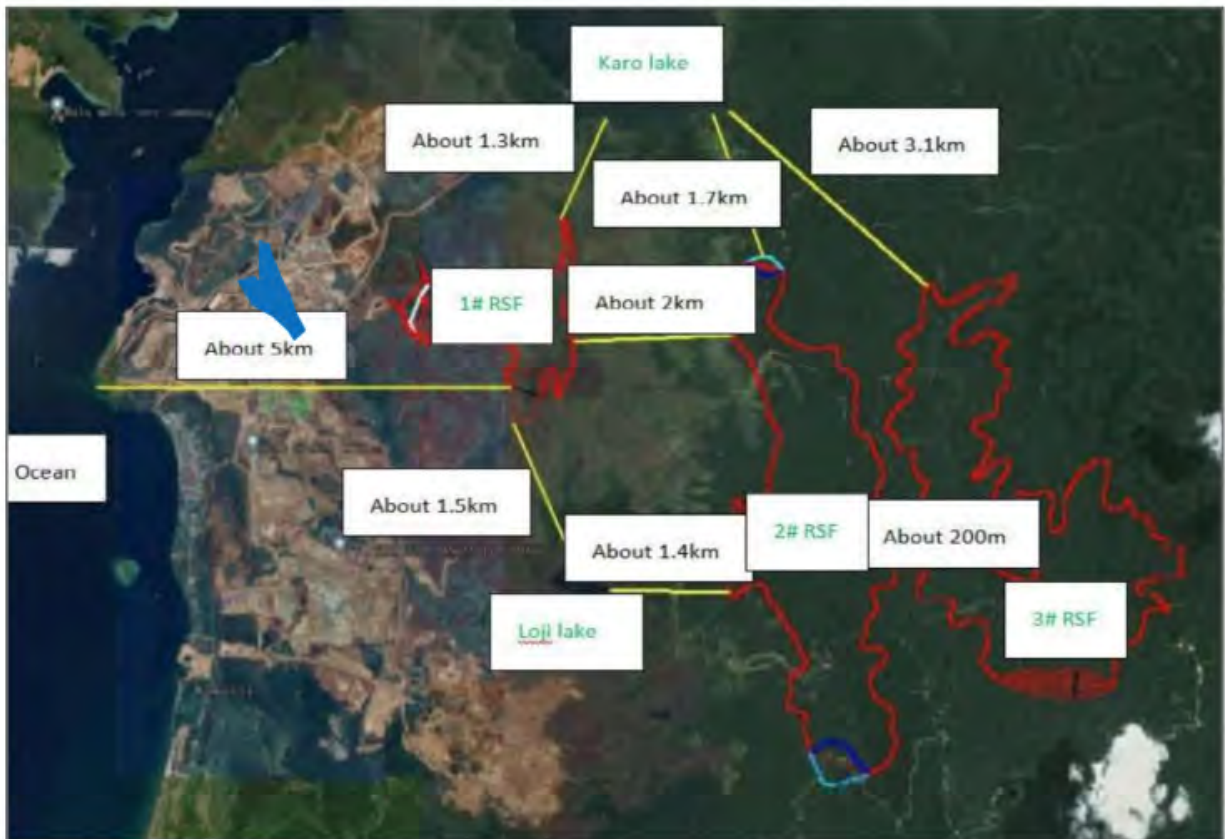
**Figure 7-4: Dry stack tailings facility and conventional RSF locations**

**Notes:** Image taken from the conventional TSF design report. The blue shaded area is the approximate location and size of the dry stack tailings facility.
