## Meyer Comments

### Maury Island RI/FS/dCAP

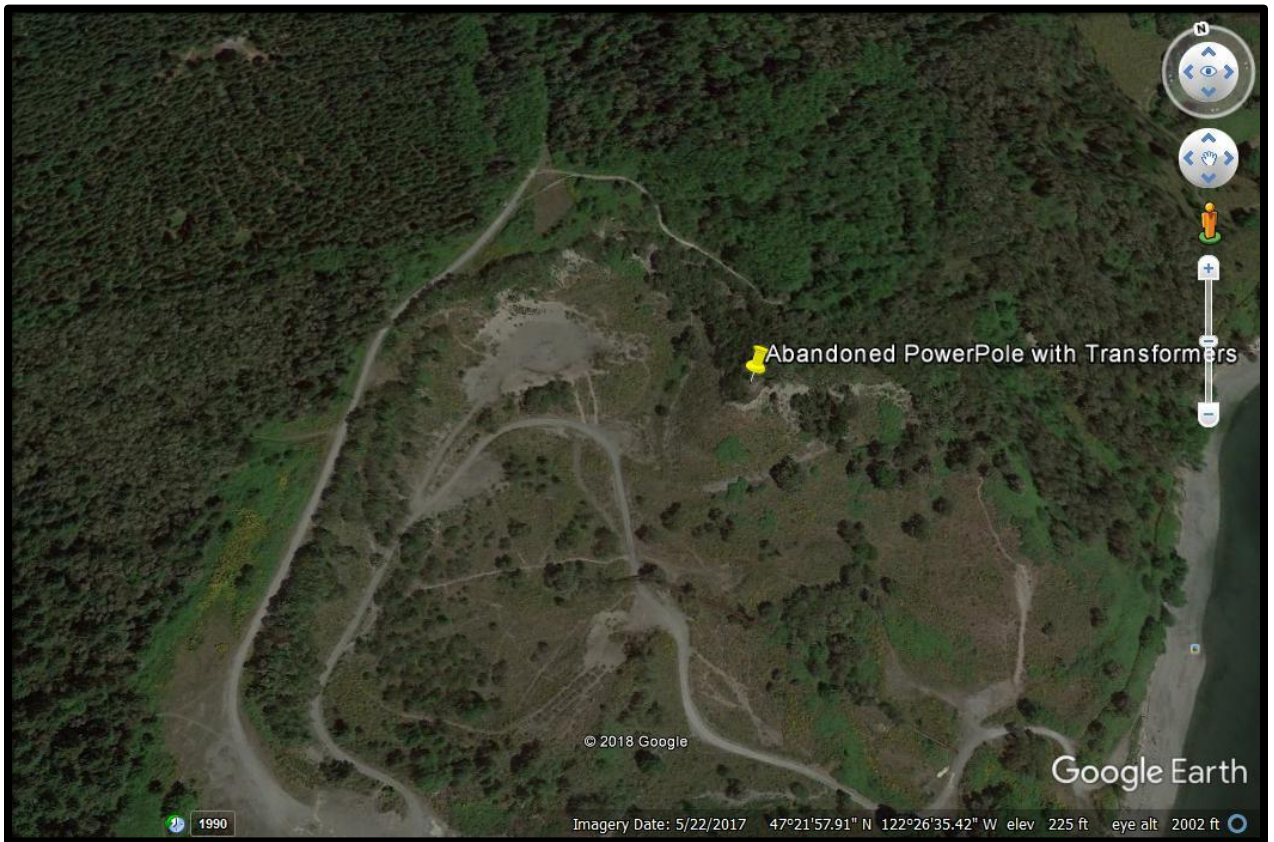
**FIGURE 1**

6. The RI does not mention the presence of two pole-mounted transformers on an abandoned power pole. The transformers could be a source of PCBs in soil at the base of the pole. The cleanup action should include removal of these transformers and testing of the soil at the base of the pole for PCBs. The location of the power pole is shown on Figure 1.
