## US Route 169 – ROAD SAFETY AUDIT

Sherburne County, Minnesota

### FINAL REPORT

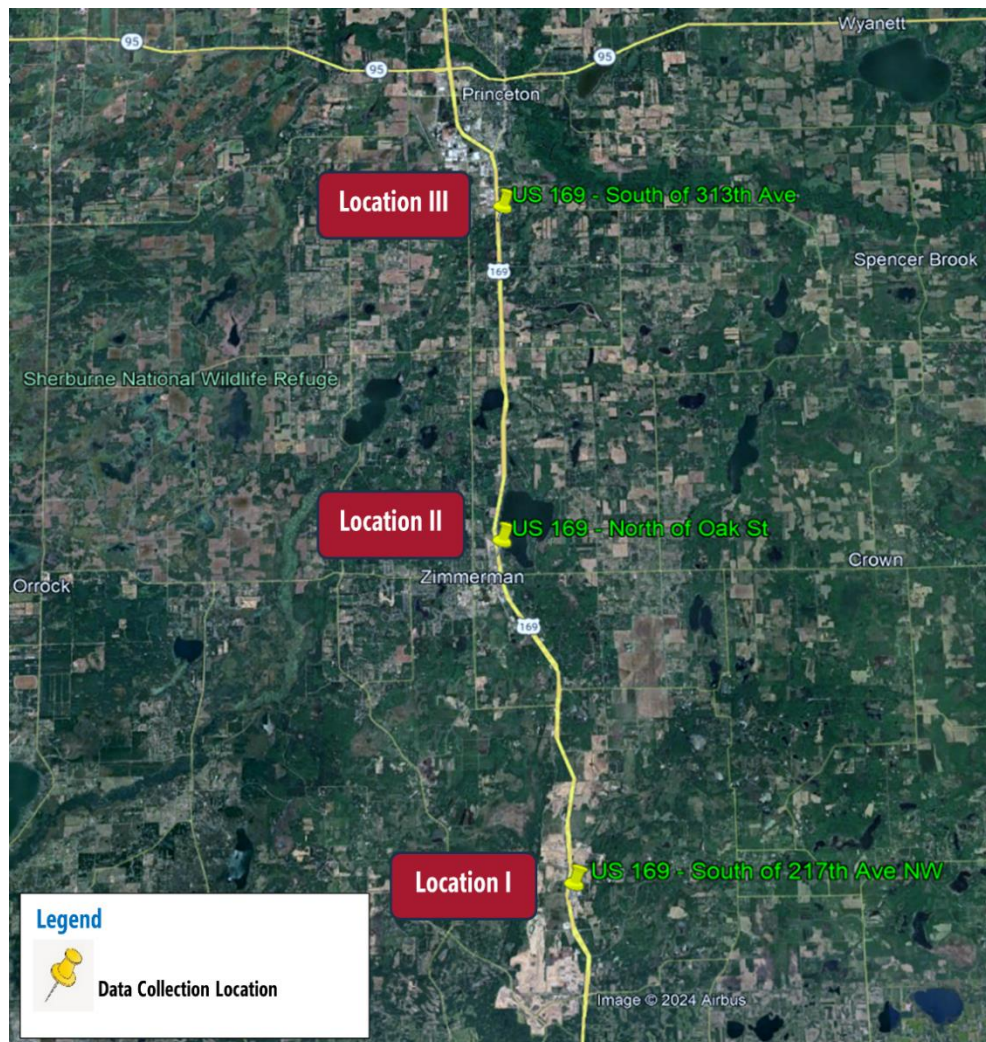
**Exhibit 2-1. Locations of Traffic Data Collection**

The three data collection sites, as shown in **Exhibit 2-1**, are:

- Location I: South of 217th Ave NW
- Location II: North of Oak St (Zimmerman)
- Location III: South of 313th Ave (Princeton)

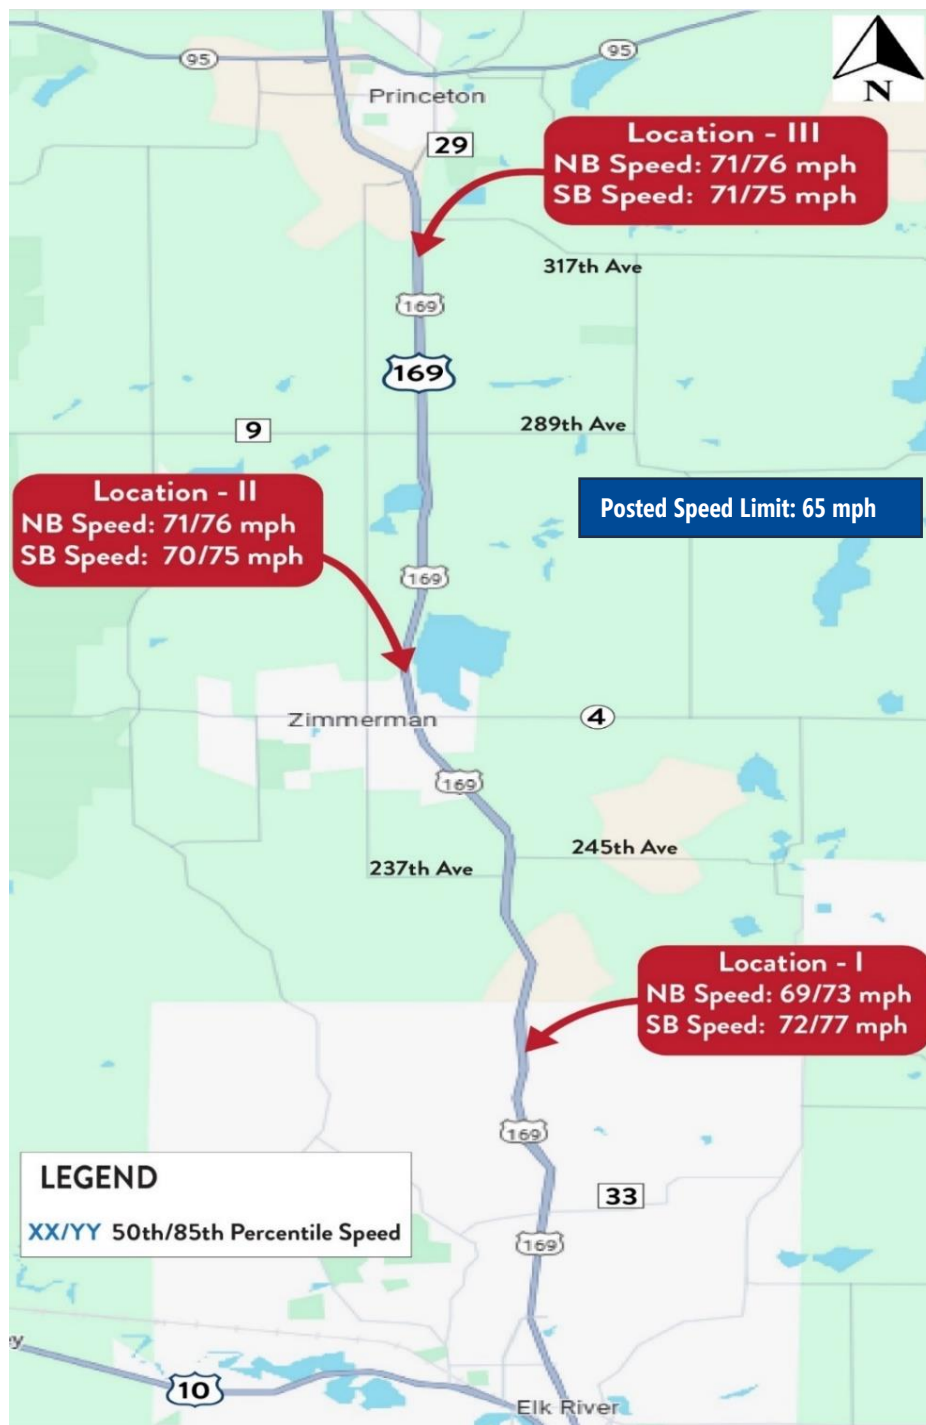
**Exhibit 2-5. 50th and 85th Percentile Speeds at the Three Locations**

Speed data was gathered from a statistically valid sample of vehicles on weekdays. The posted speed limit along the study corridor is 65 mph. **Exhibit 2-6** summarizes the 50th and 85th percentile speeds observed at the three data collection locations. The 50th percentile speed (the speed at which 50% of vehicles travel at or below) consistently exceeded the posted speed limits by an average of 5 mph. Similarly, the 85th percentile speed (the speed at which 85% of vehicles travel at or below) surpassed the posted limit by an average of 10 mph.

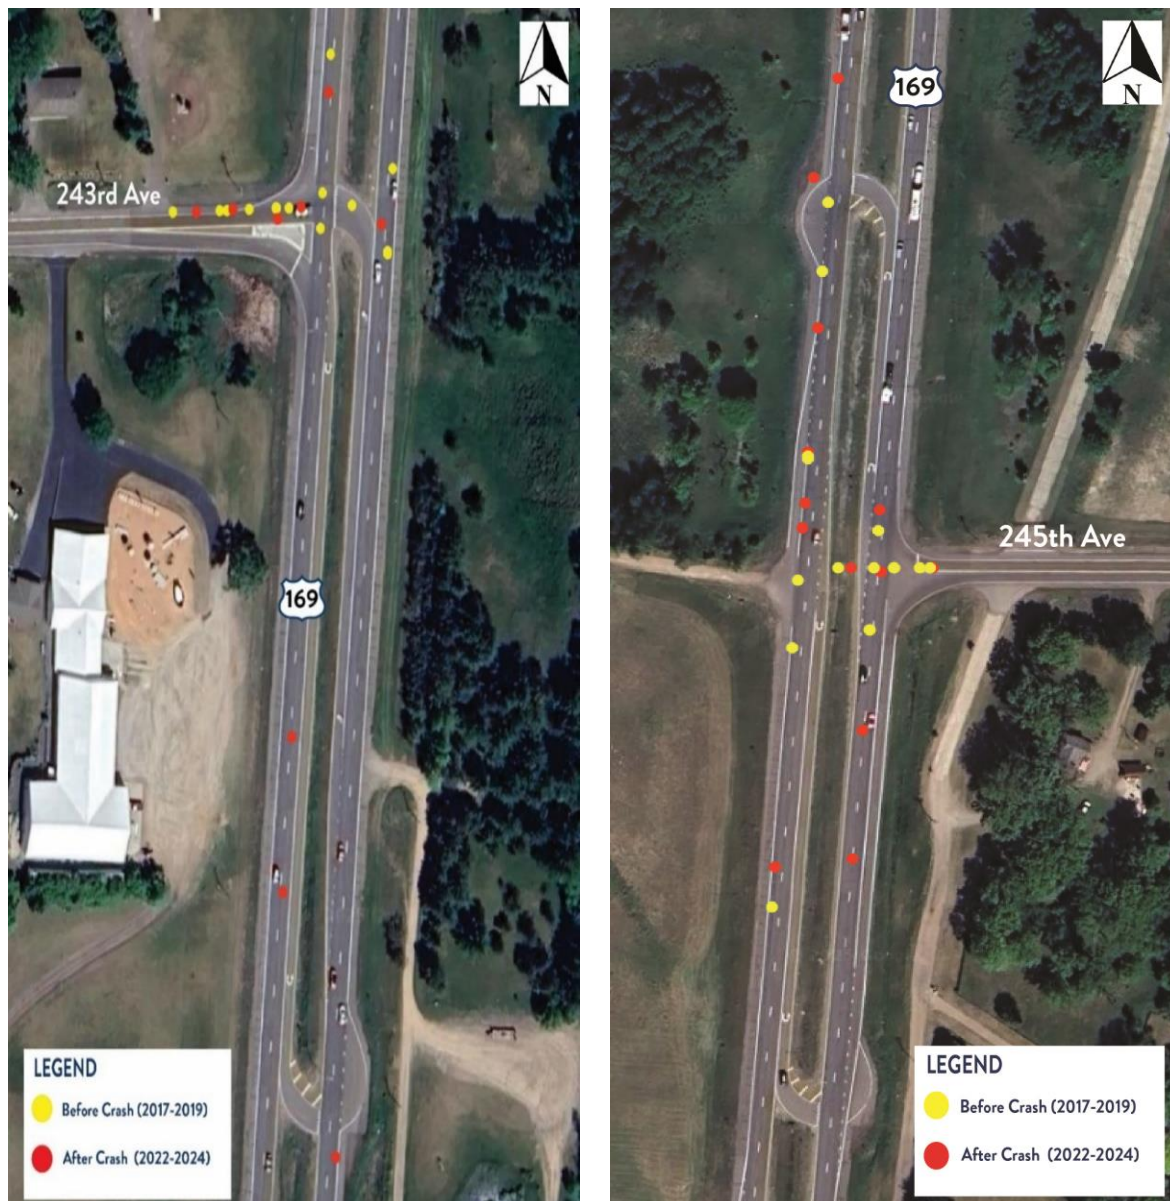
**Exhibit 2-10. Before-After Crashes at J-Turn Intersections**

The spatial distribution of crashes before and after the installation of J-turns is illustrated on the following map for each intersection. A summary of the crash data analysis is provided in **Table 3**. The analysis indicates a 36% reduction in the total number of crashes at the 243rd Ave intersection and a 13% reduction at the 245th Ave intersection following the implementation of J-turns. Furthermore, intersection-related crashes, as labeled by police officers in the field, decreased by 33% at the 243rd Ave intersection and 27% at the 245th Ave intersection. While angle crashes remained at zero before and after the installation of J-turns at the 243rd Ave intersection, they were reduced by 43% at the 245th Ave intersection after the installation of J-turns. These findings suggest an improvement in safety performance, likely due to the J-turn installations.

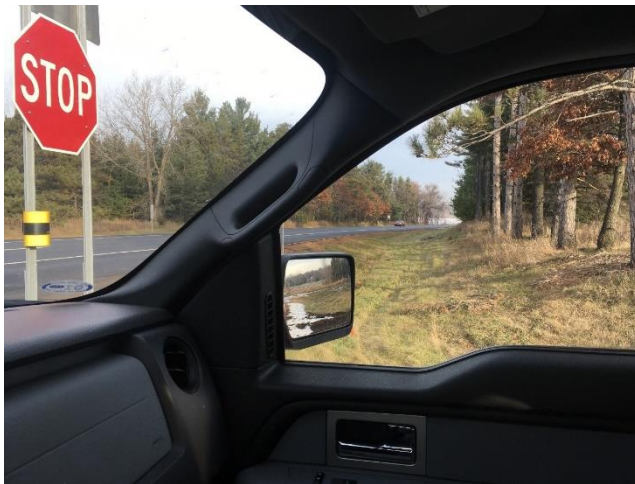
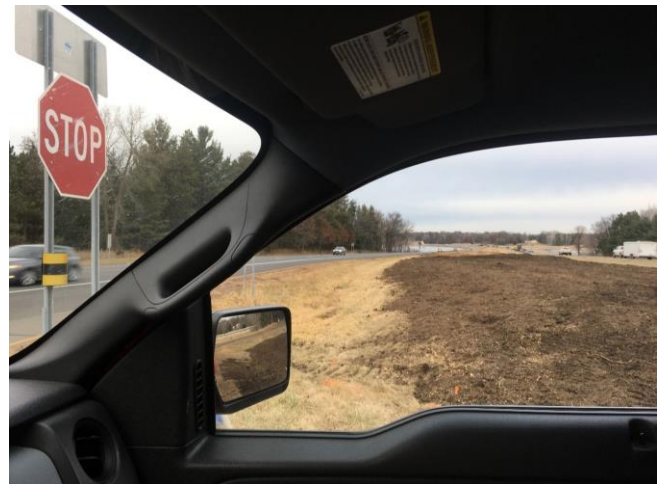
**Exhibit 2-12. Tree Removal at 283rd Ave Crossover Berm**

MnDOT has undertaken multiple projects aimed at improving safety and traffic flow along the US 169 corridor. One notable project was the tree removal initiative, which focused on enhancing sight distance. In the Year 2017, MnDOT initiated a tree removal project to enhance safety on the US 169 corridor. The project's main goal was to address sight distance issues caused by trees within the median, which posed visibility challenges for crossing traffic.

The tree removal was executed at several key locations along the US 169 corridor, particularly in areas with high traffic volumes and considerable sight distance issues. While there are currently no major visibility issues related to median vegetation, future tree clearing may be necessary to maintain adequate sight lines and expand the roadside clear zone—both critical for improving overall safety of the motorists.

**Before Tree Removal**

**After Tree Removal**

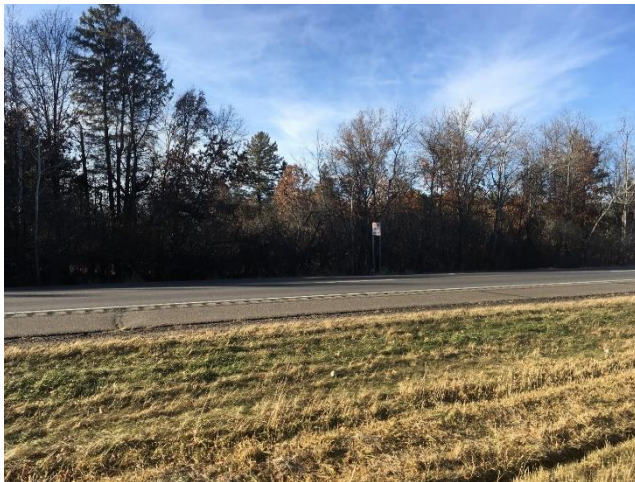
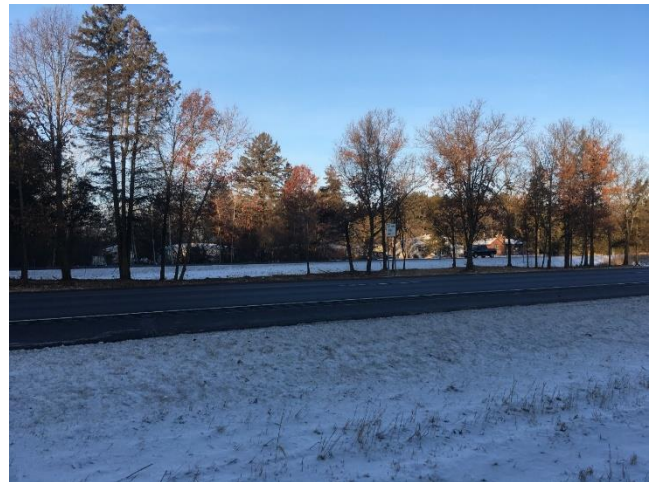
**Exhibit 2-13. Tree Removal in Median Near Game Farm**

**Before Tree Removal**

**After Tree Removal**

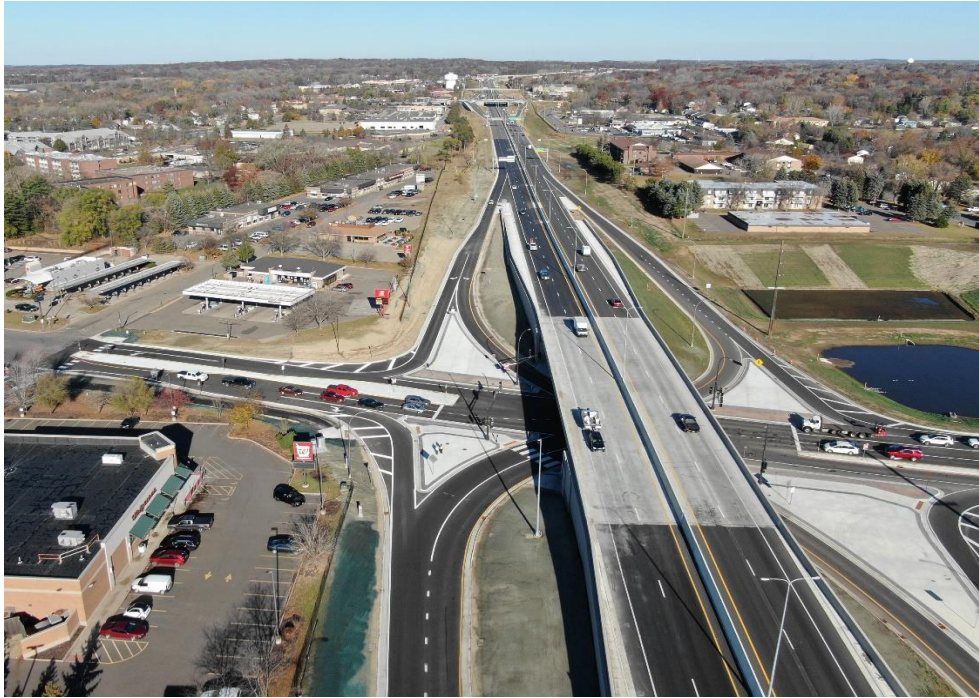
**Exhibit 2-14. Elk River Interchange Project (Source: MnDOT)**

The removal of the signals in Elk River and the construction of interchanges have significantly enhanced traffic flow, safety, and capacity along the US 169 corridor in Elk River. However, this has created a continuous stream of traffic, making it challenging for crossing streets north of Elk River to find adequate gaps to cross US 169. The increased traffic flow downstream of the interchange in the north of Elk River has affected the ability of crossing/turning vehicles to safely and efficiently navigate the corridor between Elk River and Zimmerman. The community has also expressed concerns about finding adequate gaps in the

northbound traffic to cross the mainline traffic. This situation underscores the need for further evaluation and the potential implementation of additional safety measures to address these challenges.

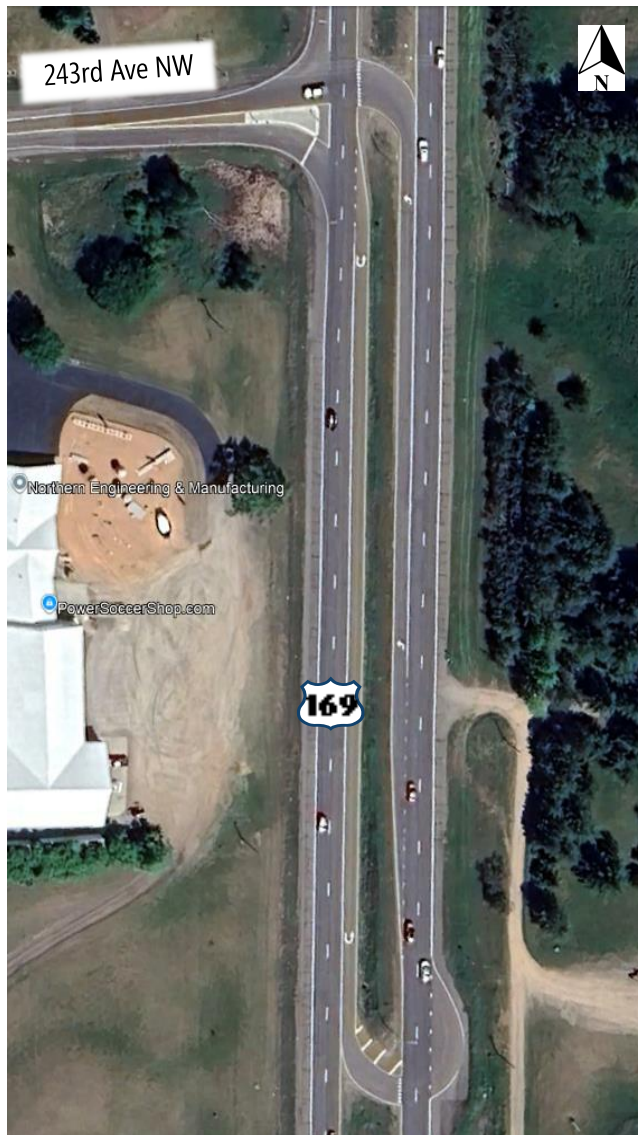
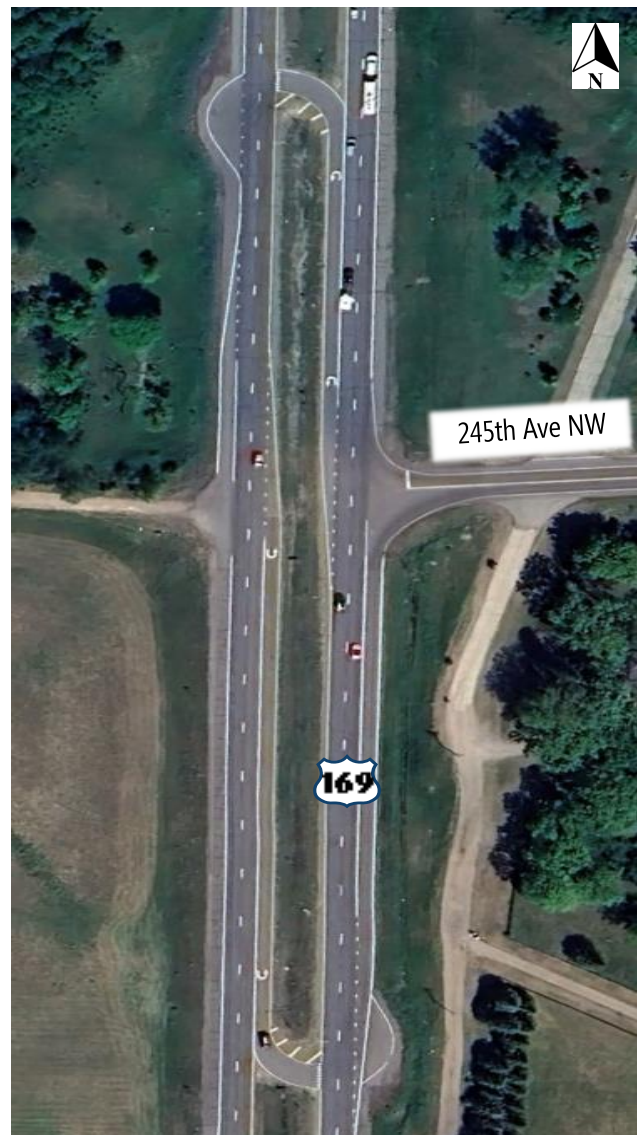
Exhibit 2-15. J-Turns at US 169 (Source: Google)

J-Turn at 243rd Ave W

J-Turn at 245th Ave W

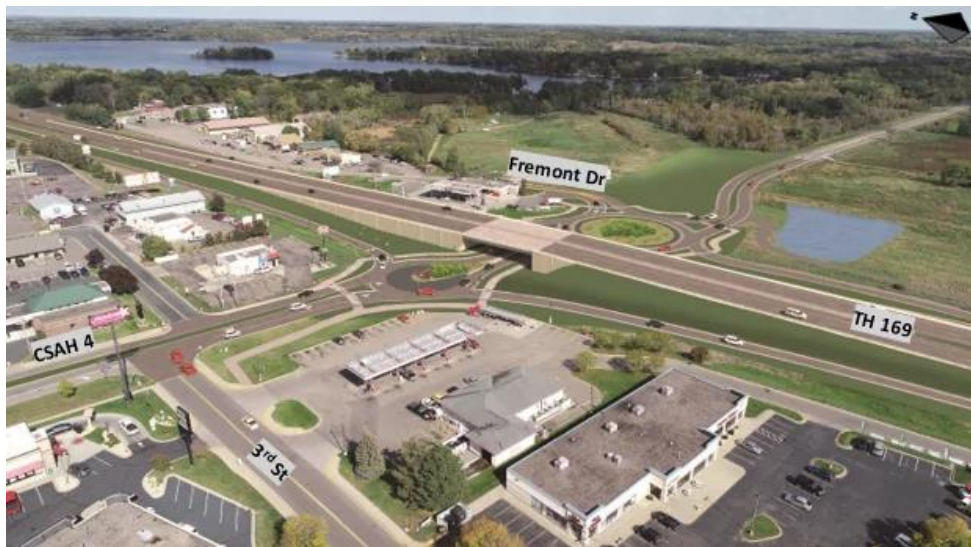
**Exhibit 2-16. Zimmerman Interchange Project (Source: Bolton & Menk Inc.)**

The Zimmerman Interchange Project is an effort to improve the intersection of US 169 and County Road 4 (Fremont Avenue). This intersection is currently the last remaining signalized crossing along the US 169 expressway north of Elk River until the signal at the Grand Casino Mille Lacs in Vineland, which is over 60 miles north of Elk River. As part of the broader “169 Redefine” initiative, the project aims to replace the existing at-grade signalized intersection with a grade-separated interchange to enhance safety, mobility, and operational efficiency for all users, including motorists, freight, transit, pedestrians, and bicyclists.

Traffic volumes are projected to reach 51,000 vehicles per day by Year 2045, leading to severe congestion and rerouting onto adjacent corridors without improvements. Furthermore, the intersection has a concerning safety record, with 101 crashes reported between the Year 2015 and Year 2019. The crash rate is more than four times the statewide average, and the rate of fatal and serious injury crashes is six times higher. Rear-end collisions, which account for 77 of the 101 crashes, are primarily attributed to signal-induced backups.

By removing the last remaining traffic signal on US 169 between Onamia and Elk River, the project will create a continuous free-flow corridor, significantly improving travel time reliability and reducing stop-and-go conditions contributing to rear-end collisions. This uninterrupted flow will enhance the corridor's function as a principal arterial, supporting regional mobility for commuters, freight, and recreational travelers. From a safety perspective, the elimination of the signal will address the high crash rate at the intersection, which has historically been more than four times the statewide average. However, the improved mainline flow on US 169 will introduce new challenges for traffic on crossing streets, particularly upstream and downstream of the interchange. With the removal of the traffic signal, vehicles on nearby local roads will find it more difficult to find acceptable gaps in the traffic stream to cross or merge onto US 169. This is a common trade-off when converting signalized intersections to interchanges on high-volume corridors. To mitigate this, the project includes access management strategies such as converting nearby intersections to right-in/right-out configurations. These measures are intended to maintain local circulation and reduce the risk of crashes caused by risky crossing maneuvers. Construction of the Zimmerman Interchange project is scheduled to begin in Year 2025 and end in Year 2026.

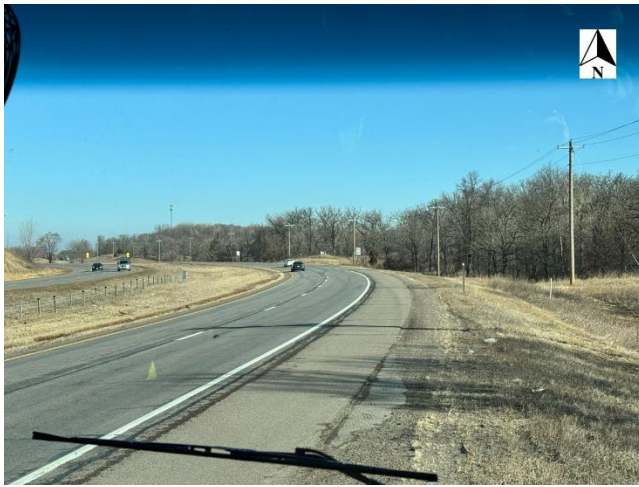
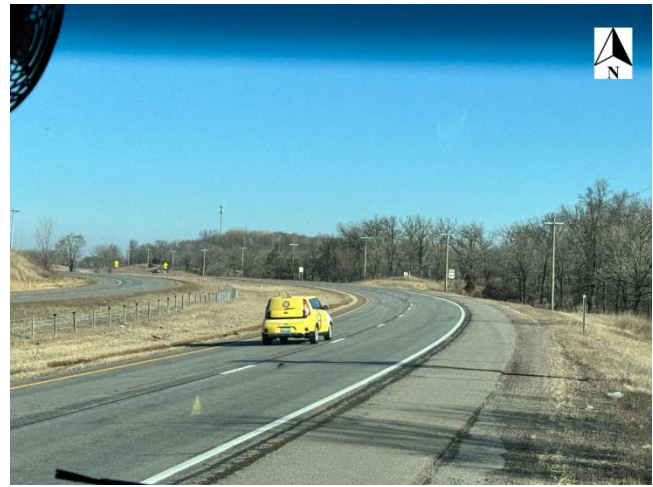
**Exhibit 3-1. Location 1: Horizontal Curve South of 211th Ave NW**

As an example, the team identified safety concerns at the horizontal curve South of 211th Ave NW, which experienced a high frequency of run-off-road crashes, particularly during slippery pavement conditions. The edge line rumble strips of the northbound lane in this area were found to have faded and needed to be reinstalled. Additionally, the curve appeared to have a "flat" super-elevation, which required further examination with a ball bank indicator to determine if a change in superelevation was needed.

**Exhibit 3-1** presents images that depict the roadway conditions at the location.

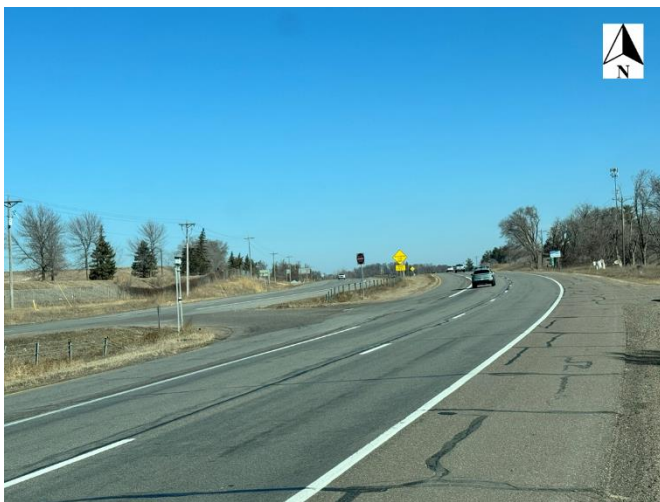
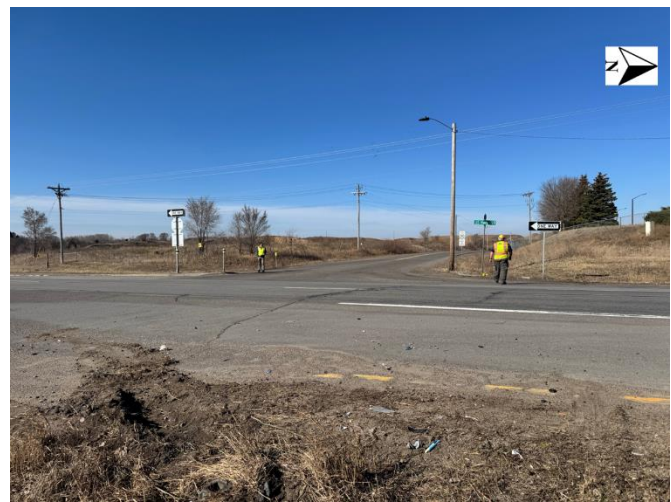
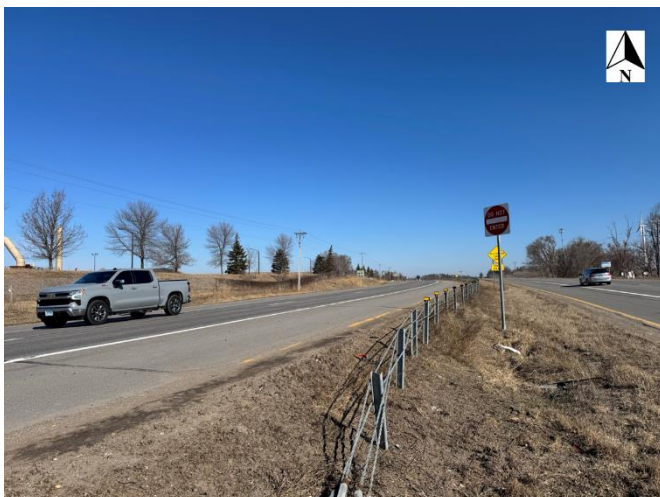
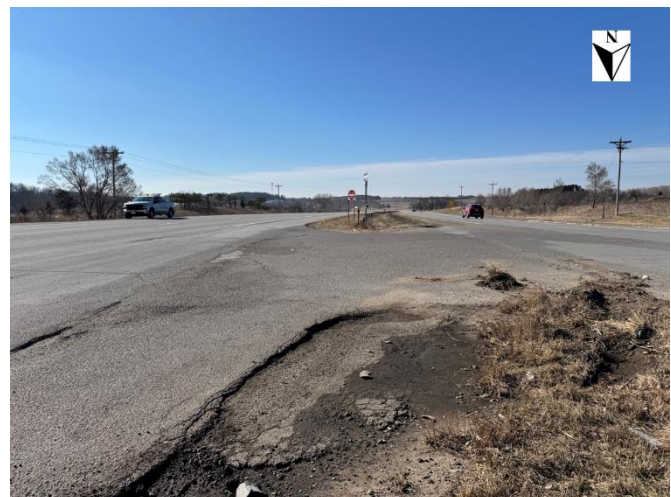
**Exhibit 3-5. Location 4: Horizontal Curve and Intersection of 221st Ave NW**

**Exhibit 3-5** presents images depicting the roadway conditions at the location.

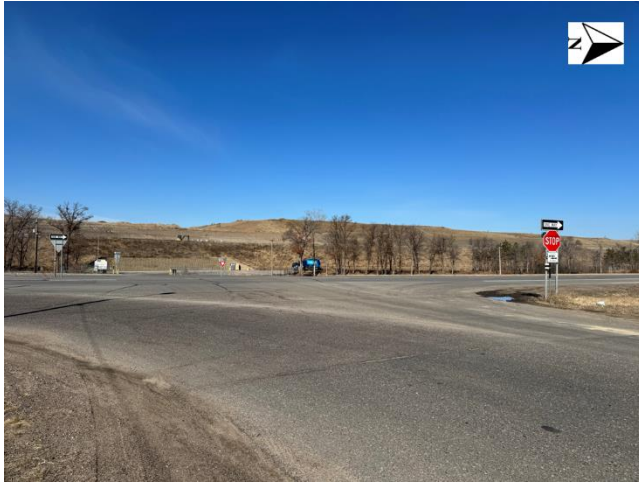
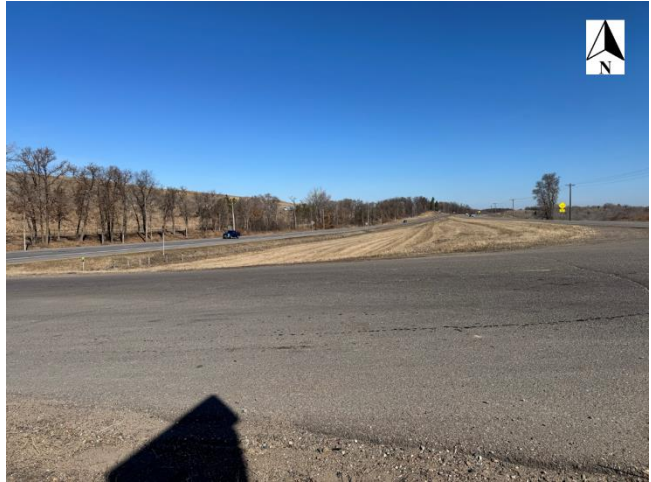
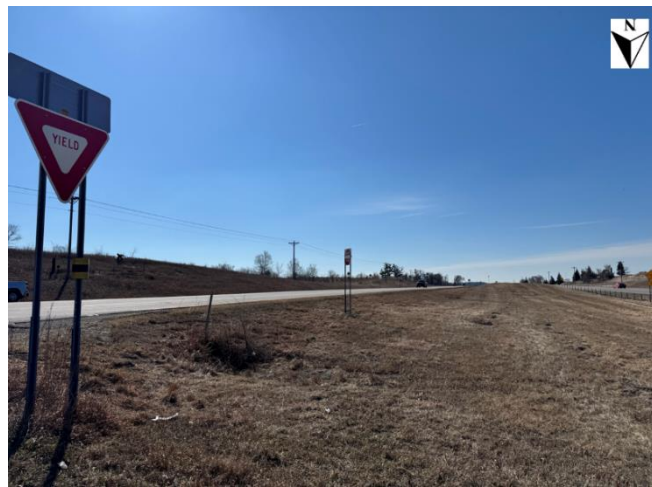
**Exhibit 3-6. Location 5: Access Roads and Crossover of 225th Ave NW and Elk River Landfill**

**Exhibit 3-6** presents images depicting the roadway conditions at the location.

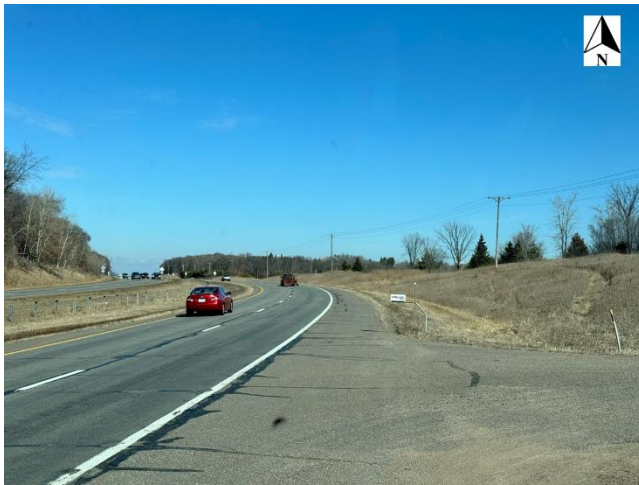
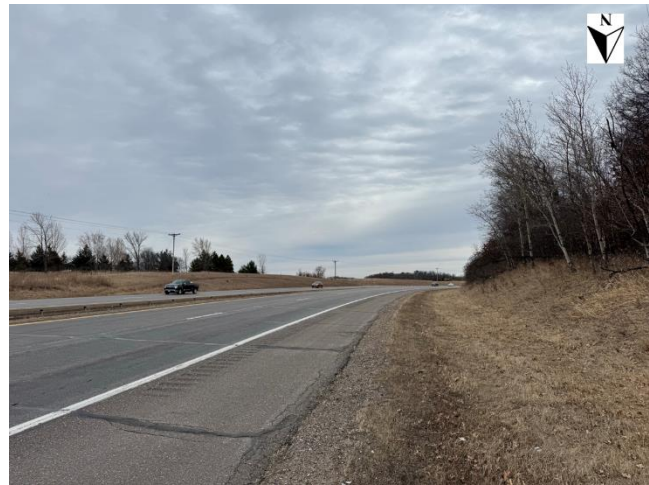
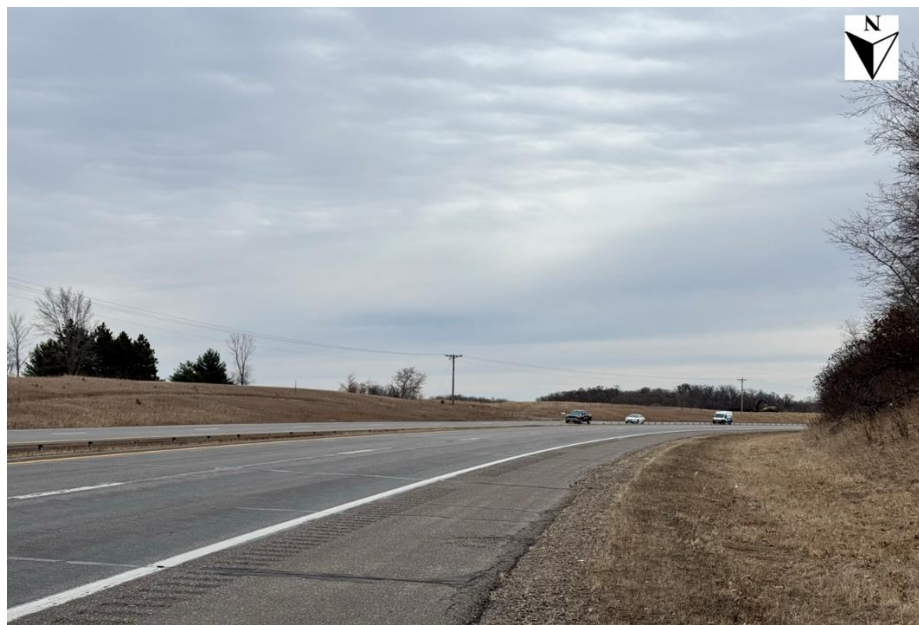
**Exhibit 3-7. Location 6: Horizontal Curve North of 225th Ave NW**

**Exhibit 3-7** presents images depicting the roadway conditions at the location.

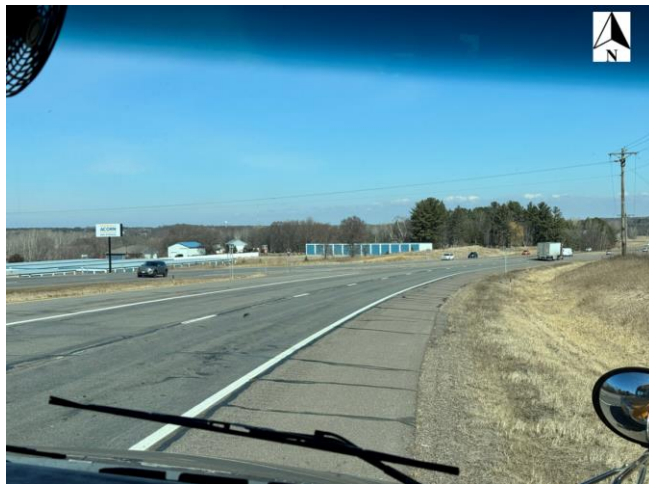
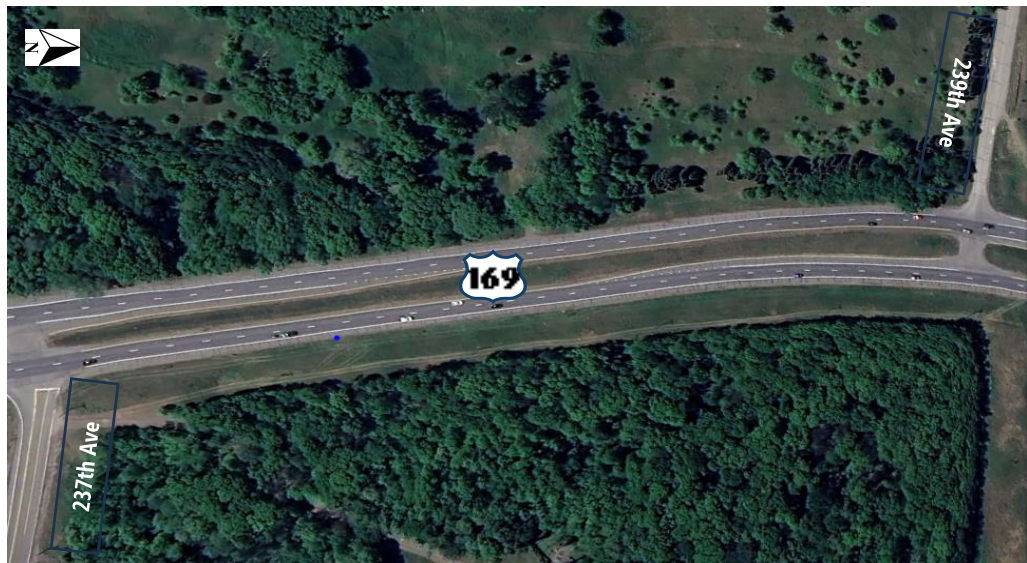
**Exhibit 3-8. Location 7: Segment Between 237th Ave NW and 239th Ave NW**

**Exhibit 3-8** presents images depicting the roadway conditions at the location.

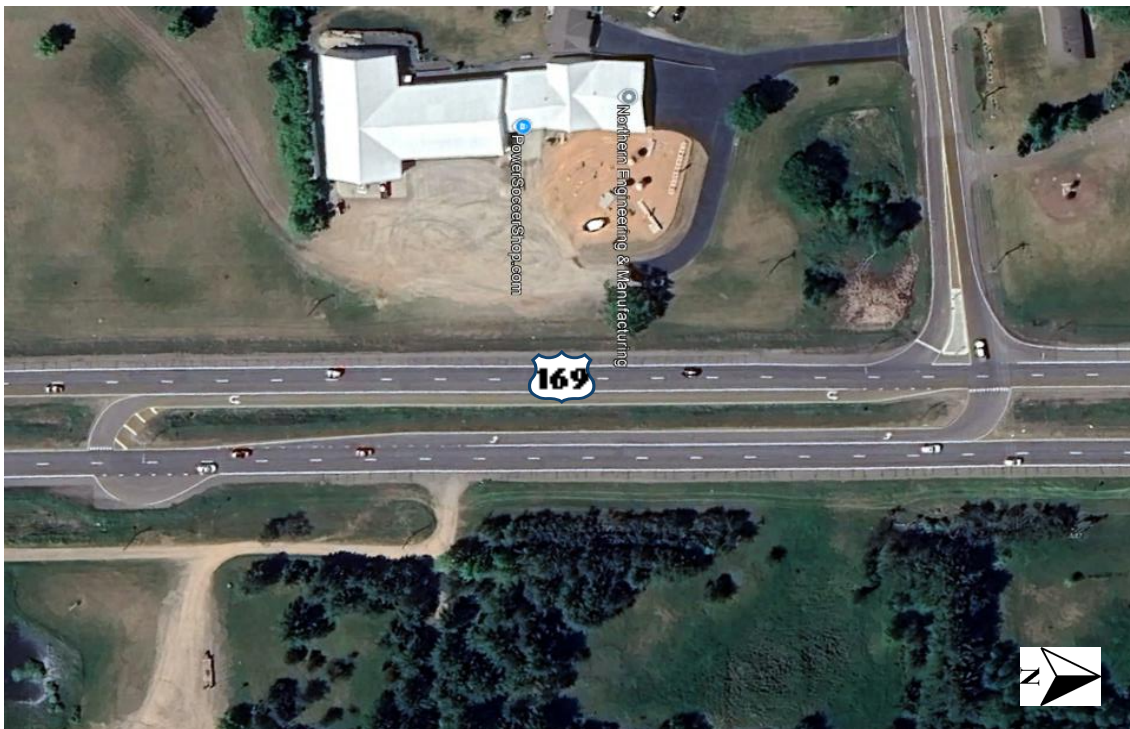
**Exhibit 3-9. Location 8: Intersection of 243rd Ave NW**

**Exhibit 3-9** presents images depicting the roadway conditions at the location.

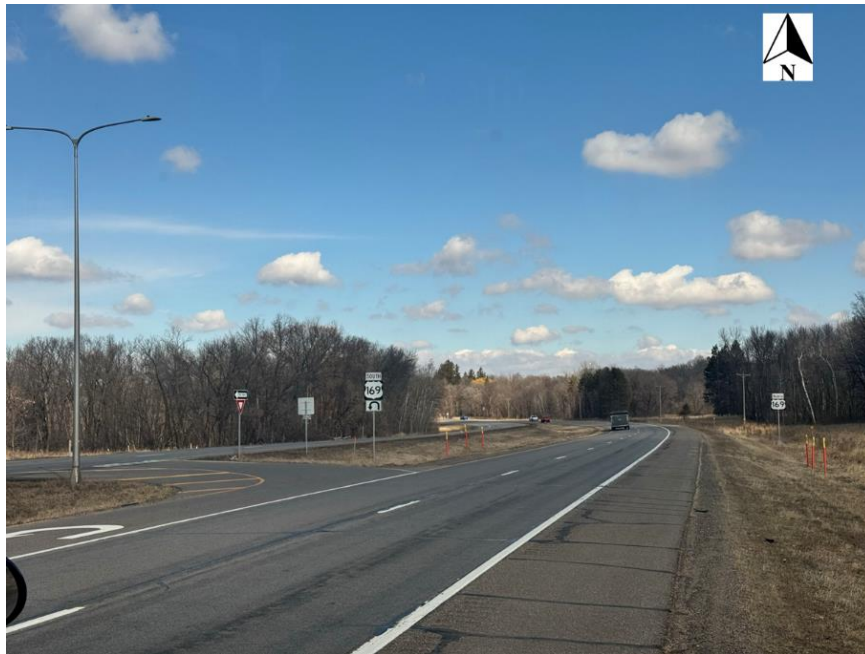
**Exhibit 3-10. Location 9: Intersection of 245th Ave NW (County Rd 19)**

**Exhibit 3-10** presents images depicting the roadway conditions at the location.

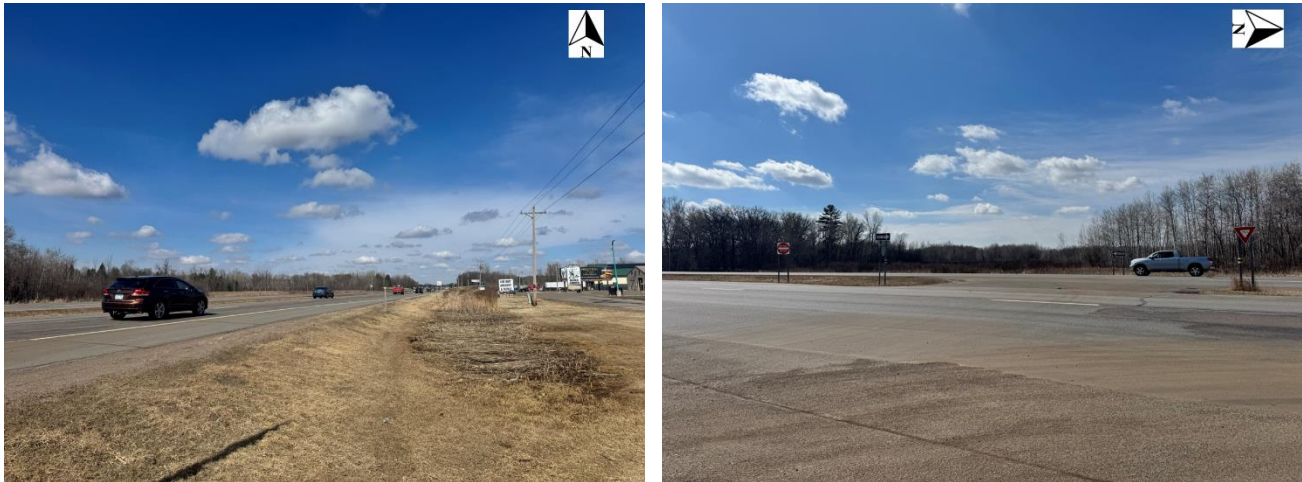
**Exhibit 3-11. Location 10: Access Road and Crossover of 253rd Ave NW**

**Exhibit 3-11** presents images depicting the roadway conditions at the location.

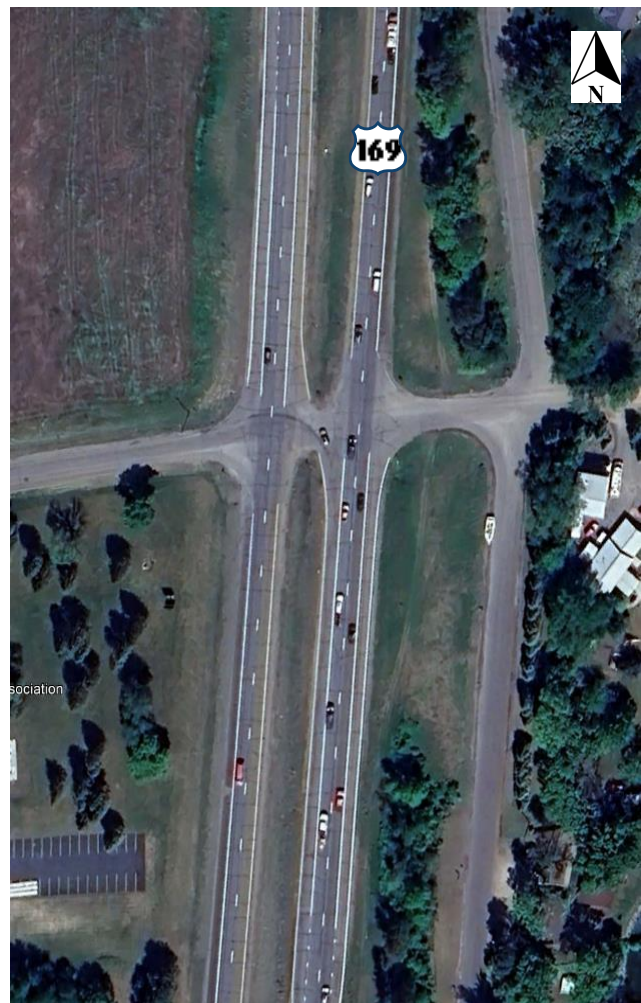
**Exhibit 3-12. Location 11: Intersection and Crossover at 273rd Ave**

**Exhibit 3-12** presents images depicting the roadway conditions at the location.

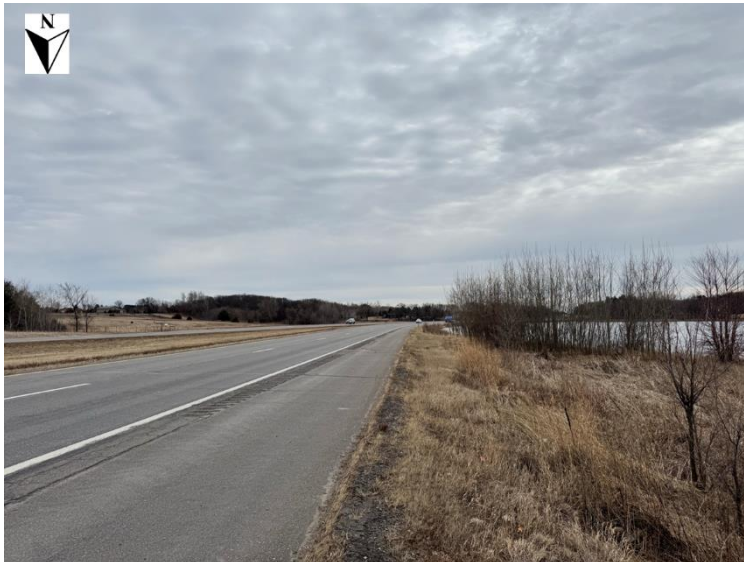
**Exhibit 3-14. Location 13: Horizontal Curve Next to Cantlin Lake**

**Exhibit 3-14** presents images depicting the roadway conditions at the location.

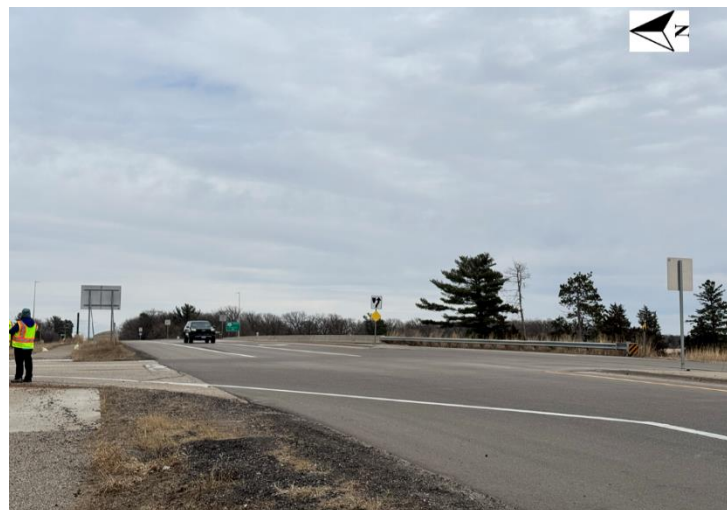
**Exhibit 3-15. Location 14: Intersections at West Ramps of US 169 to 289th Ave NW (CSAH 9)**

**Exhibit 3-15** presents images depicting the roadway conditions at the location.

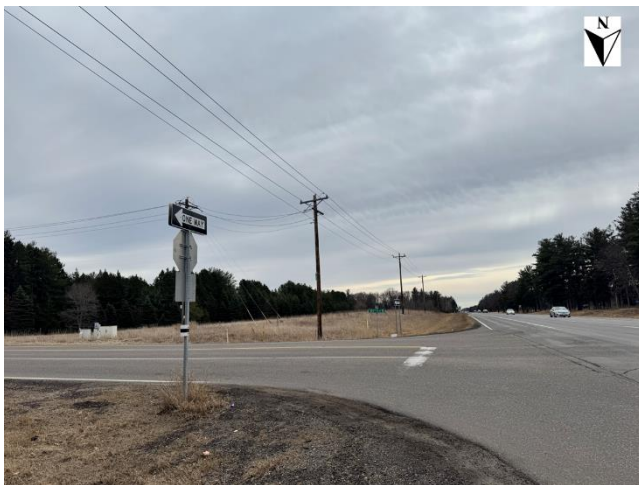
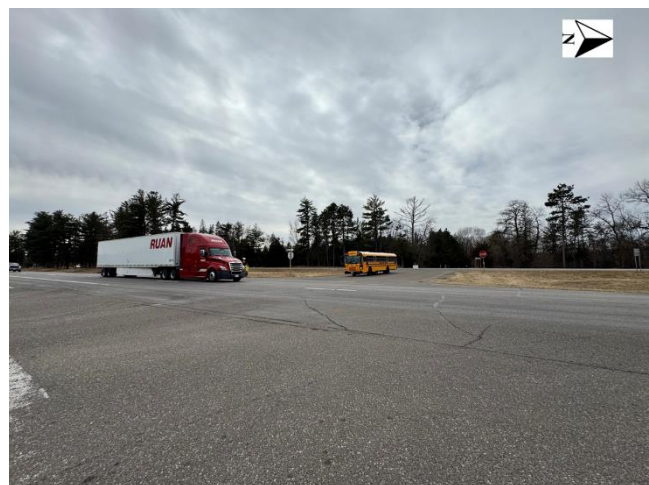
**Exhibit 3-16. Location 15: Intersection and Crossover of 305th Ave NW**

**Exhibit 3-16** presents images depicting the roadway conditions at the location.

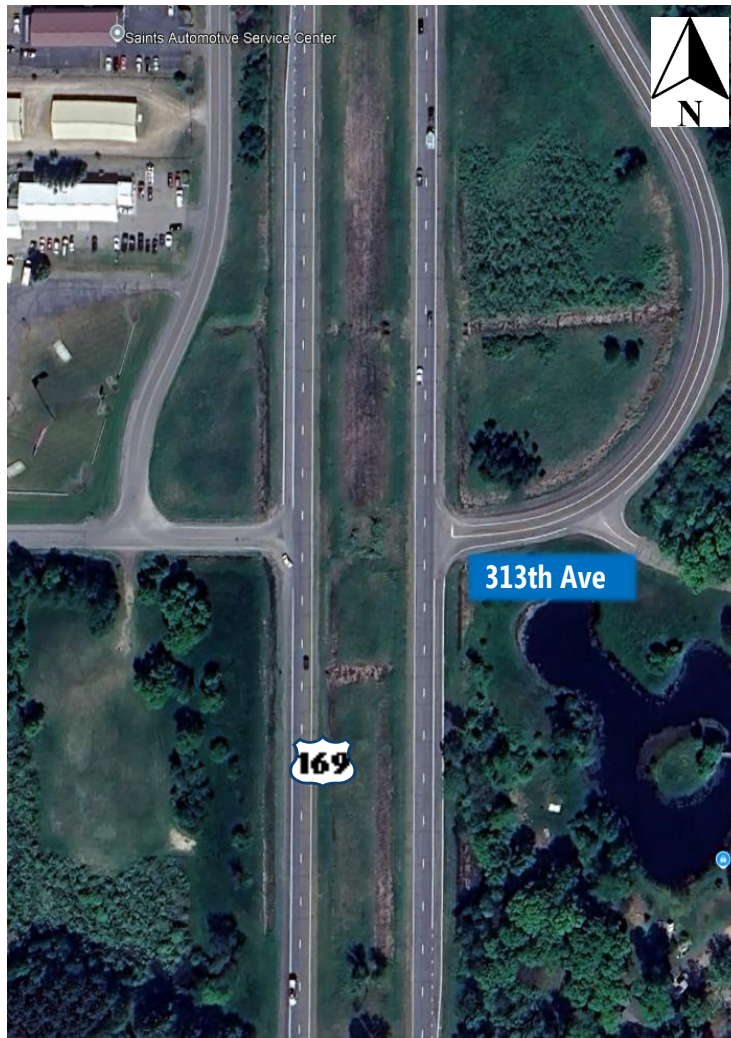
**Exhibit 3-17. Location 16: Intersection of 313th Ave NW**

**Exhibit 3-17** presents images depicting the roadway conditions at the location.

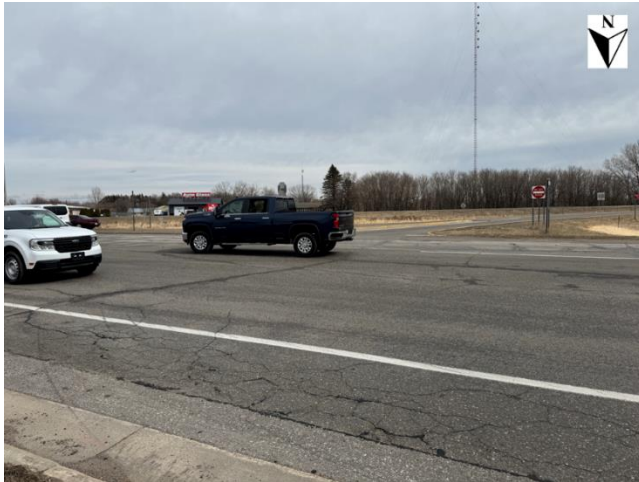
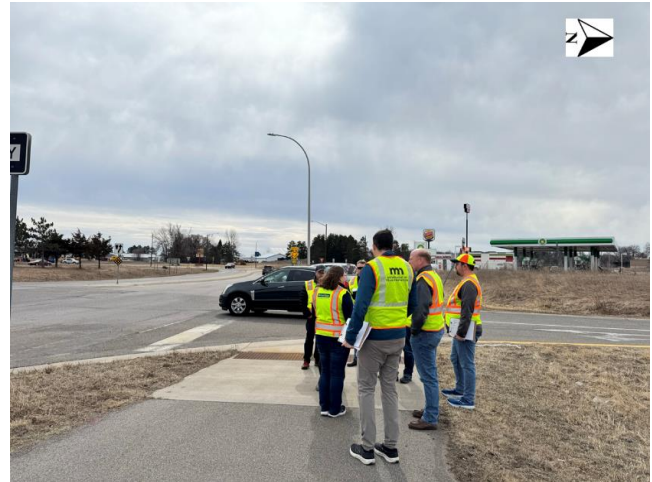
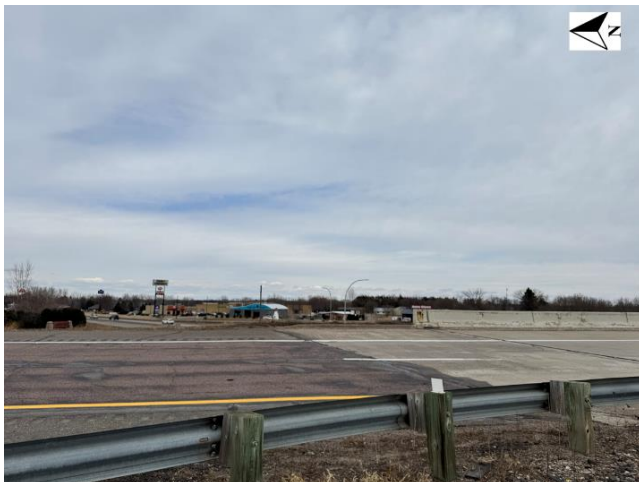
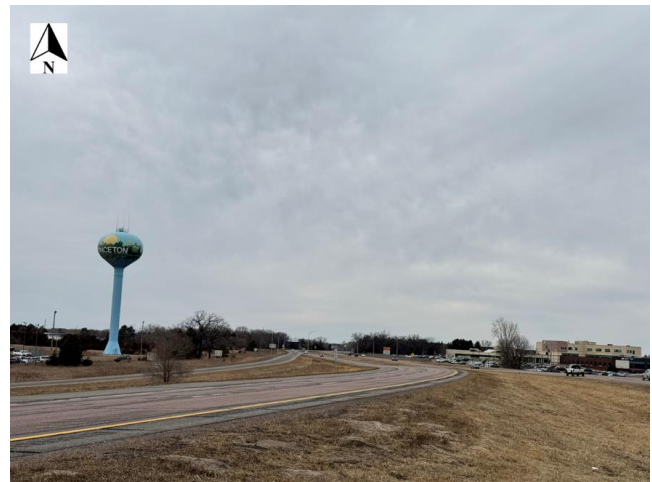
**Exhibit 3-18. Location 17: US 169 Bridge Over CSAH 29 (S Rum River Dr) and Intersections at East and West Ramps**

**Exhibit 3-18** presents images depicting the roadway conditions at the location.
