## US Route 169 – ROAD SAFETY AUDIT

Sherburne County, Minnesota

### FINAL REPORT

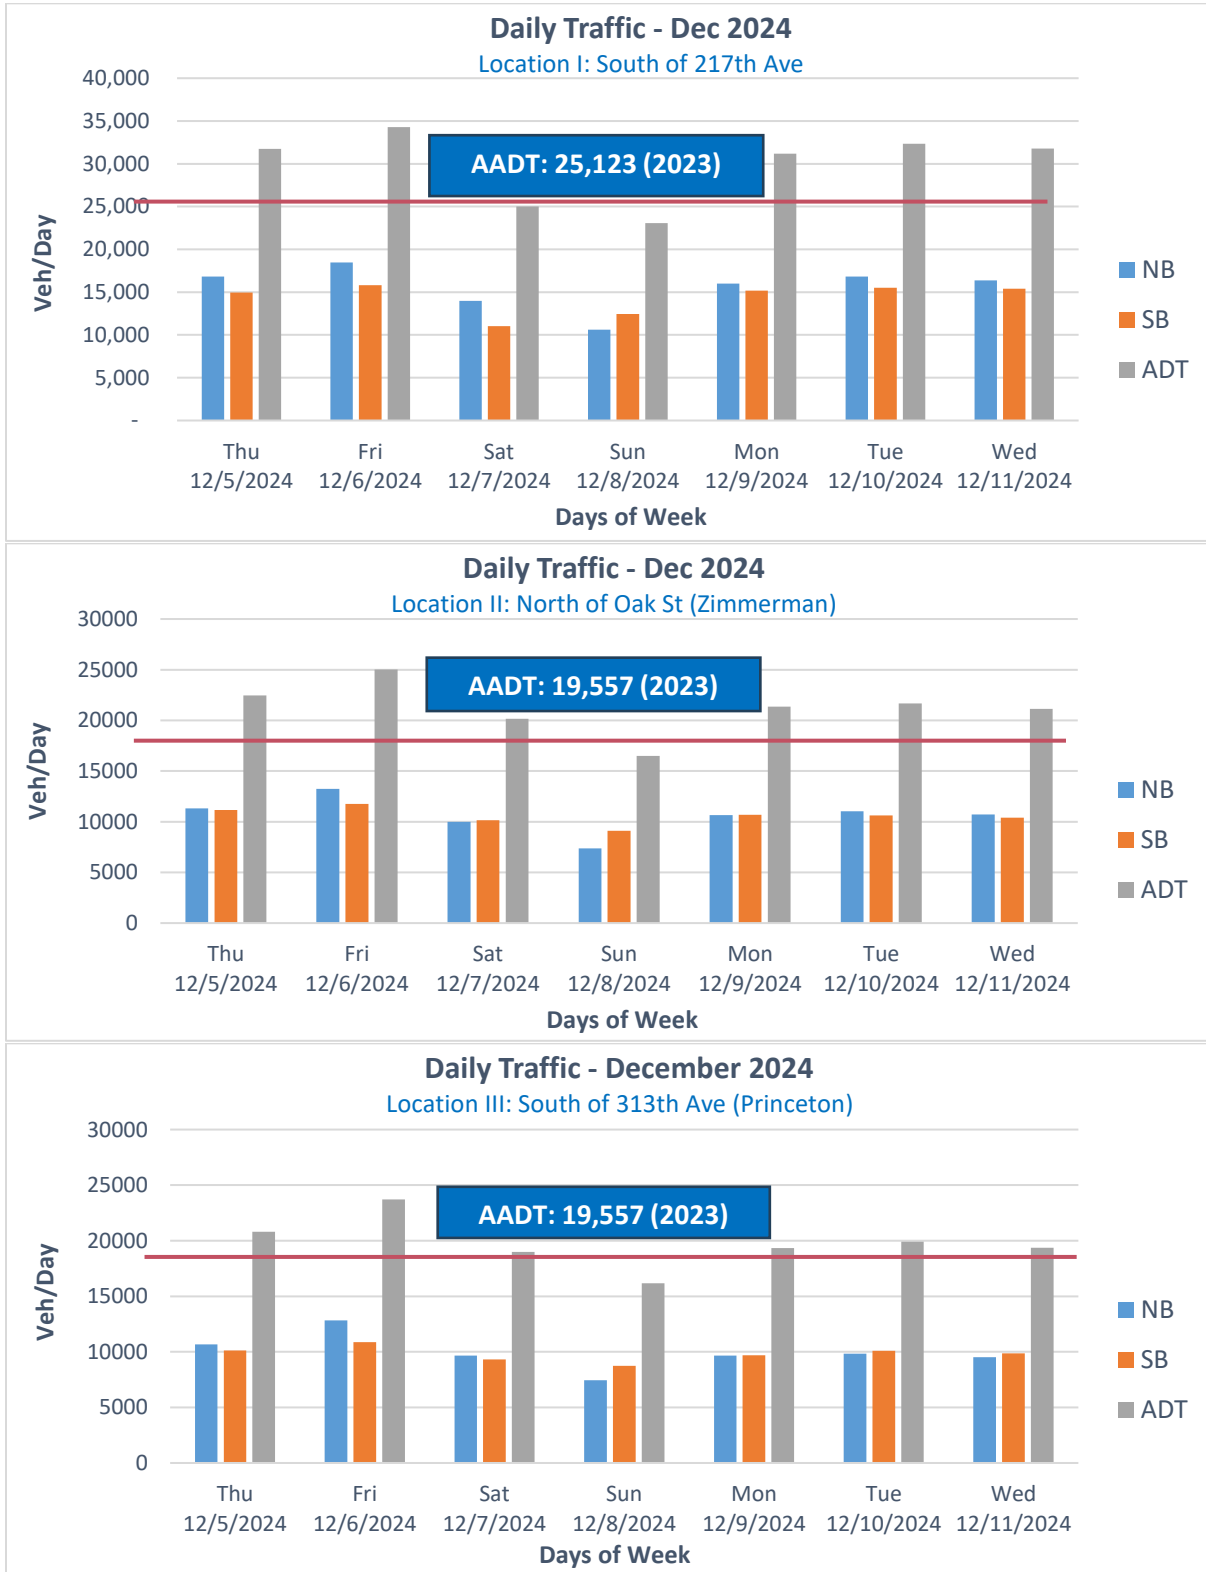
The following plots illustrate the daily traffic along US Highway 169 on different days of the week in December 2024. These plots provide a detailed overview of traffic patterns, highlighting variations in traffic volumes throughout the week. For comparison purposes, the annual average daily traffic (AADT) for the year 2023 along US Highway 169 is also included.

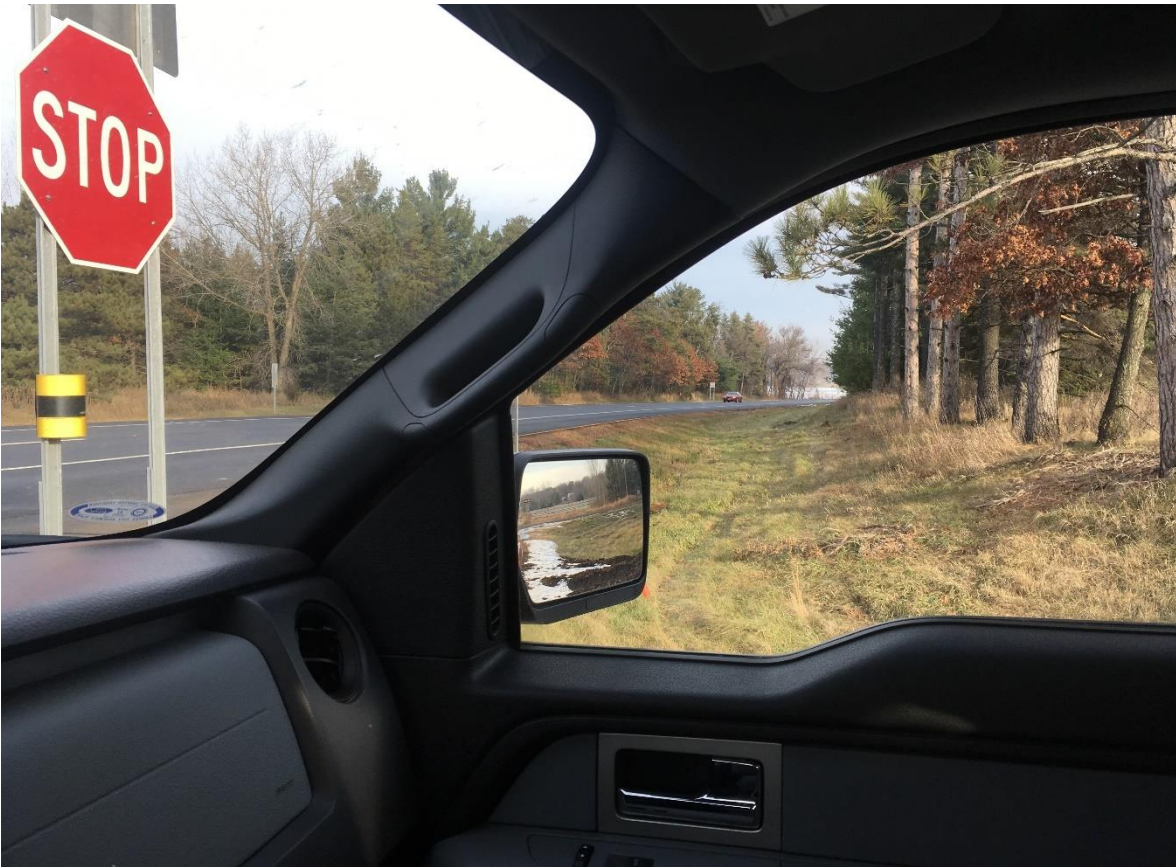
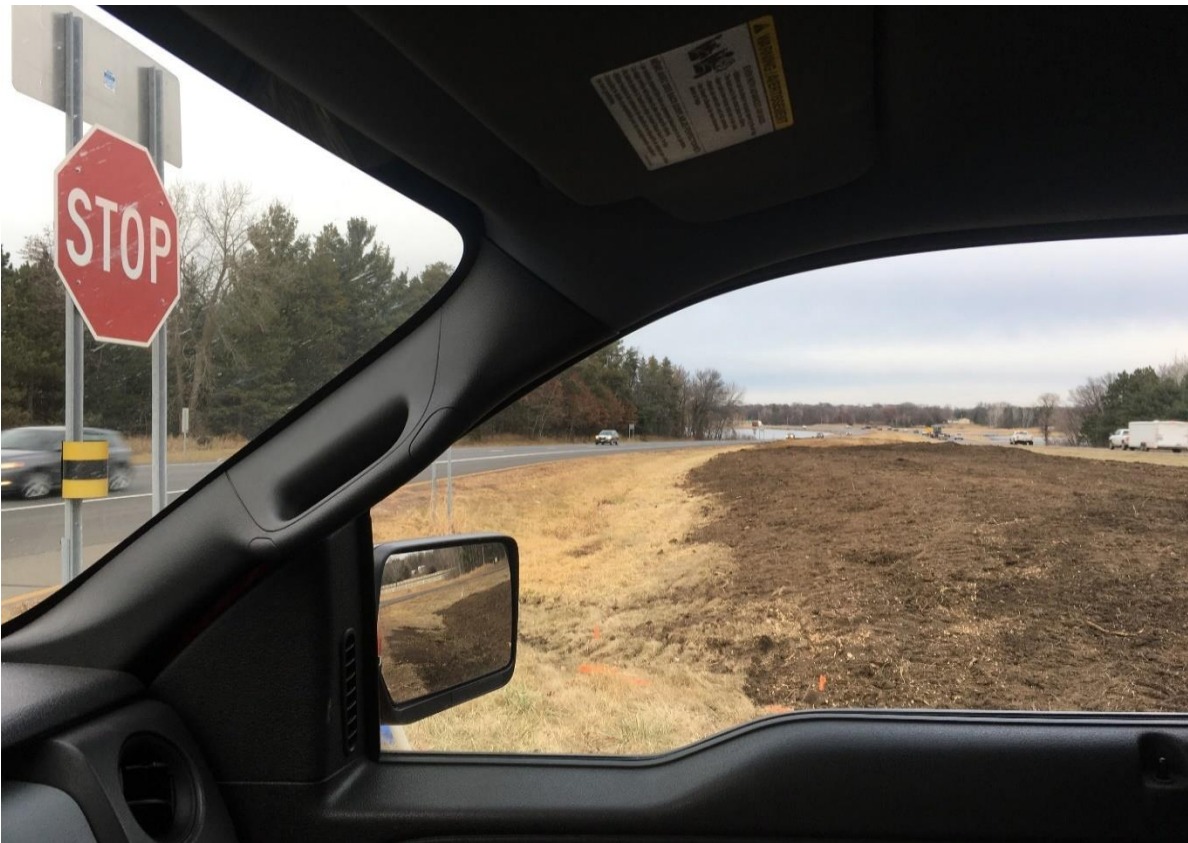
To improve the safety performance of the US 169 corridor, the MnDOT undertook a tree removal project in 2017. The primary objective was to address sight distance issues caused by trees in the median, which were particularly problematic for crossing traffic.

The tree removal was carried out at multiple critical points along the US 169 corridor, focusing on areas with high traffic volumes and significant sight distance issues. The following before and after photos illustrate the changes made through the tree removal project.

Before Tree Removal: 283rd Ave Crossover Berm

After Tree Removal: 283rd Ave Crossover Berm

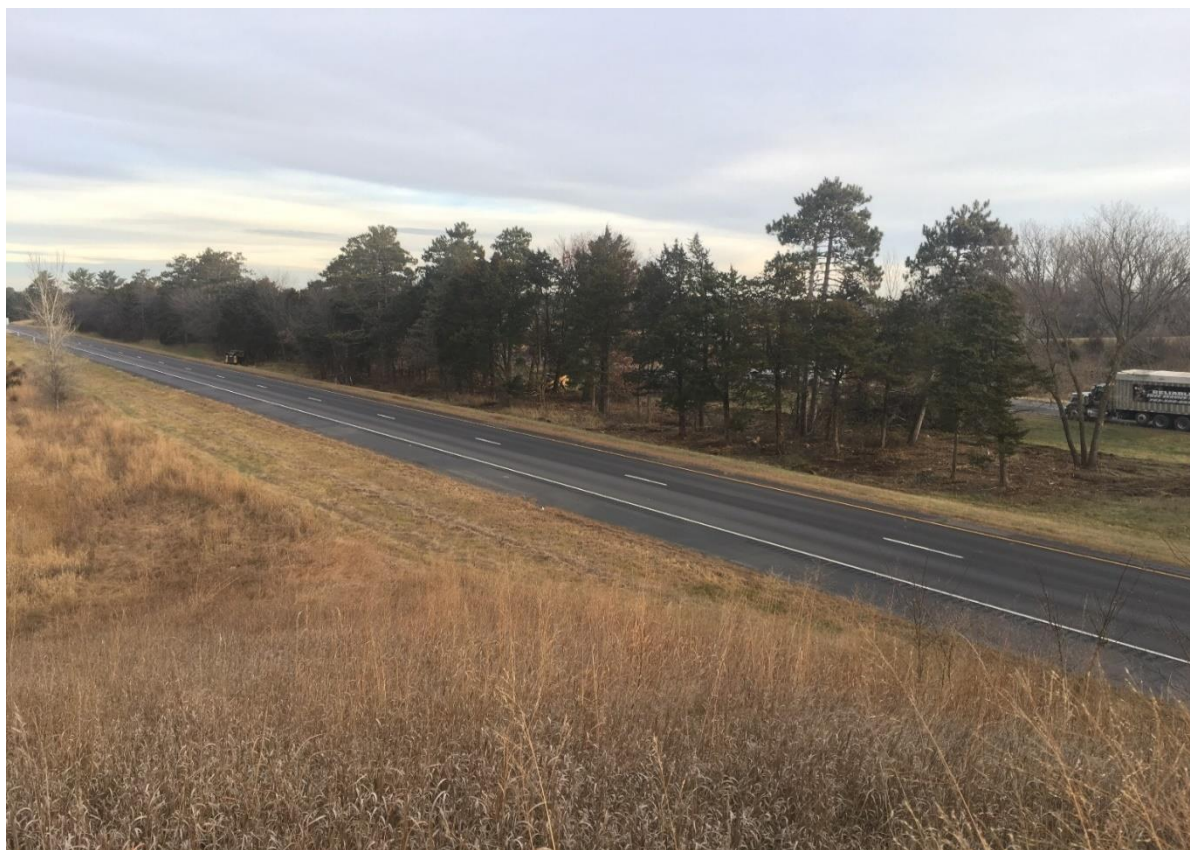
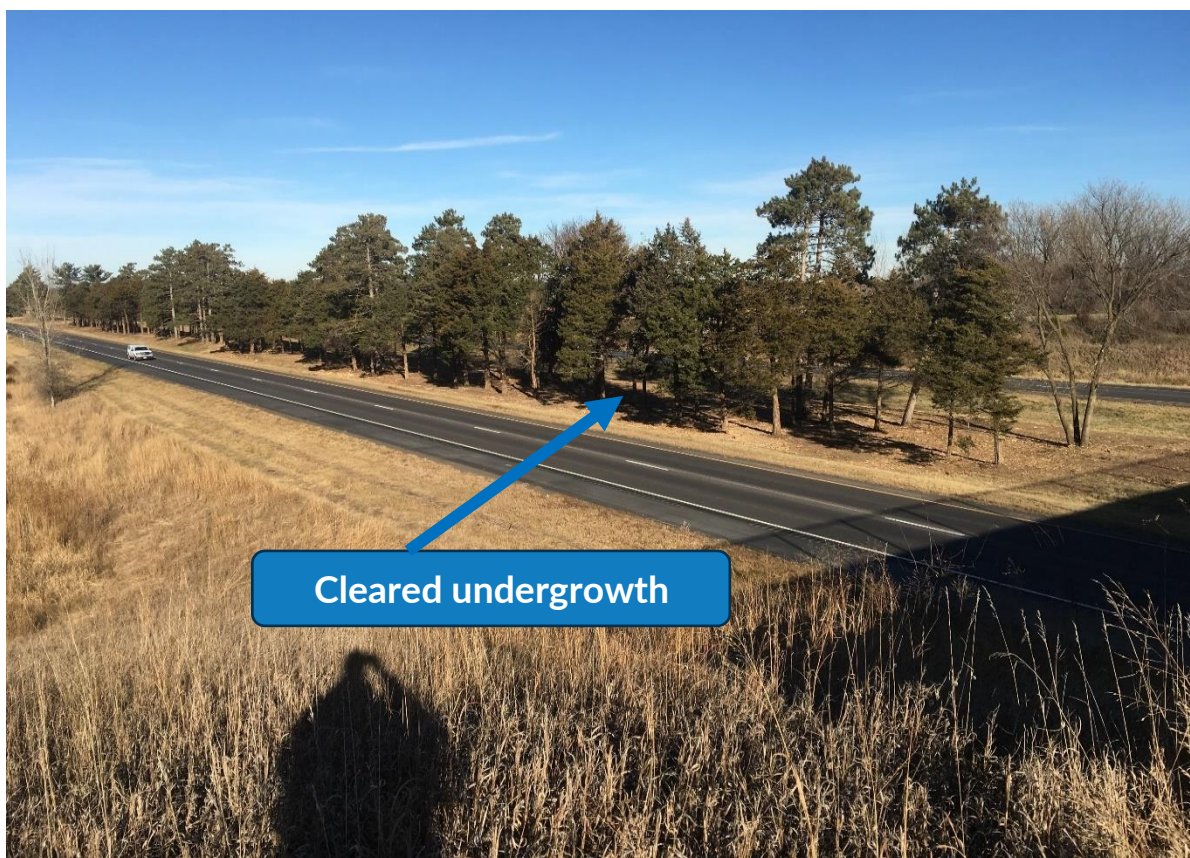
Before Tree Removal: Median Near CR 9

After Tree Removal: Median Near CR 9

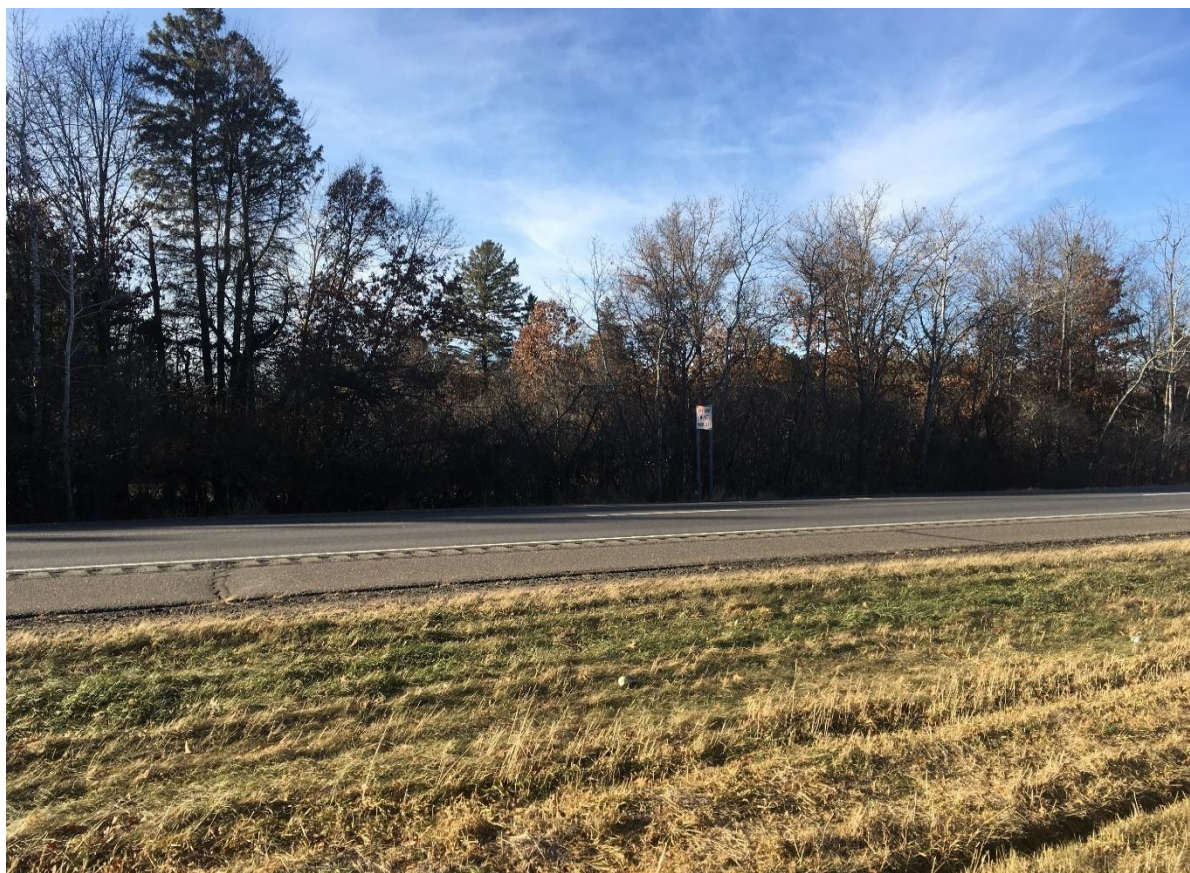
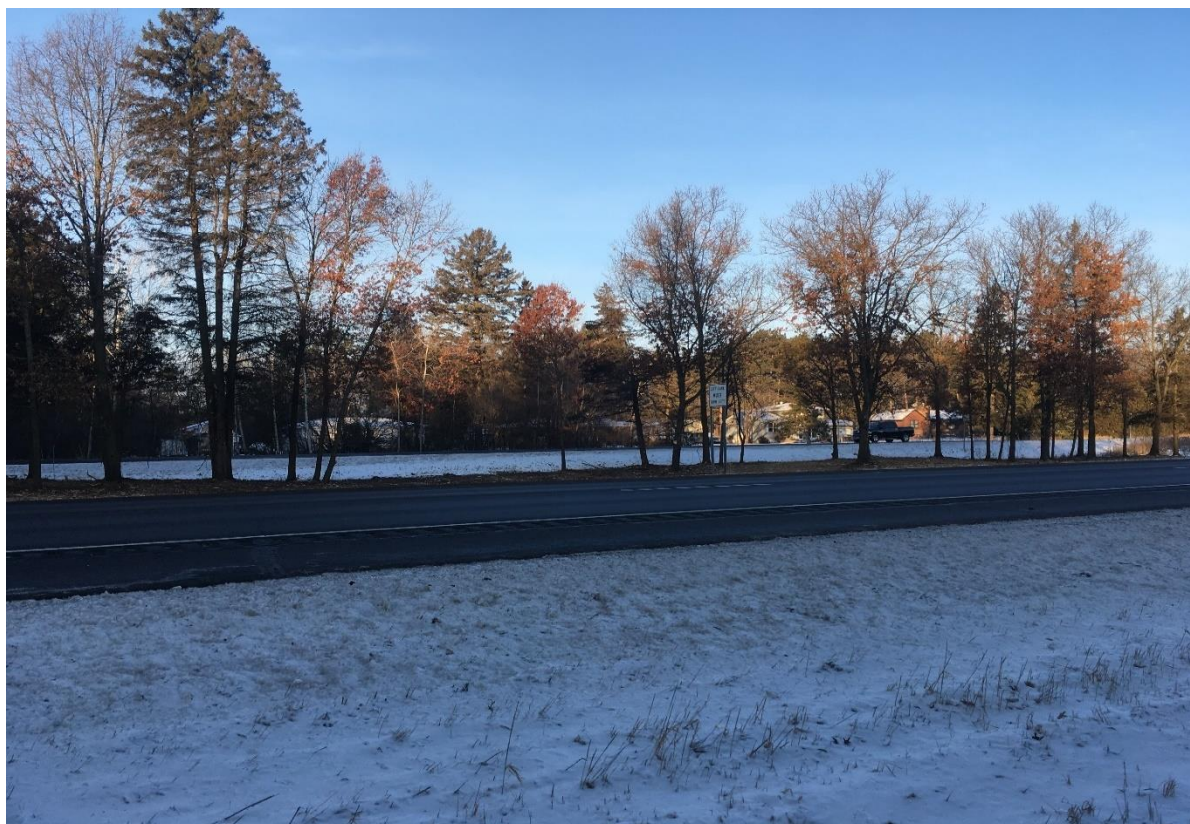
Before Tree Removal: Median Near Game Farm

After Tree Removal: Median Near Game Farm
