***Sediment Pollution from Sand Mining:  
Impact on Flood Risk, Costs, Water Quality***

***Appendix to APO BMP List Proposal***

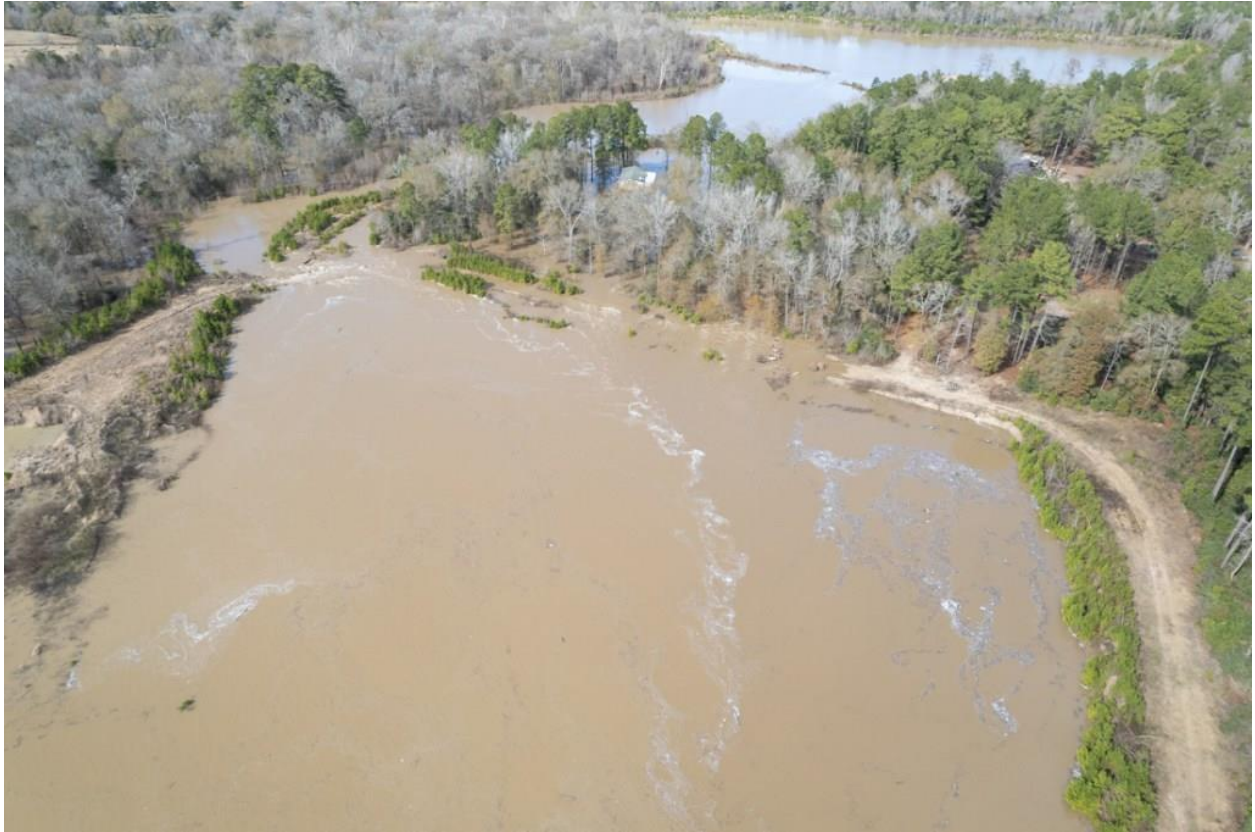
*San Jacinto East Fork capturing a mine in Plum Grove.*

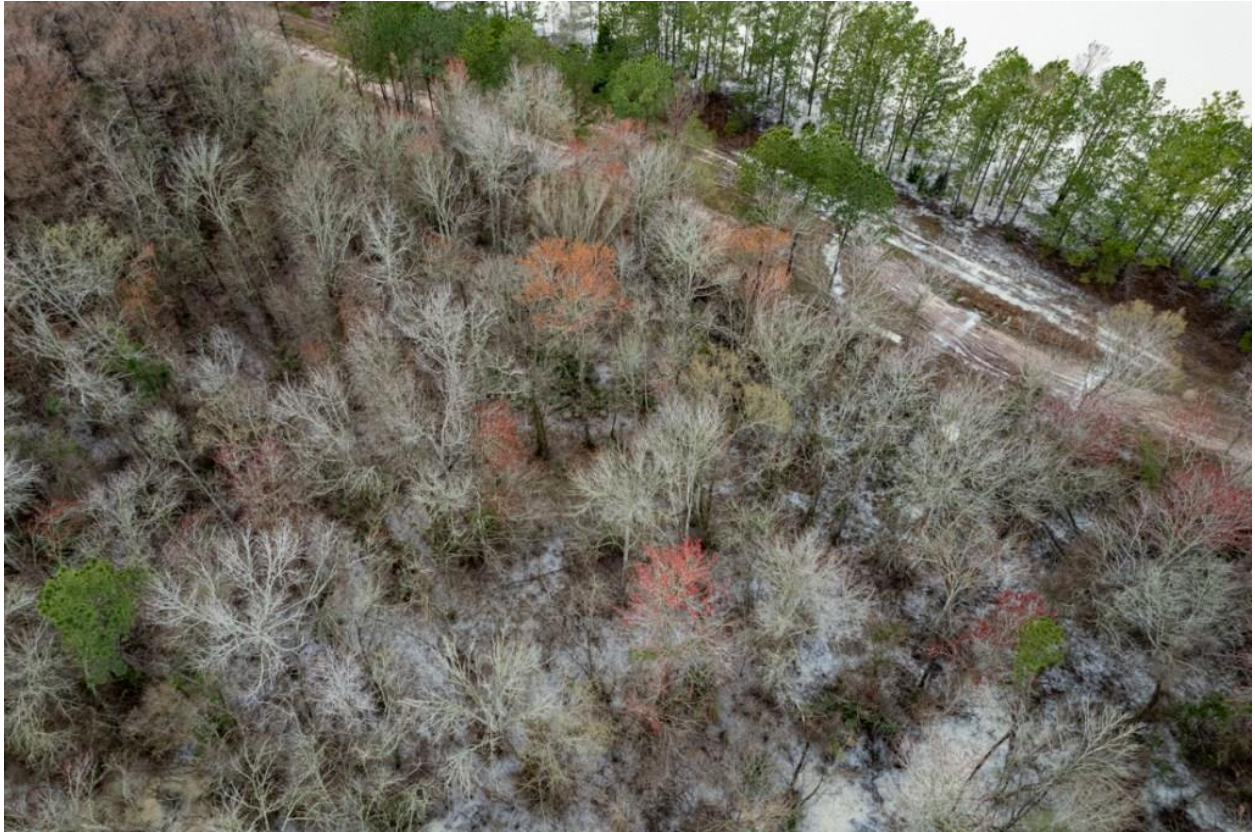
*Close up of same effluent from same pond shows source of leakage.*

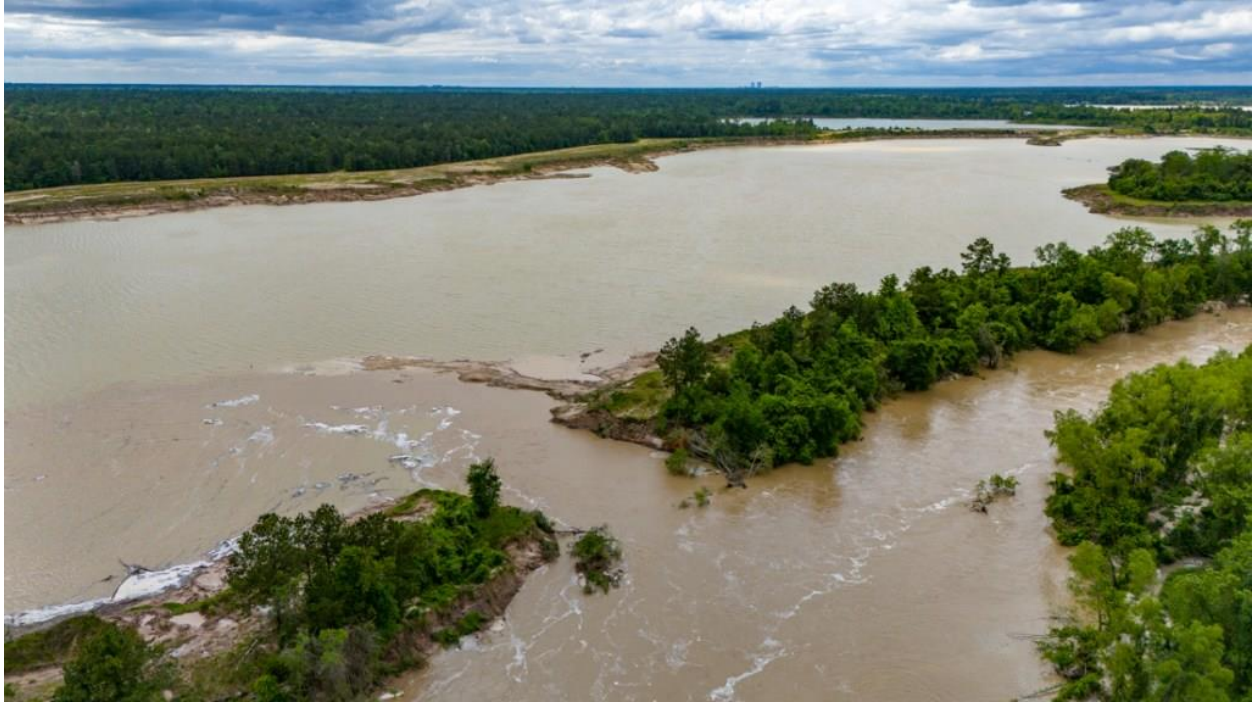
*...and flows out at the south end.*
