***Sediment Pollution from Sand Mining:  
Impact on Flood Risk, Costs, Water Quality***

***Appendix to APO BMP List Proposal***

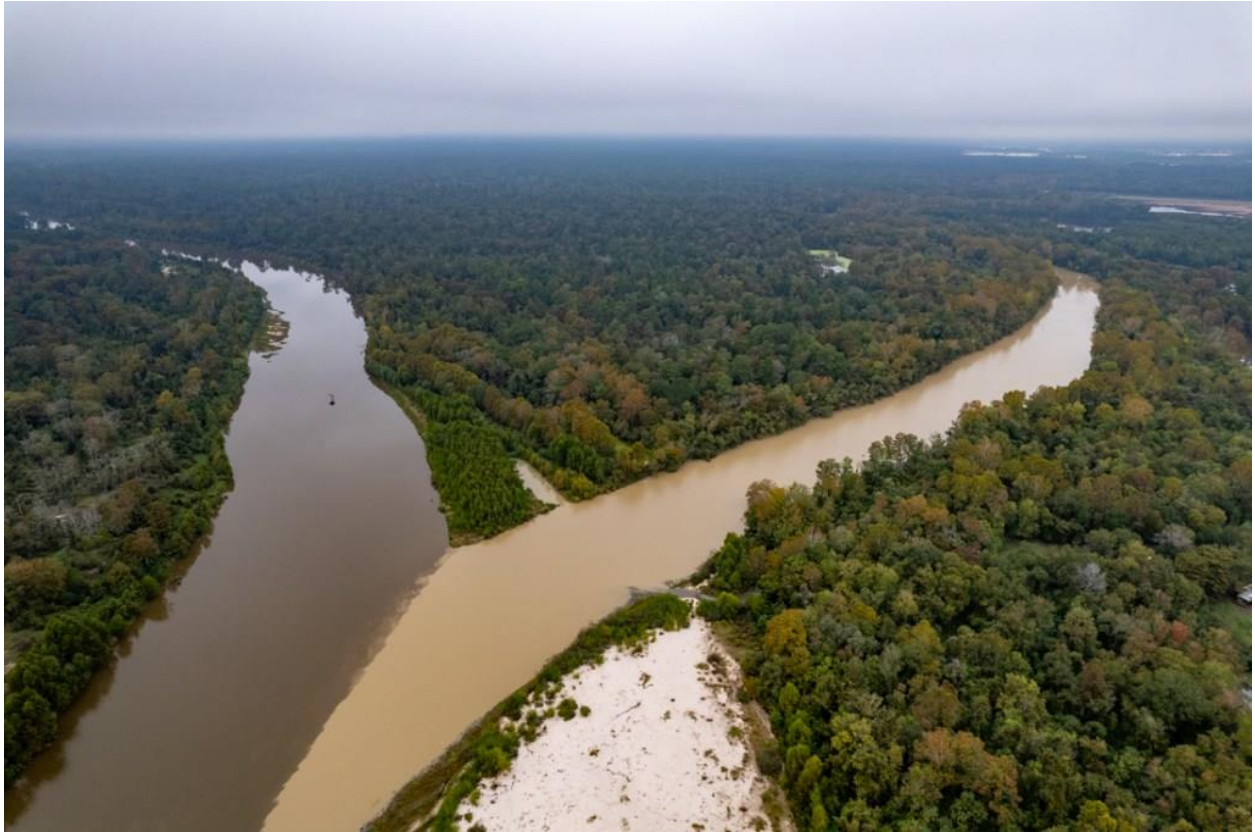
*Confluence of San Jacinto West Fork (right) and Spring Creek near US59 Bridge.  
This is a frequent sight. Twenty square miles of mines are upstream on the right  
in a 20-mile reach of the river.*

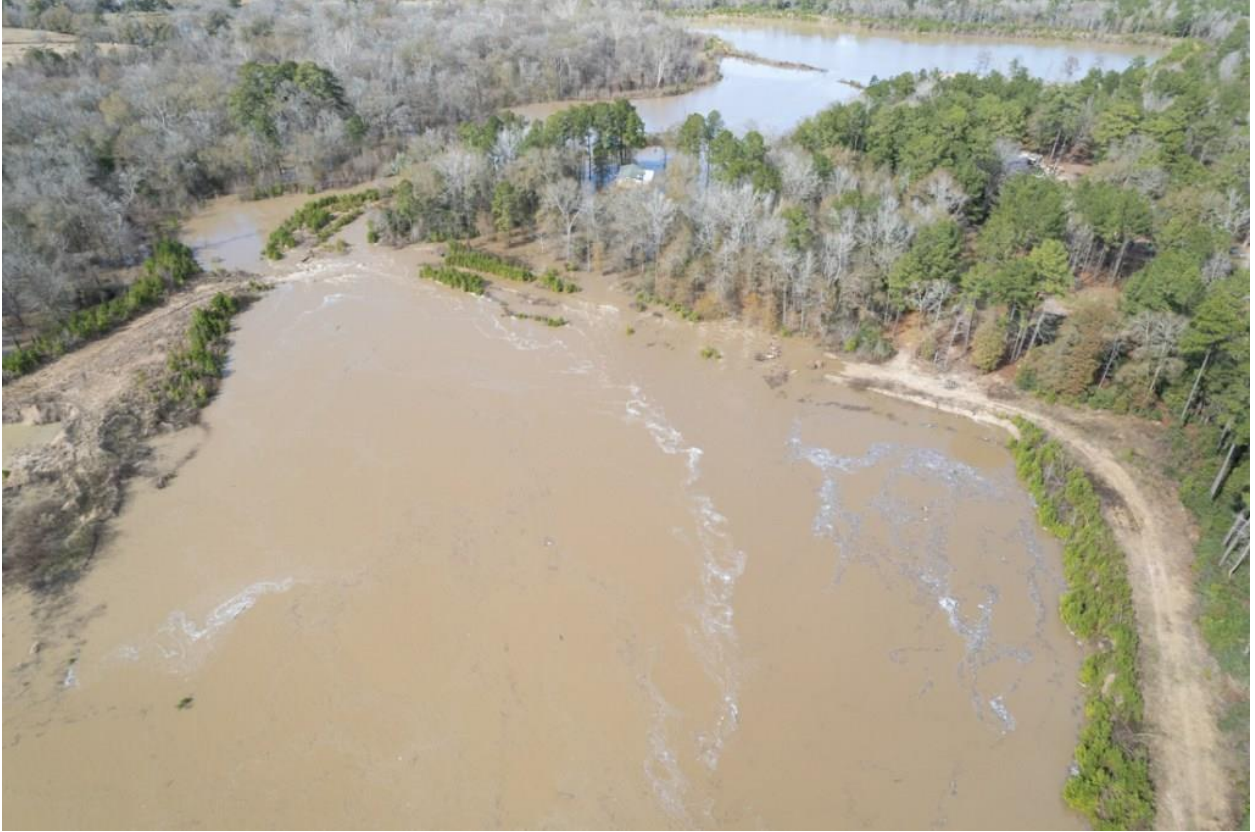
*San Jacinto East Fork capturing a mine in Plum Grove.*

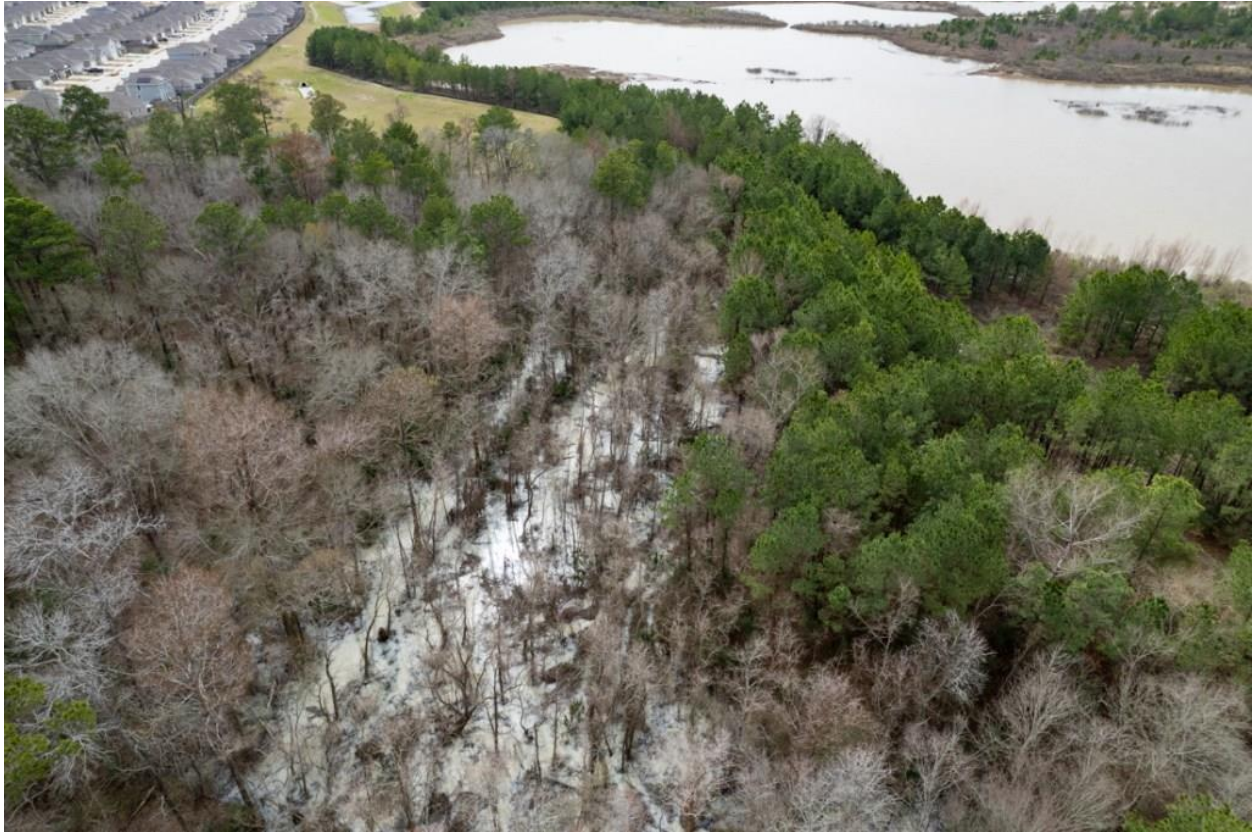
*Effluent from the Hallett settling pond on San Jacinto West Fork escaping into adjacent property owned by others.*

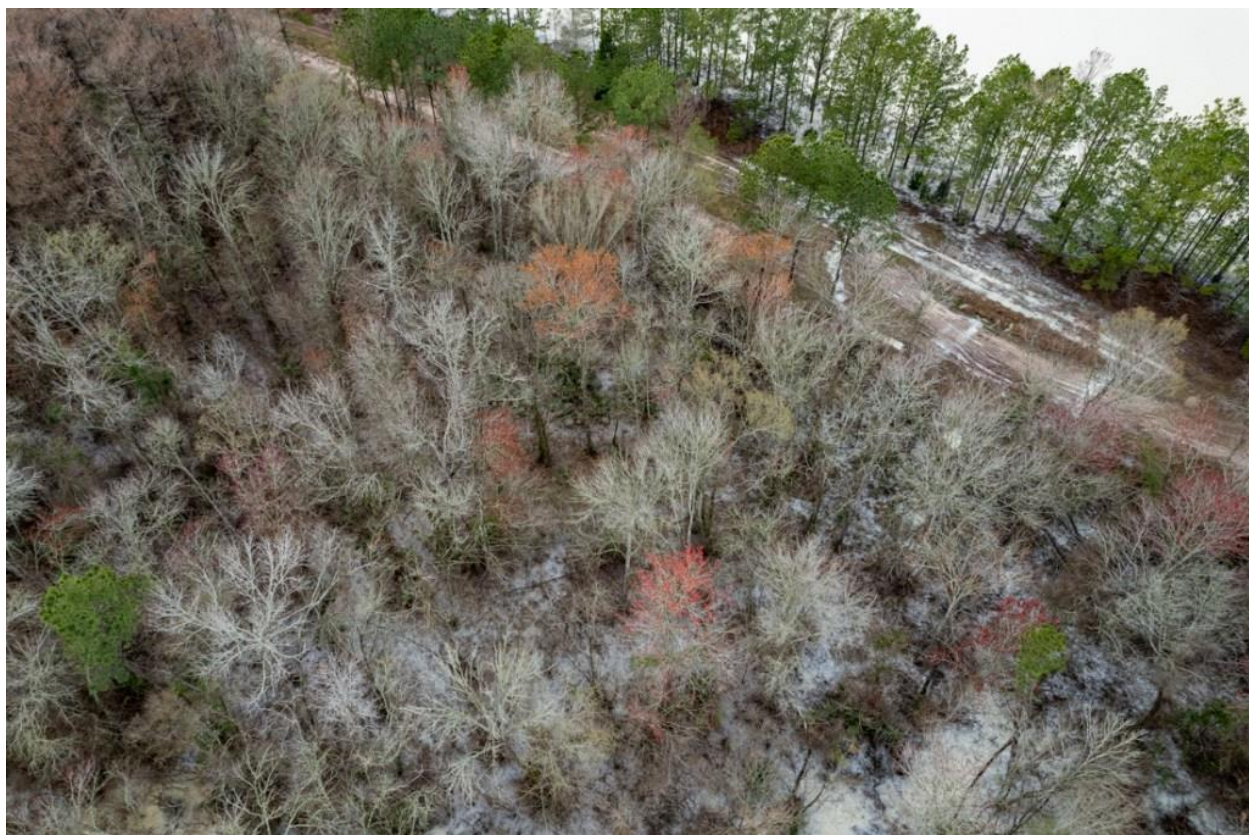
*Close up of same effluent from same pond shows source of leakage.*

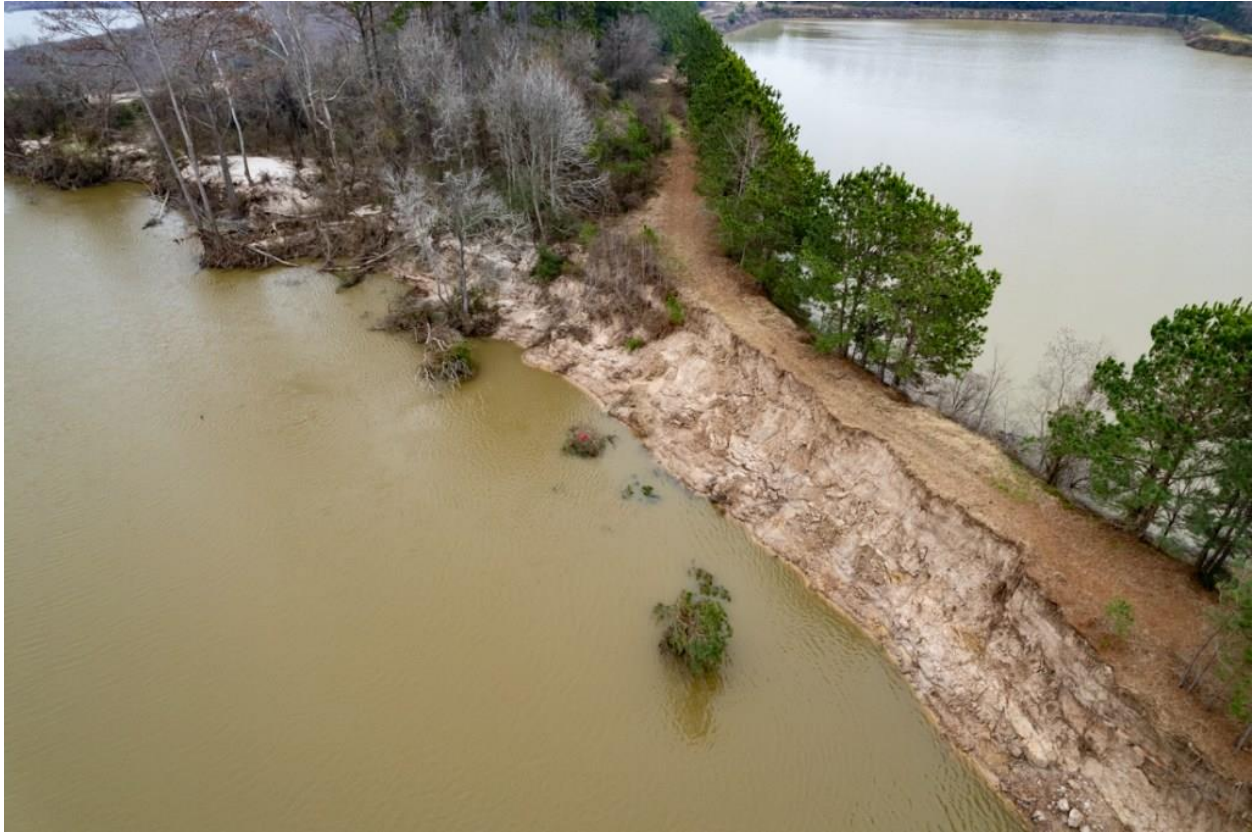
*Dike of abandoned Williams Brothers Mine (upper right) eroded by the San Jacinto West Fork (lower left).*

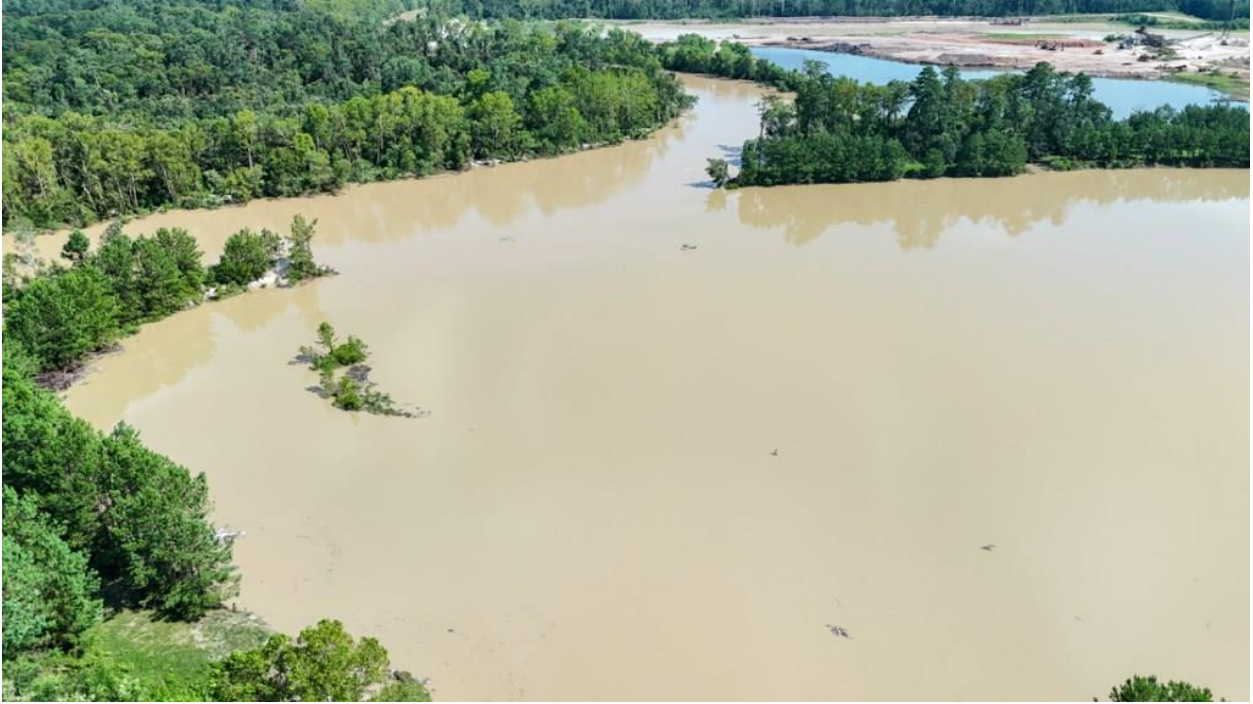
In the next flood, about three months later...

*... Hurricane Beryl eroded what was left of the wall and flowed through the pit.*

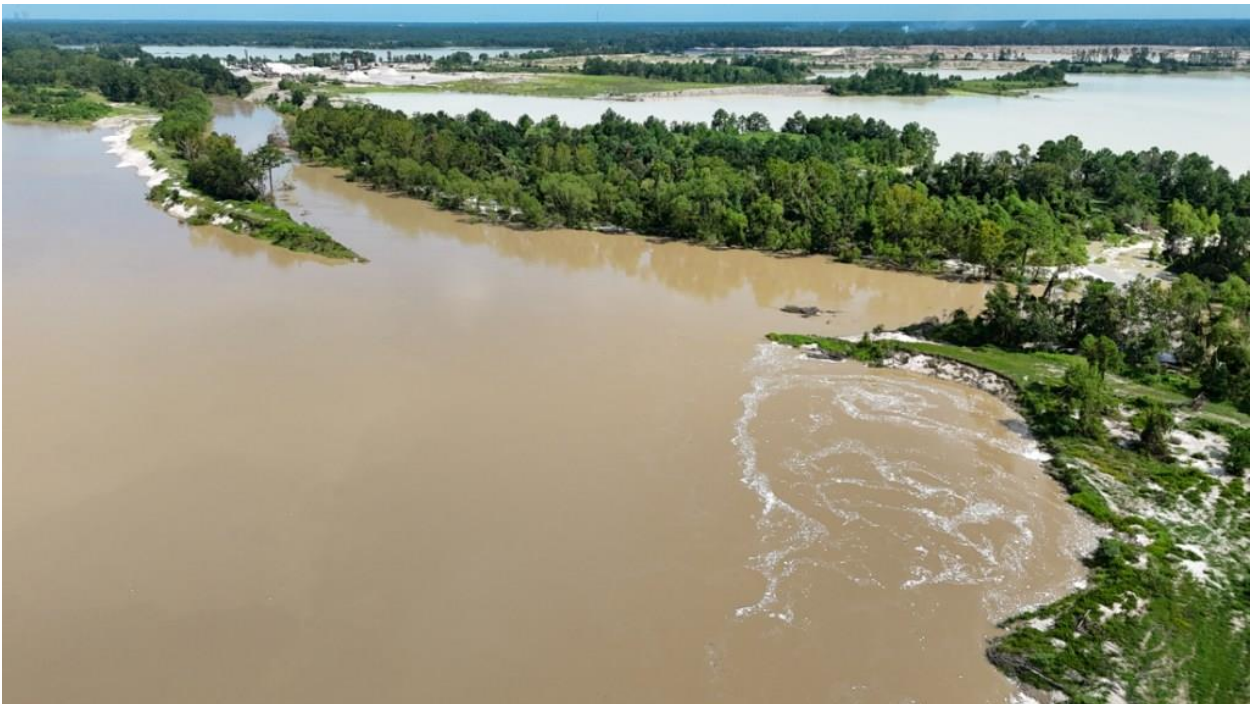
A little upstream, Hallett sold a sand pit (below left) on the San Jacinto West Fork to a real estate developer, Riverwalk Porter LLC. Within months, the river captured the pit.

*The West Fork now flows into the pit at the north end...*

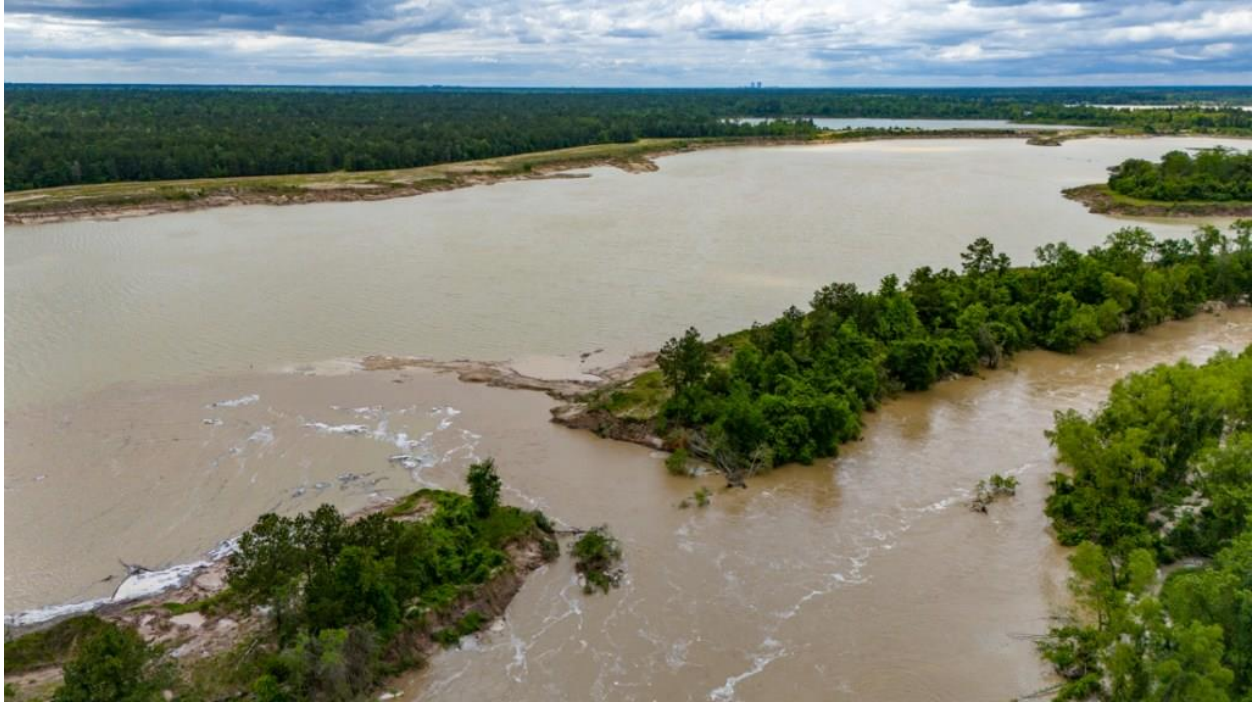
*...and flows out at the south end.*

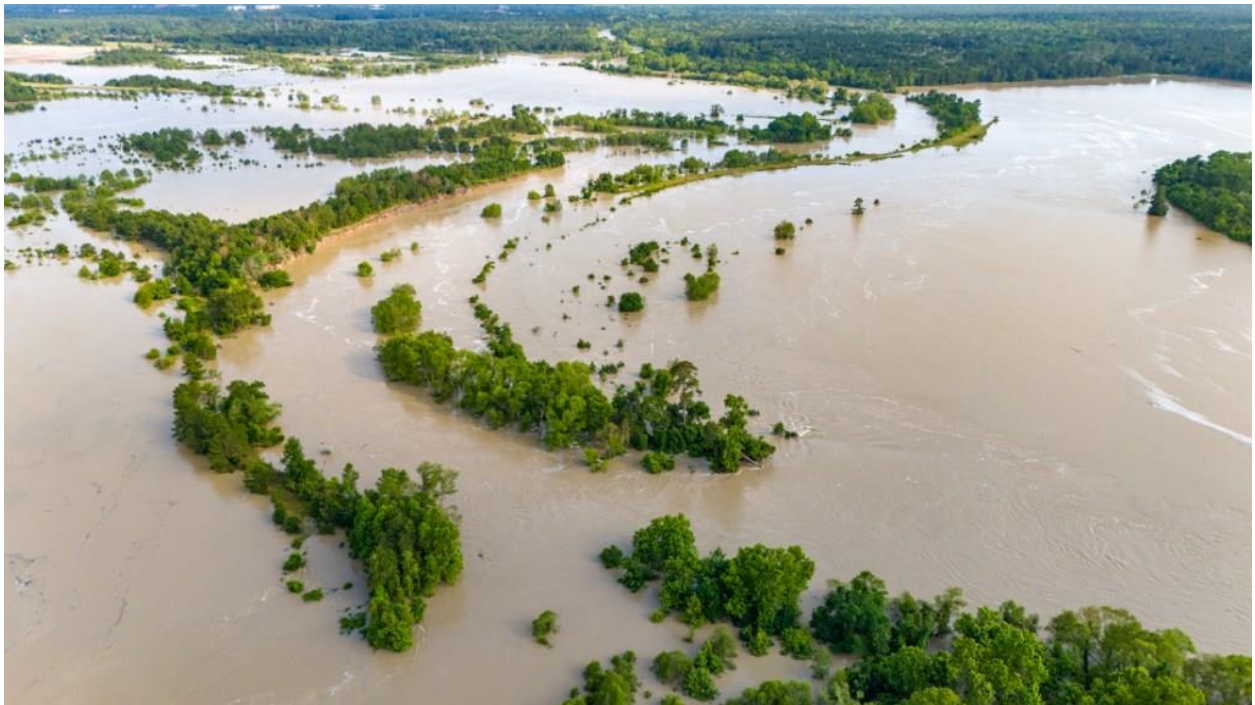
*Wider shot of same pit (to the right of the S-turn) shows both the entry breach (lower right) and exit breach (upper right) in the dikes.*

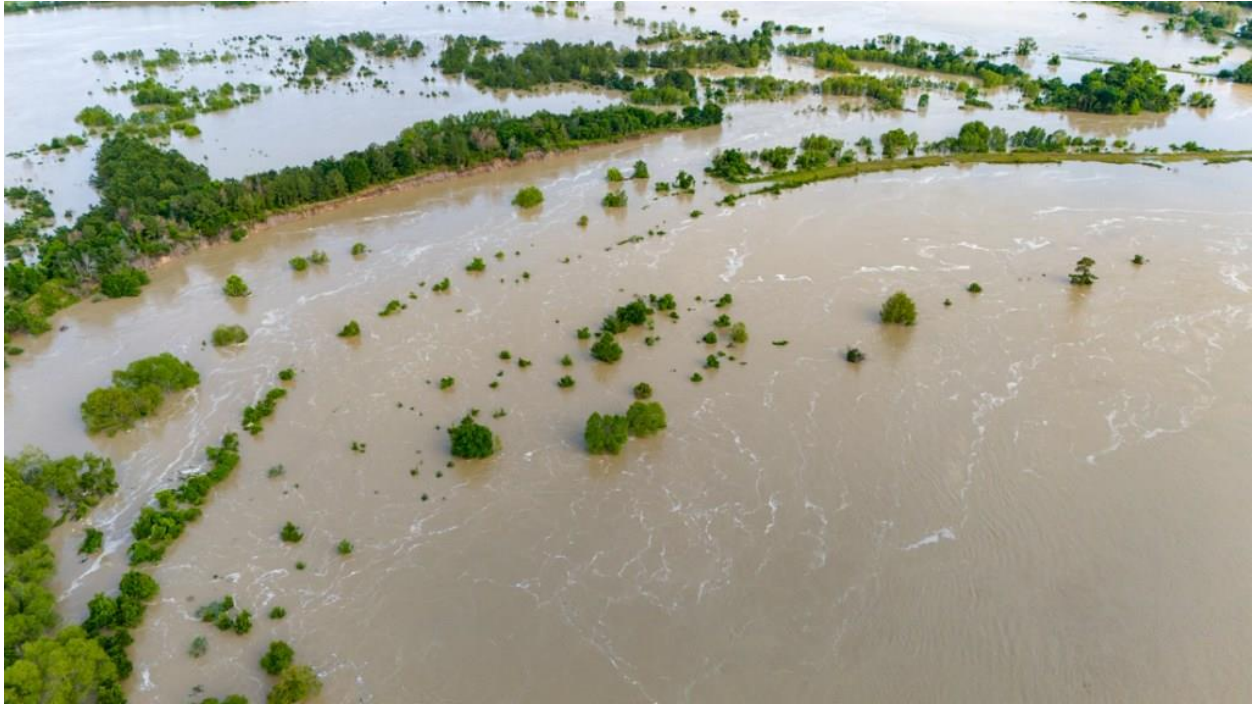
*A drone followed logs floating through this captured West Fork pit at 5 MPH.*

[5 MPH is more than fast enough to scoop up and carry off the largest grains of sand](#) and other sediment.

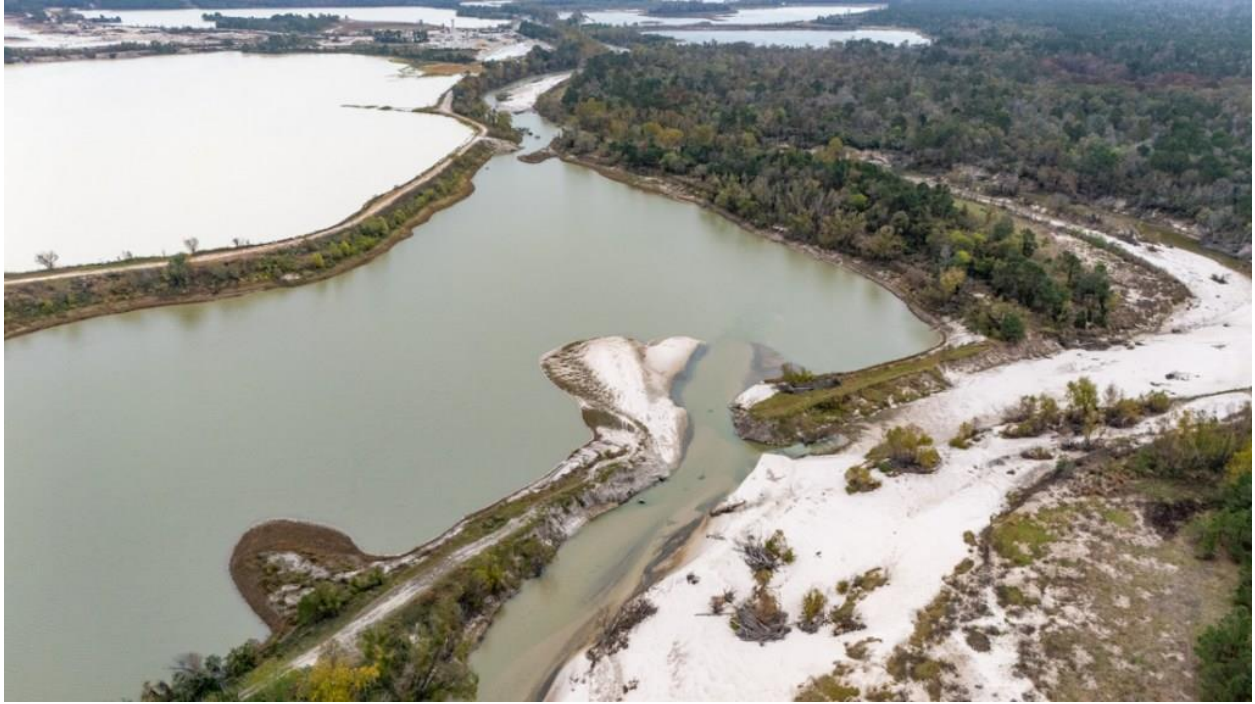
*Another West Fork pit capture at the Hallett Mine after floodwaters receded. Notice how natural channel of the river has been virtually cut off.*

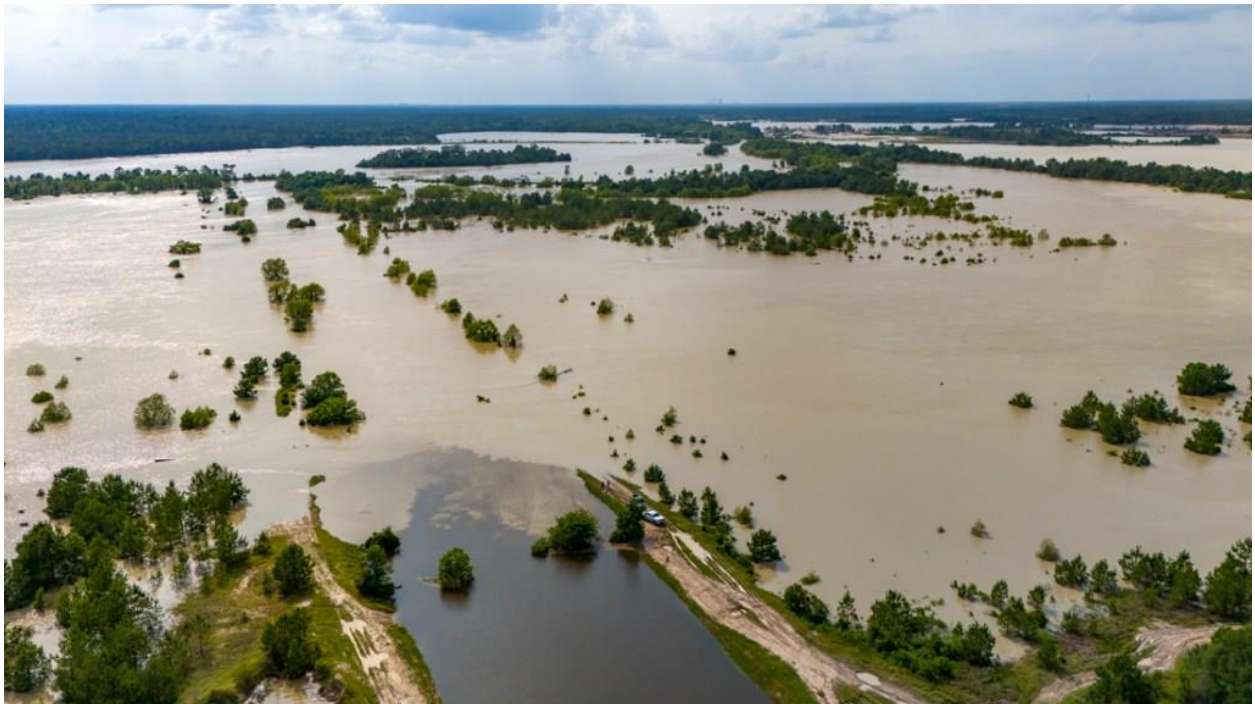
*Effluent from the Hallett Mine (upstream in upper right) polluting the West Fork at the Northpark/Oakhurst Ditch (middle foreground). Water flows right to left. Facing West.*

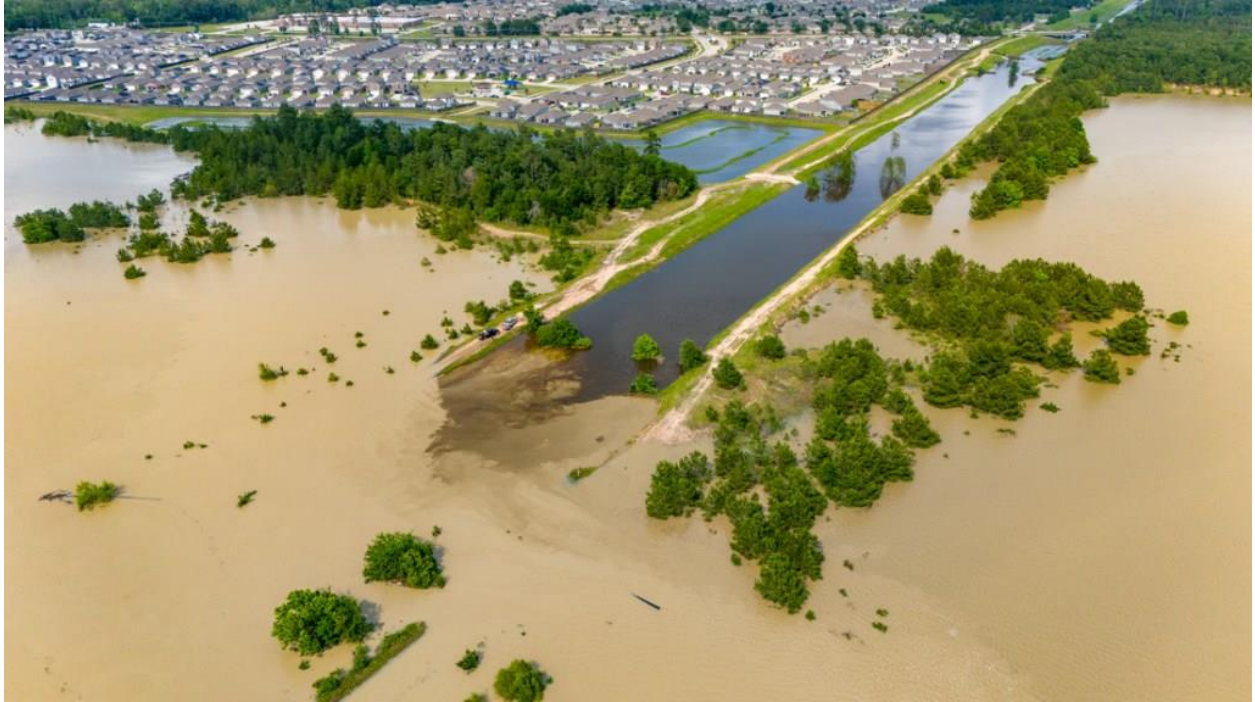
*Reverse angle (facing east) shows proximity of pollution to homes in Northpark Woods subdivision. That's the Oakhurst Ditch, which empties into the West Fork behind camera position. Water flows left to right. Hallett mine is upstream on left.*

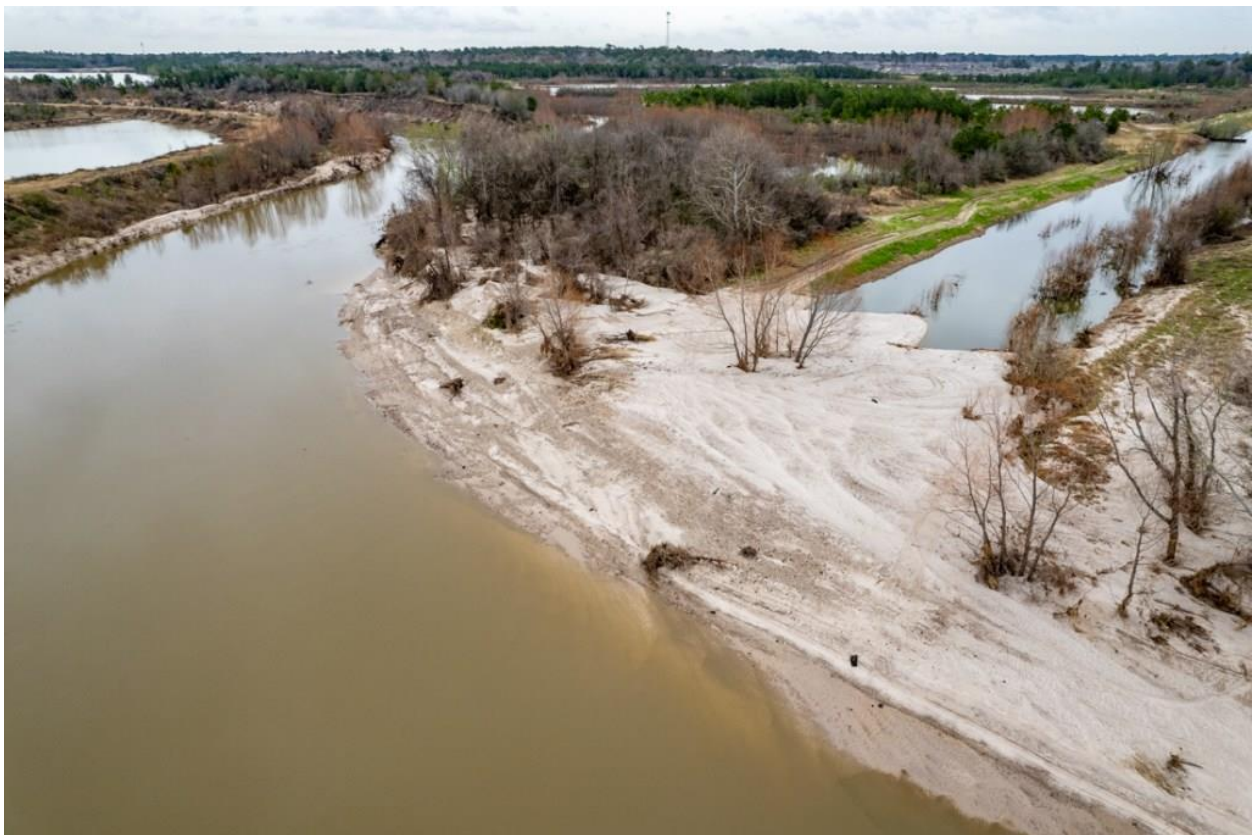
*Same ditch blocked by sand increases flood risk for homes (visible in top right).*

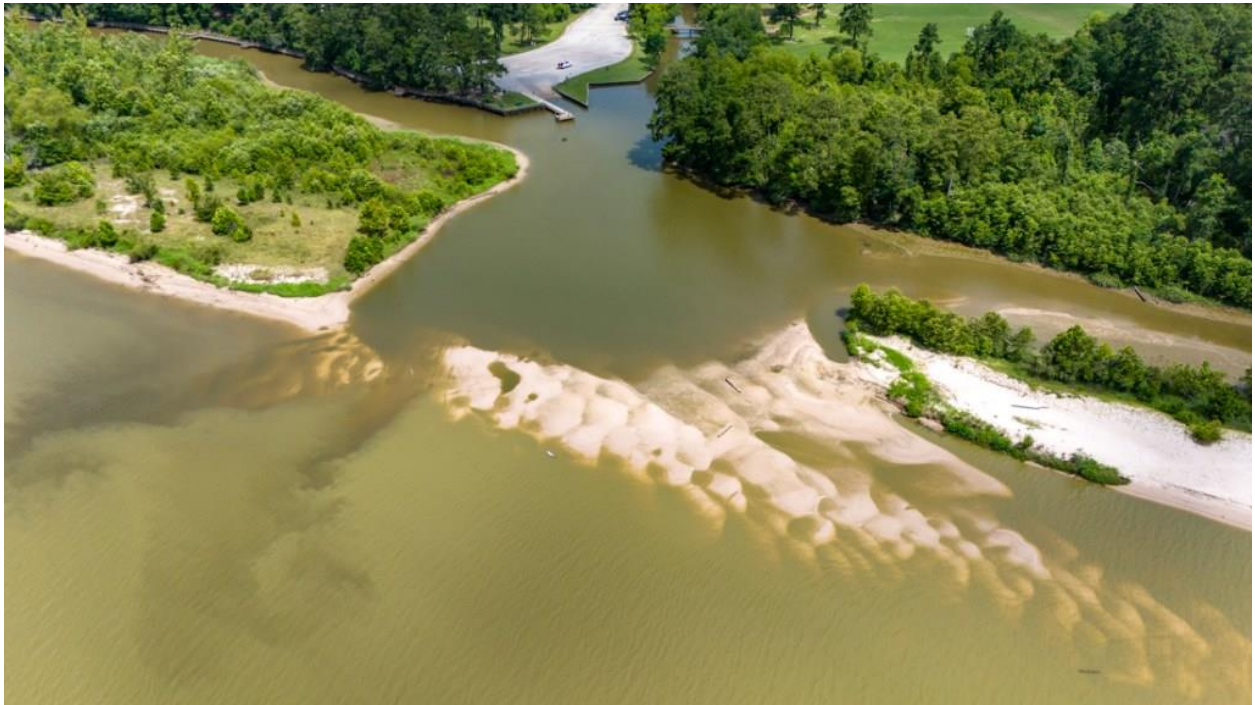
*Farther downstream, the Kingwood Diversion Ditch (top middle) also became blocked by sediment. A Harris County Flood Control District study found that the [Diversion Ditch was one of the two most dangerous flooding problems](#) in Kingwood.*

The entrance to this ditch had just recently been dredged by the Army Corps.

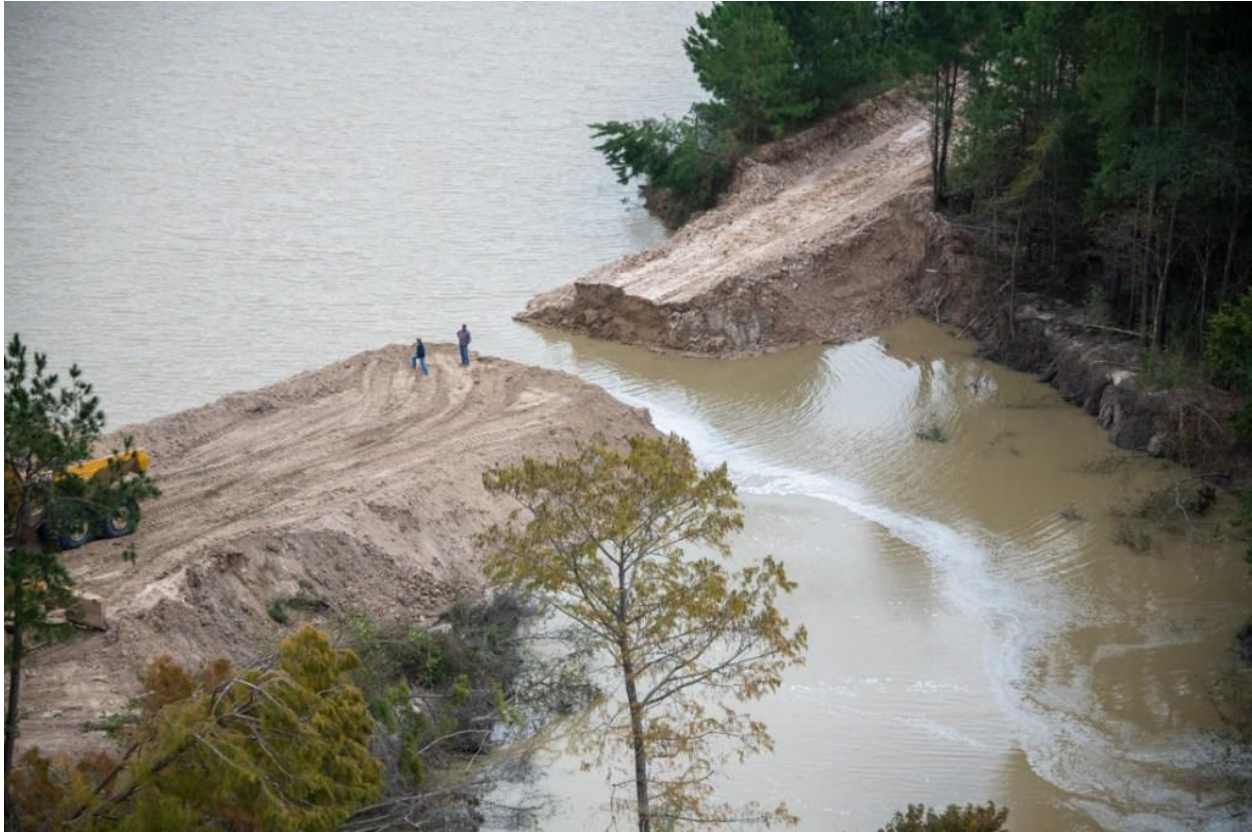
*Broken dike at the Triple PG sand mine in Porter. Industrial wastewater is flowing out of the mine into White Oak Creek which joins Caney Creek and the San Jacinto East Fork before flowing into Lake Houston.*

**Conclusion:** Mines need to be positioned farther from rivers on higher ground. Natural vegetation needs to be left in the buffer zones to slow floodwaters and reduce erosion. The measures could help solve the problems shown above and help protect the health and safety of millions of people.
