***Sediment Pollution from Sand Mining:
Impact on Flood Risk, Costs, Water Quality***

Appendix to APO BMP List Proposal

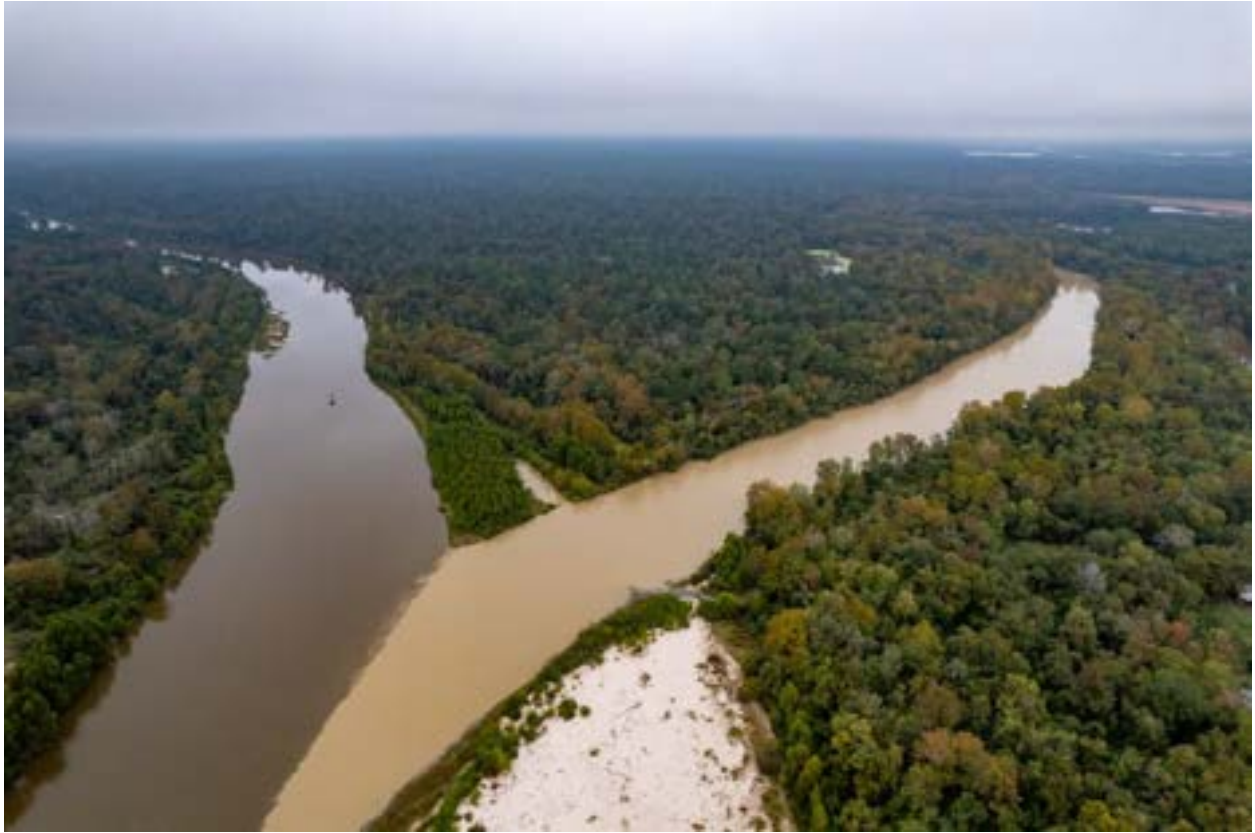
*Confluence of San Jacinto West Fork (right) and Spring Creek near US59 Bridge.
This is a frequent sight. Twenty square miles of mines are upstream on the right
in a 20-mile reach of the river.*

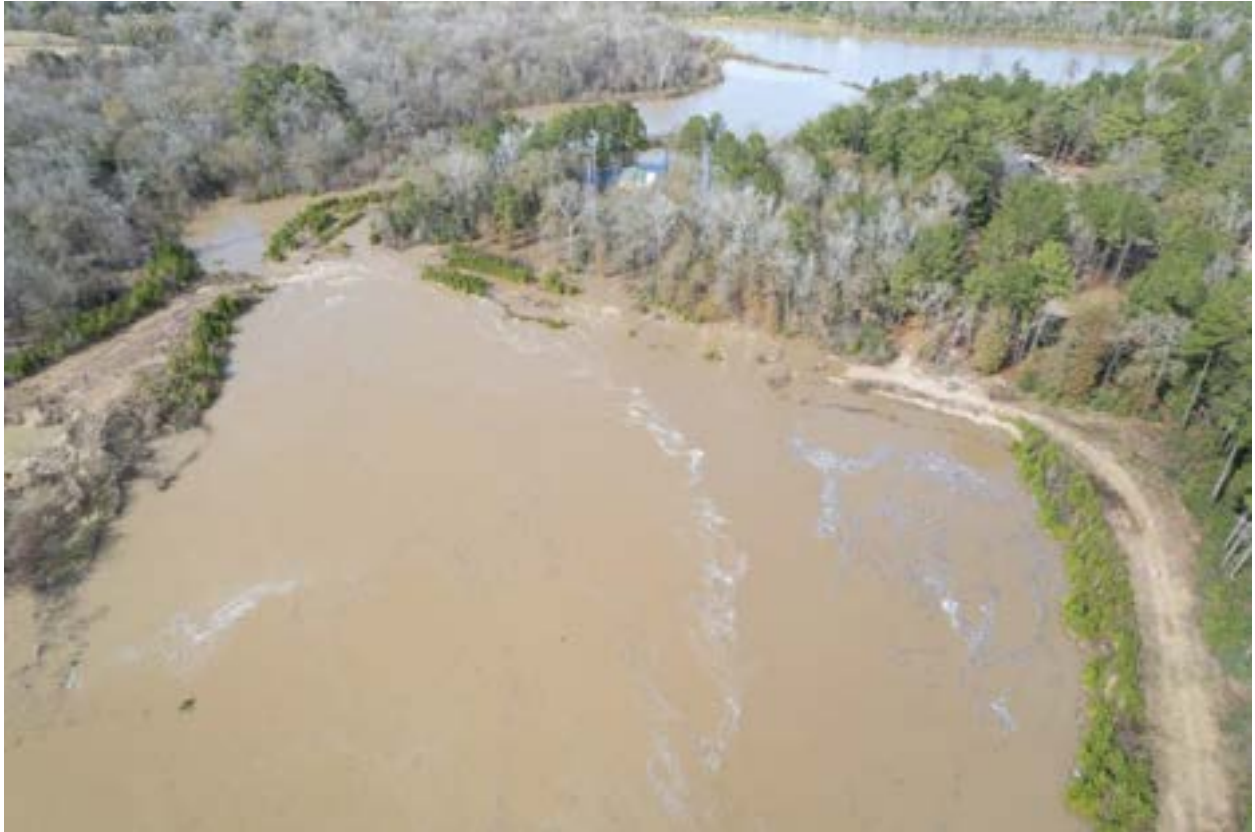
San Jacinto East Fork capturing a mine in Plum Grove.

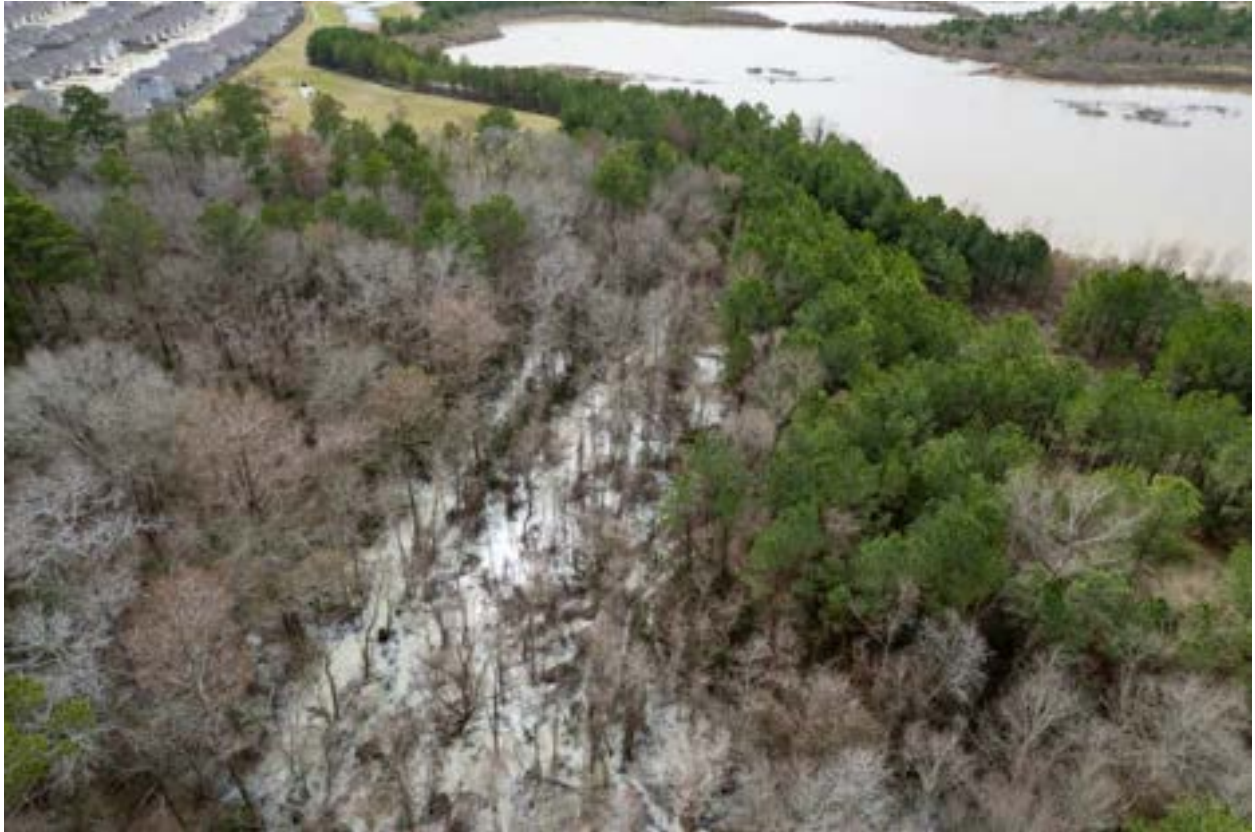
Effluent from the Hallett settling pond on San Jacinto West Fork escaping into adjacent property owned by others.

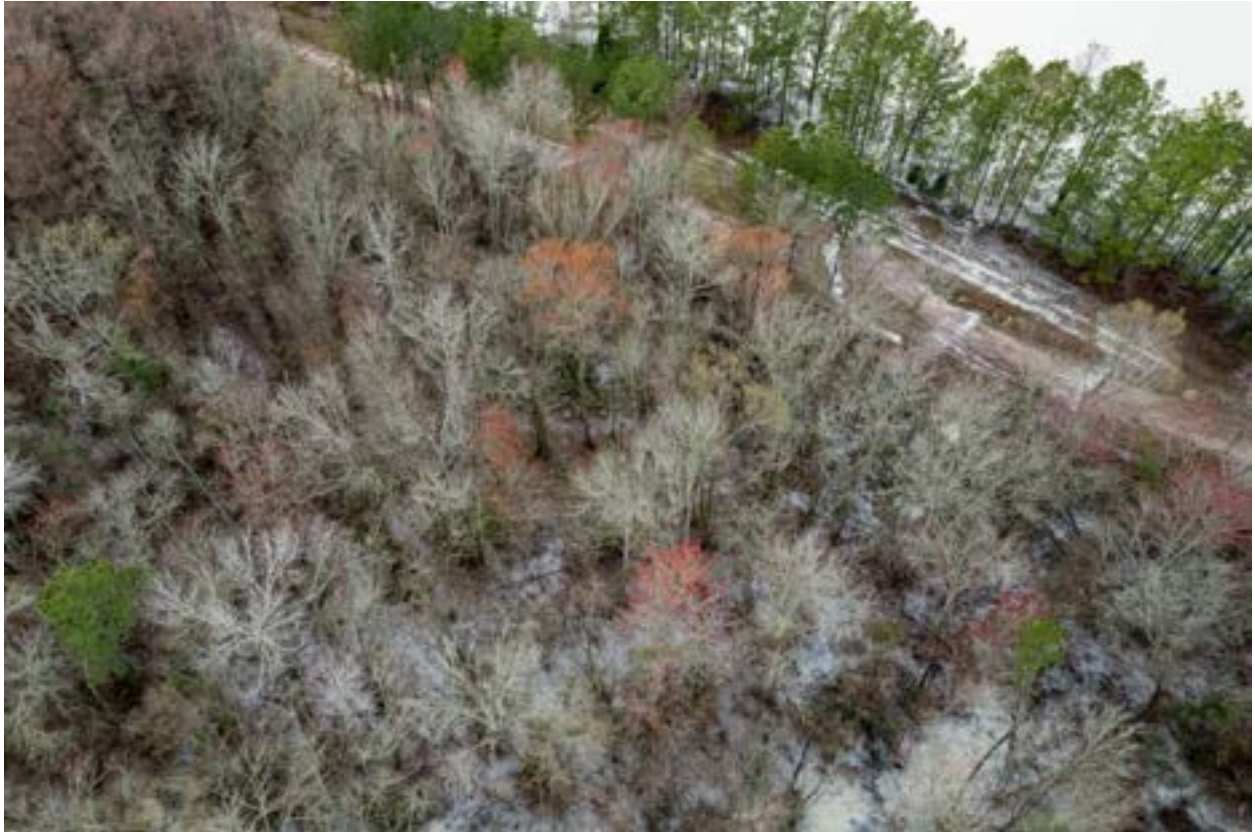
Close up of same effluent from same pond shows source of leakage.

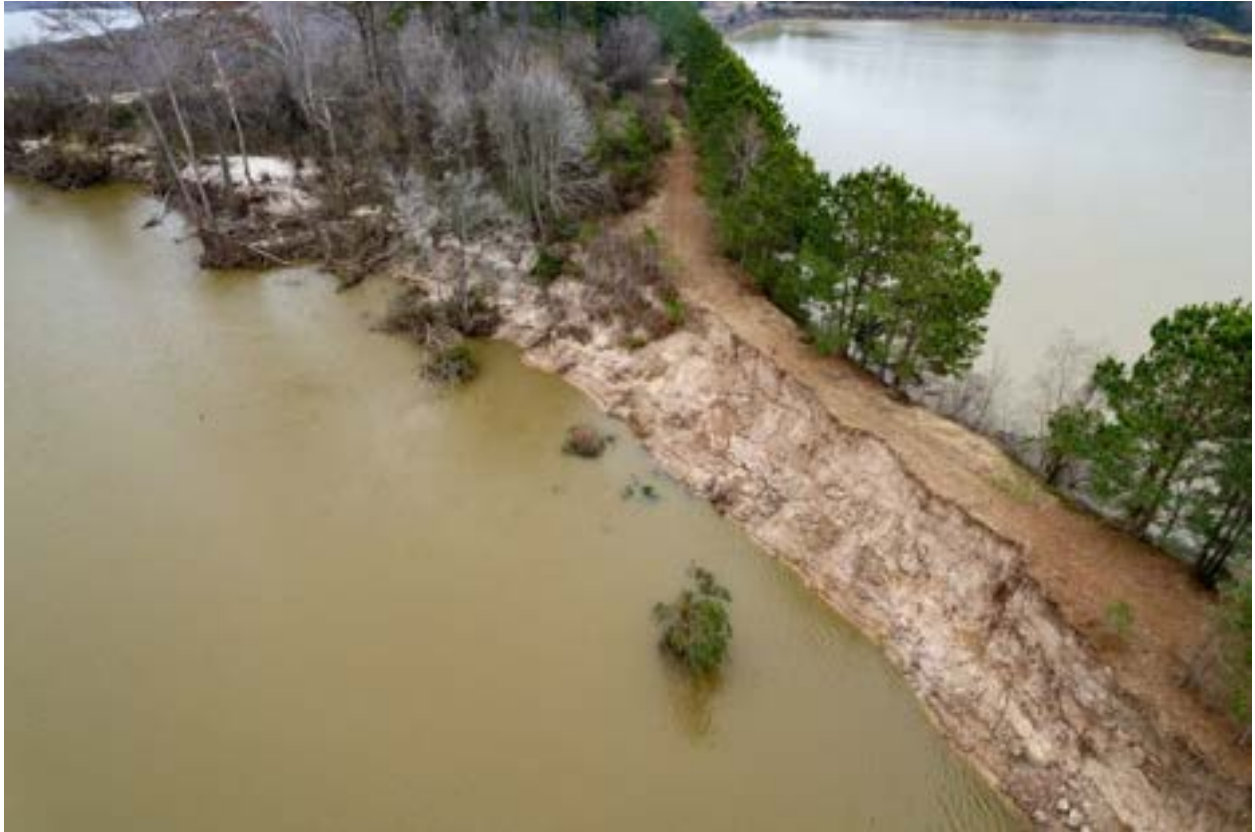
Dike of abandoned Williams Brothers Mine (upper right) eroded by the San Jacinto West Fork (lower left).

In the next flood, about three months later...

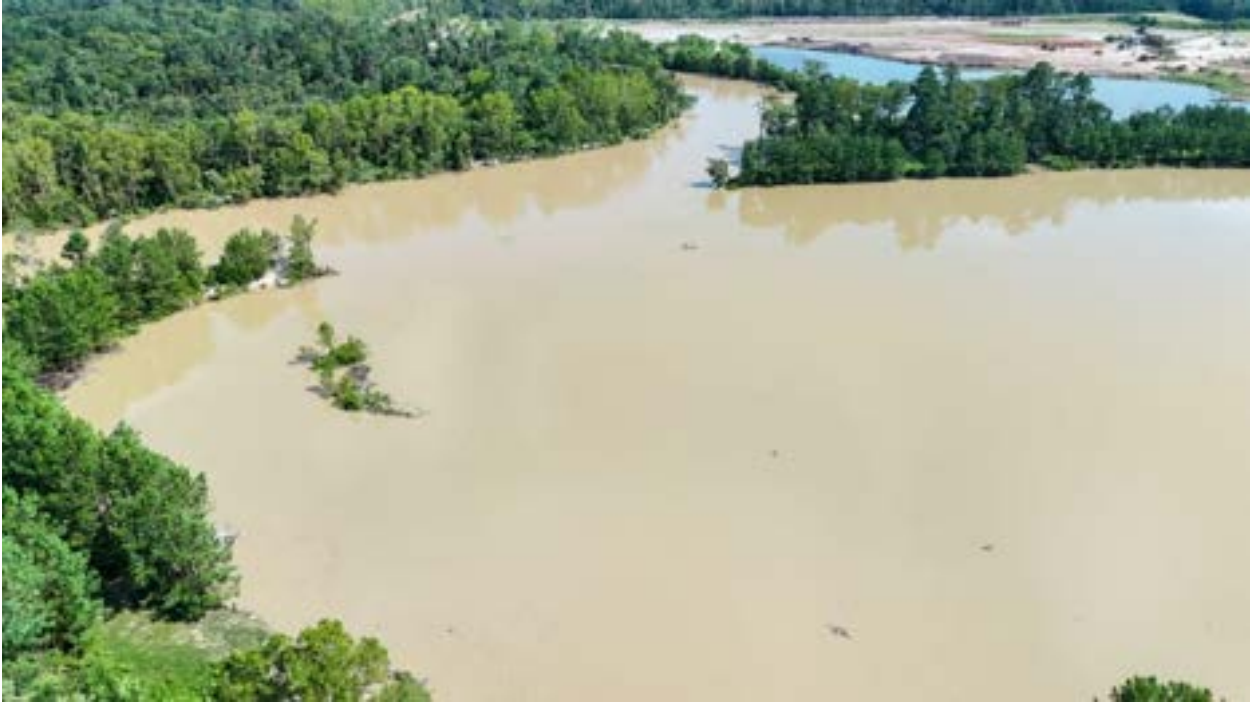
... Hurricane Beryl eroded what was left of the wall and flowed through the pit.

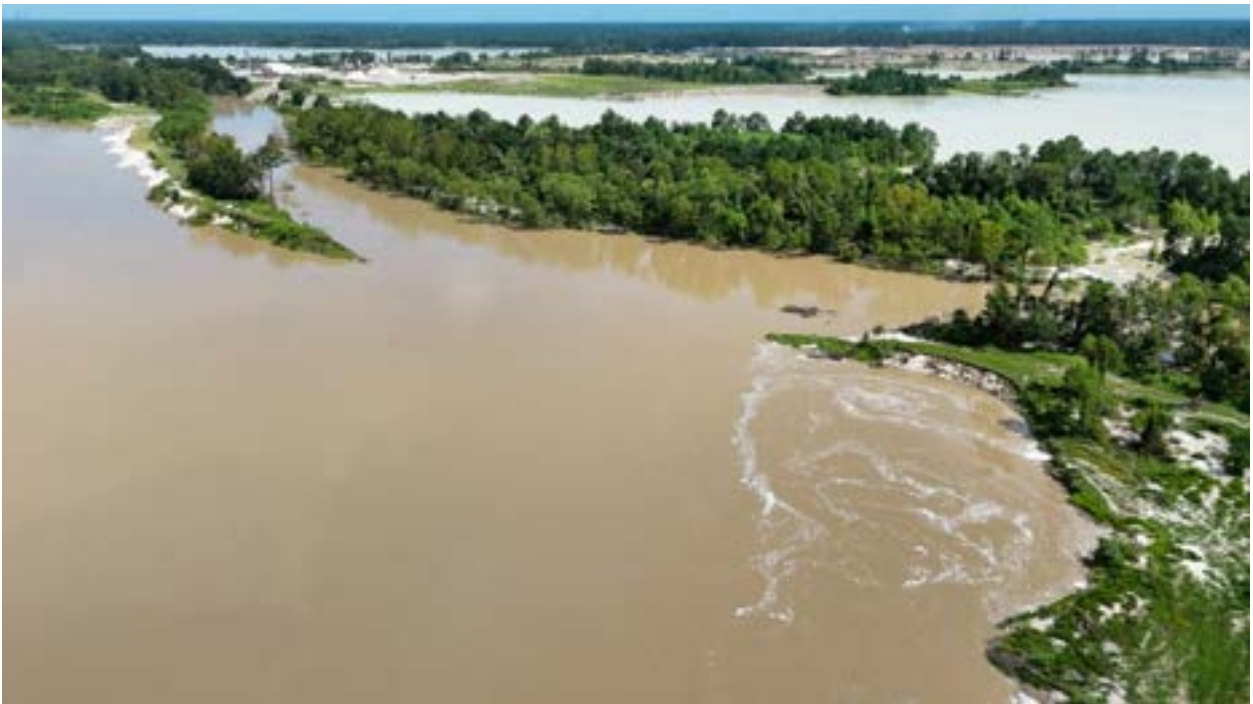
A little upstream, Hallett sold a sand pit (below left) on the San Jacinto West Fork to a real estate developer, Riverwalk Porter LLC. Within months, the river captured the pit.

The West Fork now flows into the pit at the north end...

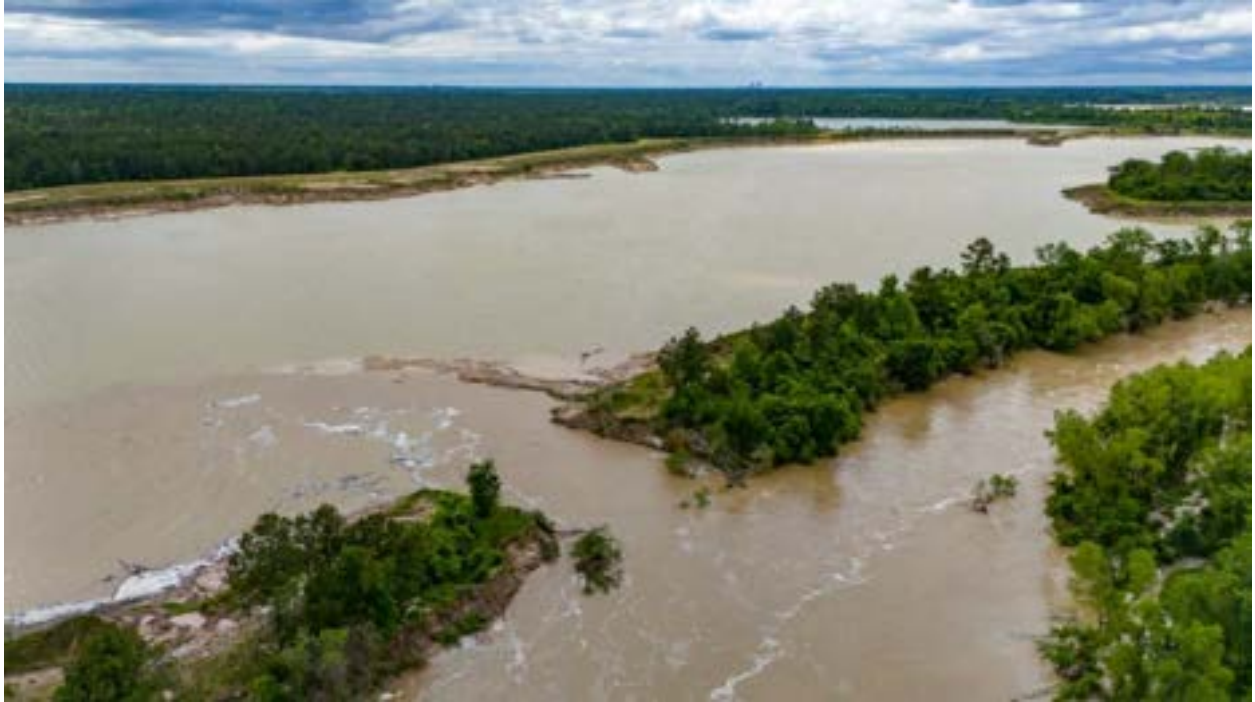
...and flows out at the south end.

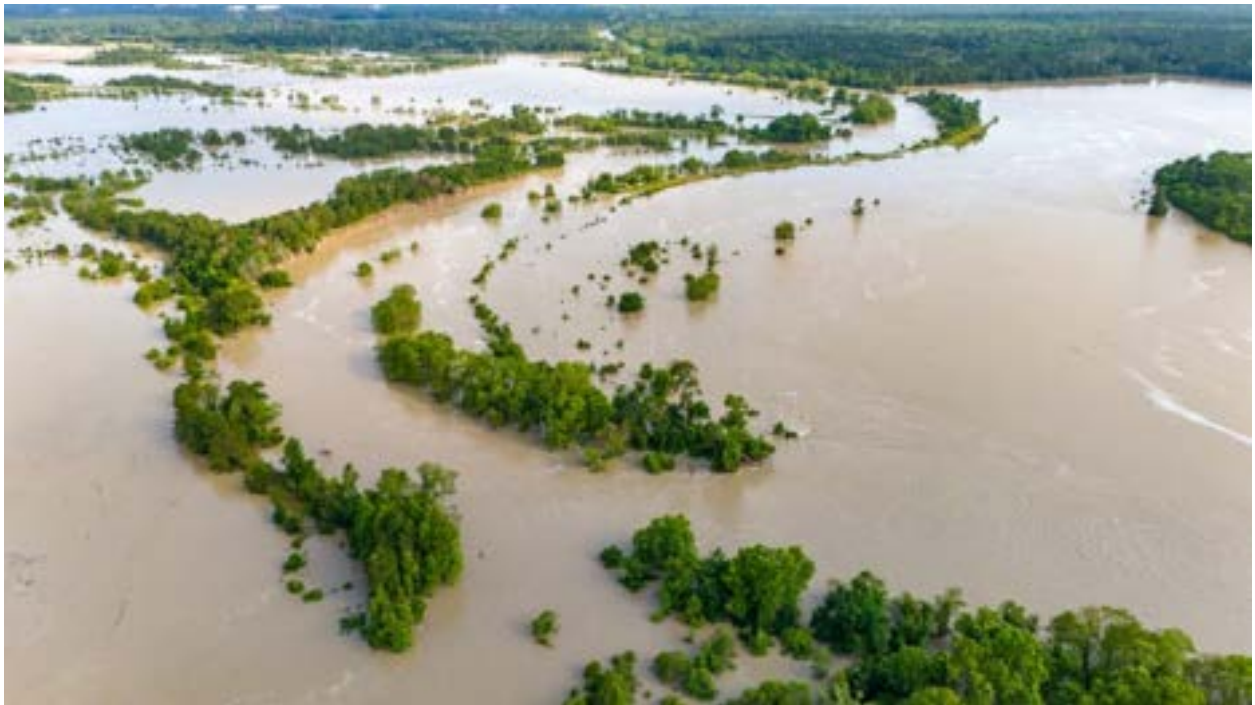
Wider shot of same pit (to the right of the S-turn) shows both the entry breach (lower right) and exit breach (upper right) in the dikes.

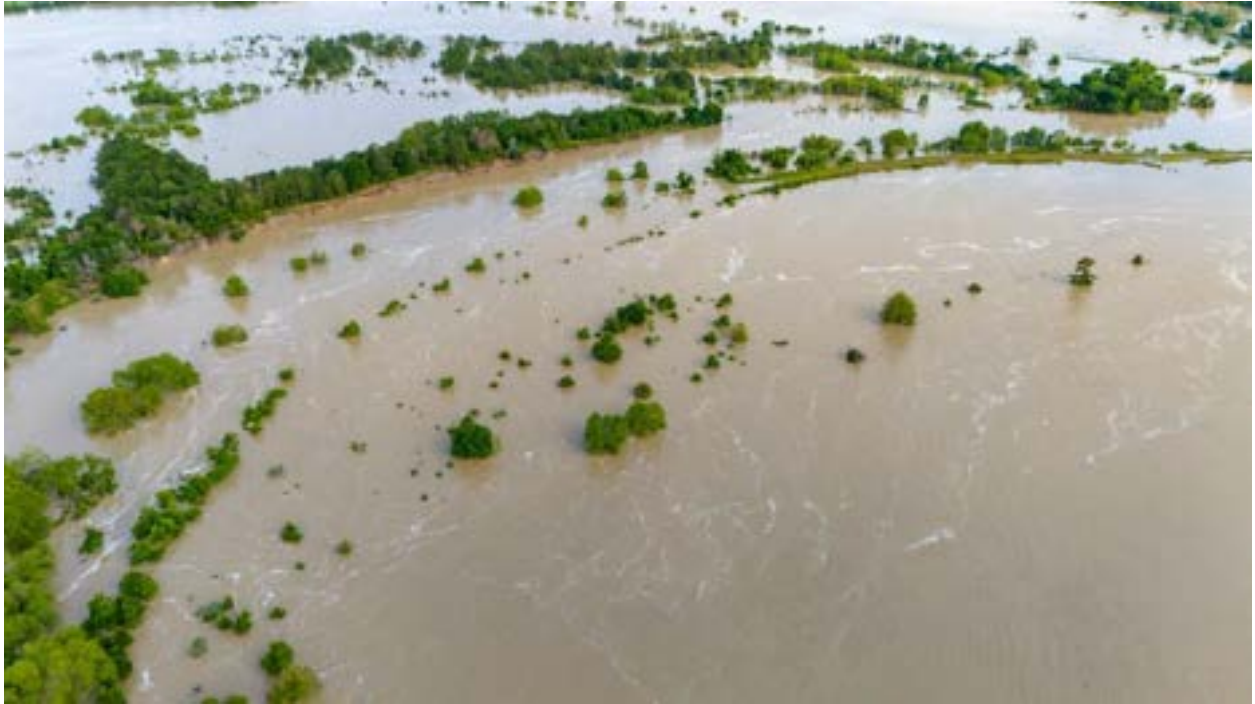
A drone followed logs floating through this captured West Fork pit at 5 MPH.

5 MPH is more than fast enough to scoop up and carry off the largest grains of sand and other sediment.

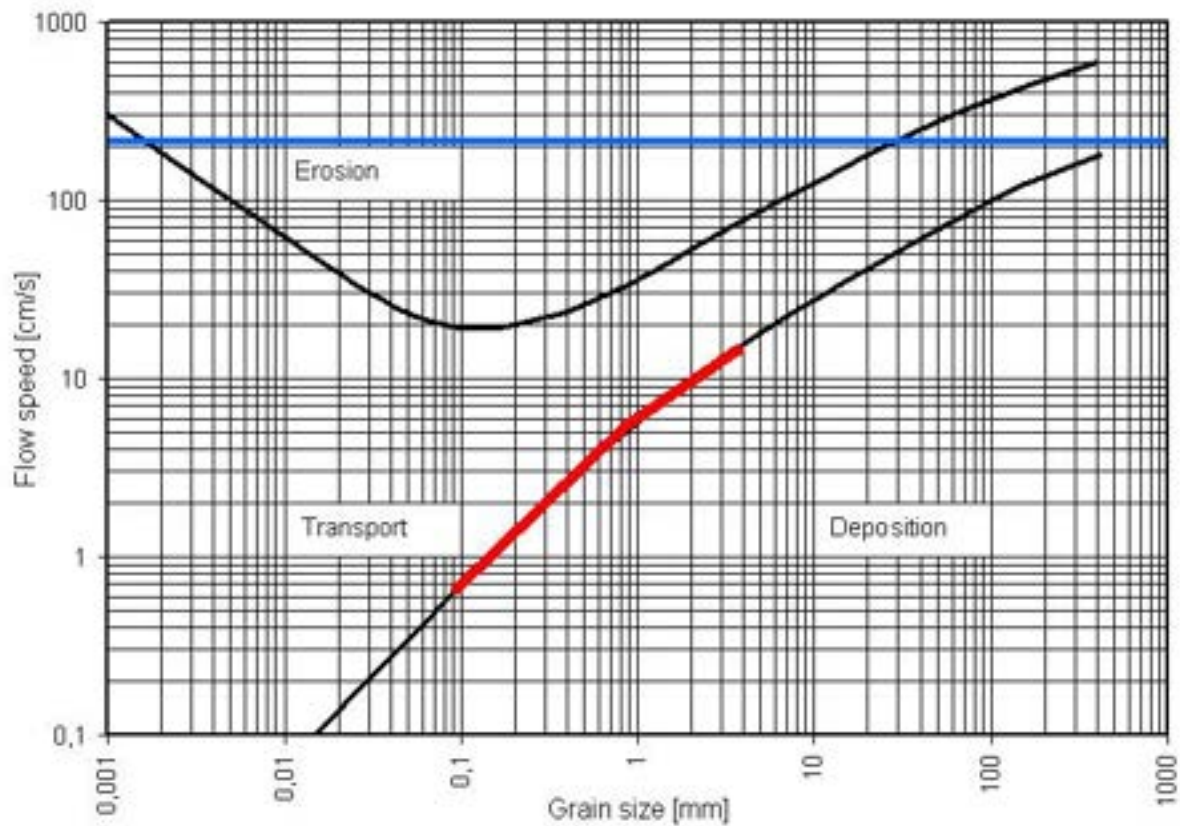
Industry-standard graph shows the speed necessary to erode, transport and deposit sand/sediment of different particle sizes. *Blue line* indicates **measured** speed of water. *Red* indicates range of typical sand sizes. Speed was greater than necessary to erode and transport all sand sizes, and even some gravel.

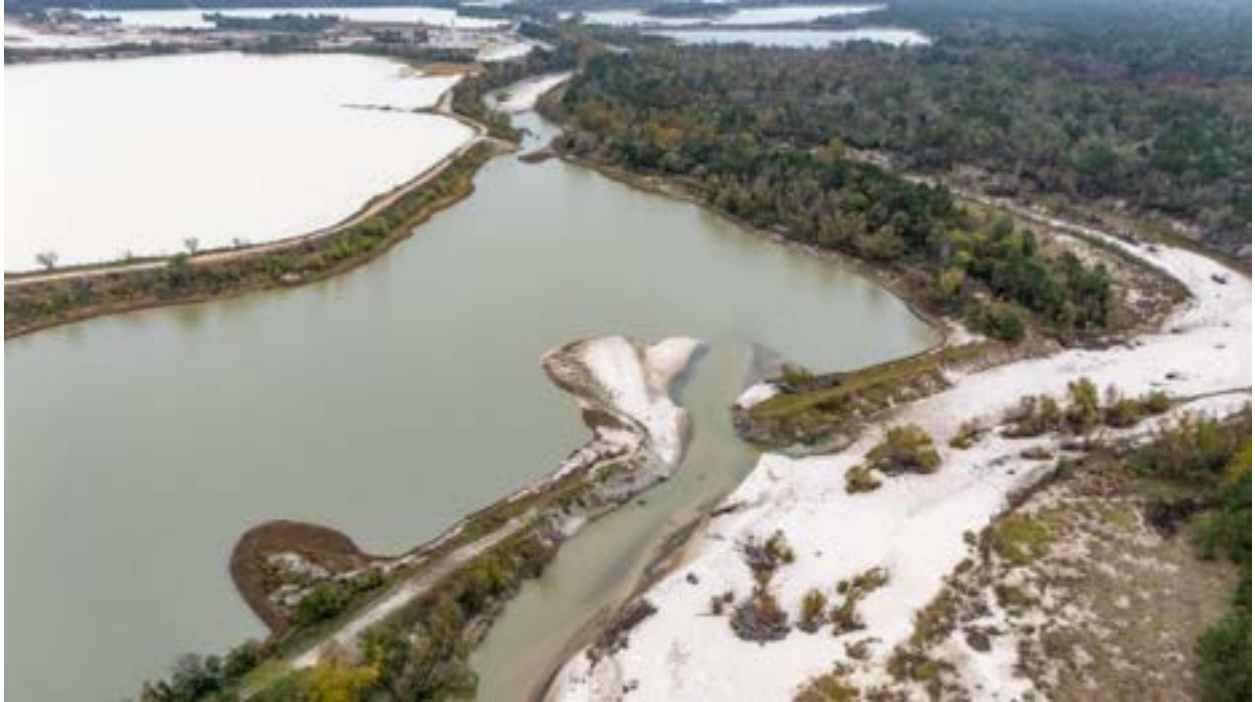
Another West Fork pit capture at the Hallett Mine after floodwaters receded. Notice how natural channel of the river has been virtually cut off.

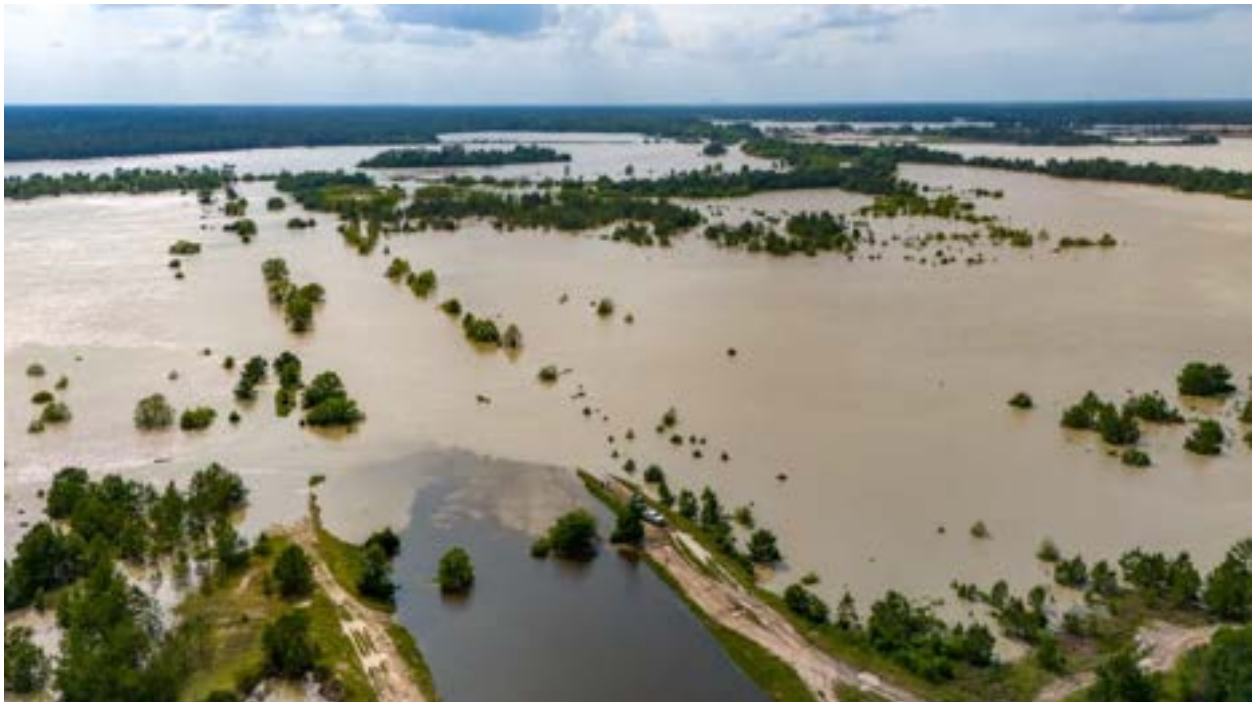
Effluent from the Hallett Mine (upstream in upper right) polluting the West Fork at the Northpark/Oakhurst Ditch (middle foreground). Water flows right to left. Facing West.

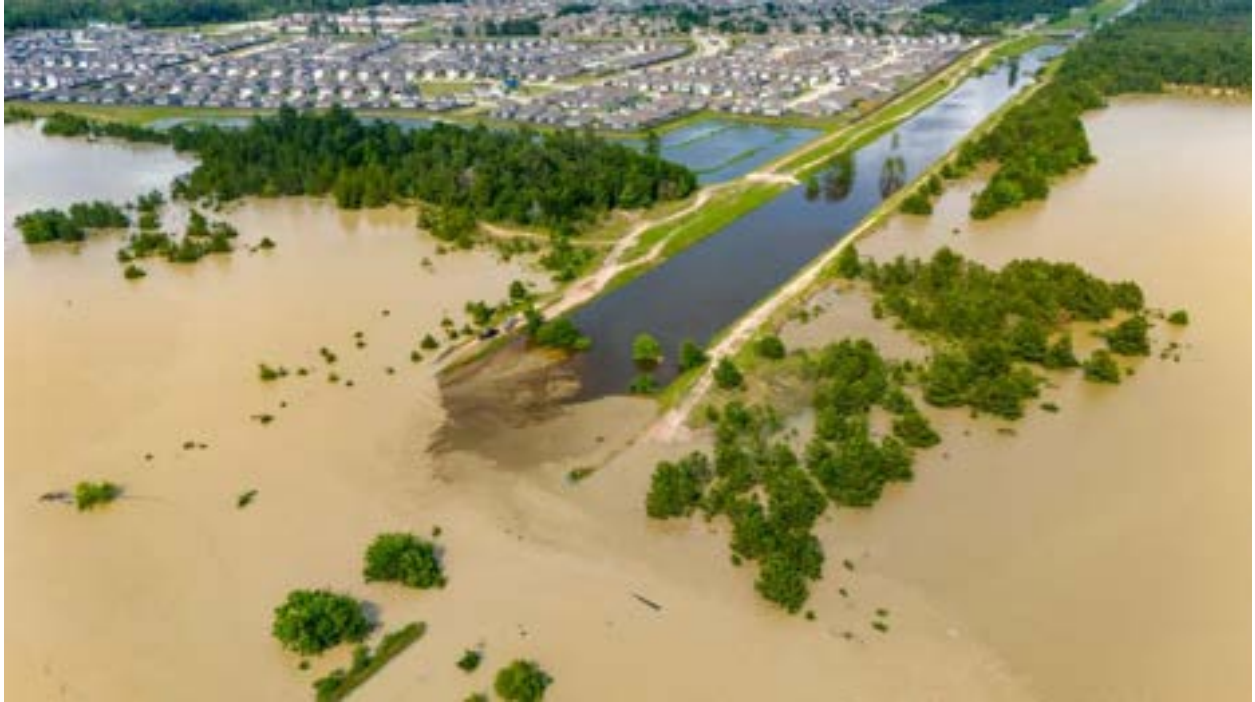
Reverse angle (facing east) shows proximity of pollution to homes in Northpark Woods subdivision. That's the Oakhurst Ditch, which empties into the West Fork behind camera position. Water flows left to right. Hallett mine is upstream on left.

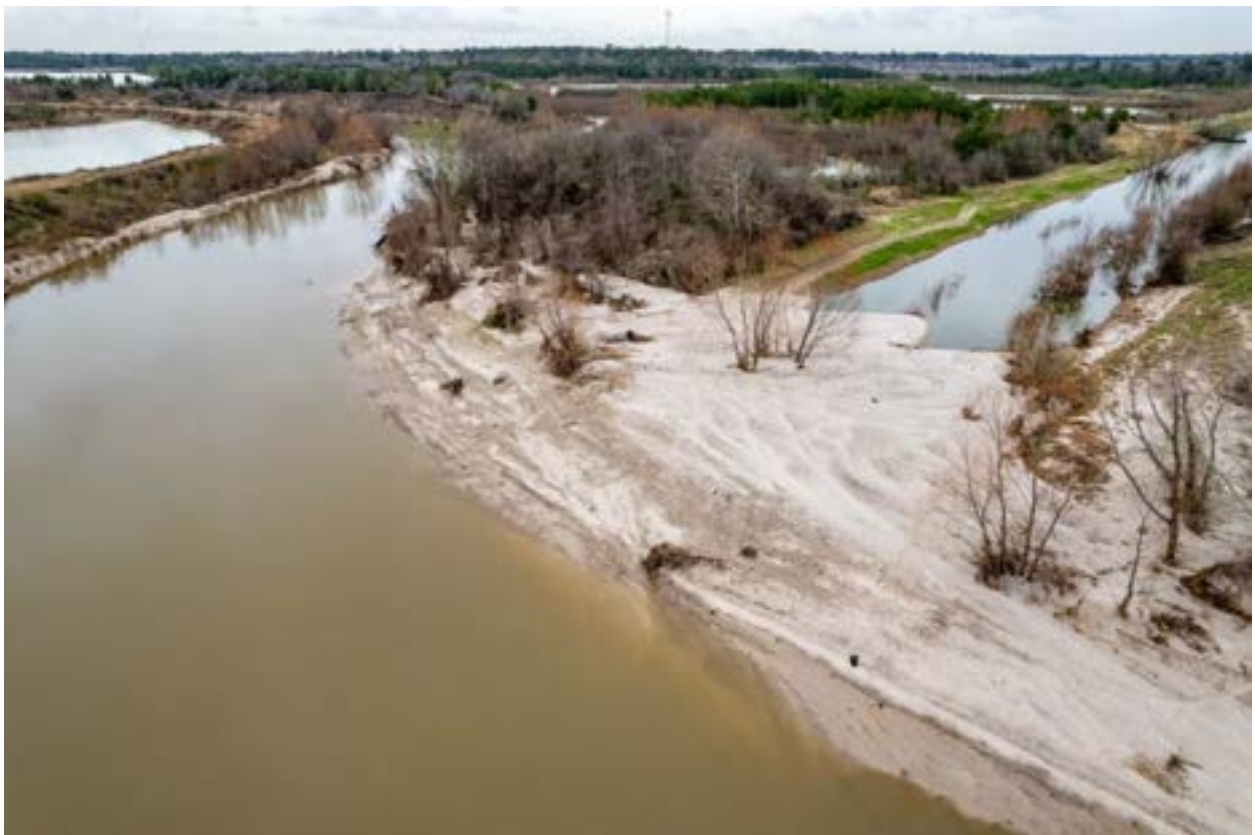
Same ditch blocked by sand increases flood risk for homes (visible in top right).

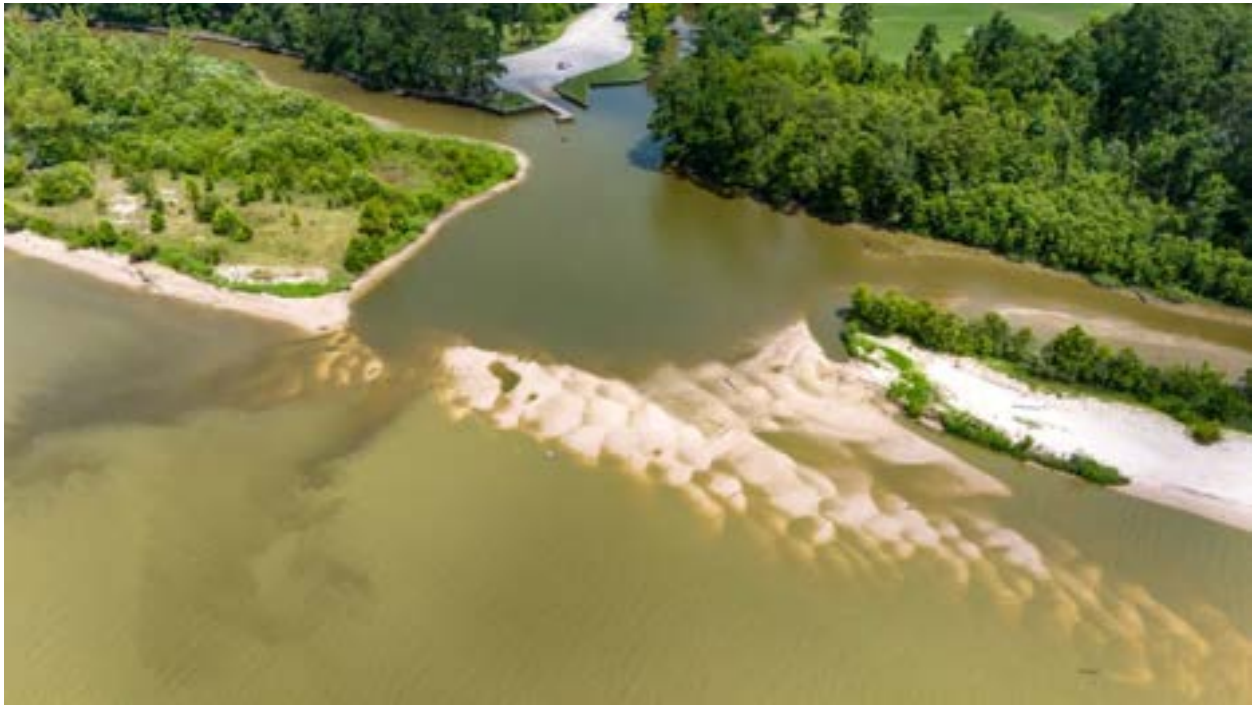
Farther downstream, the Kingwood Diversion Ditch (top middle) also became blocked by sediment. A Harris County Flood Control District study found that the [Diversion Ditch was one of the two most dangerous flooding problems](#) in Kingwood.

The entrance to this ditch had just recently been dredged by the Army Corps.

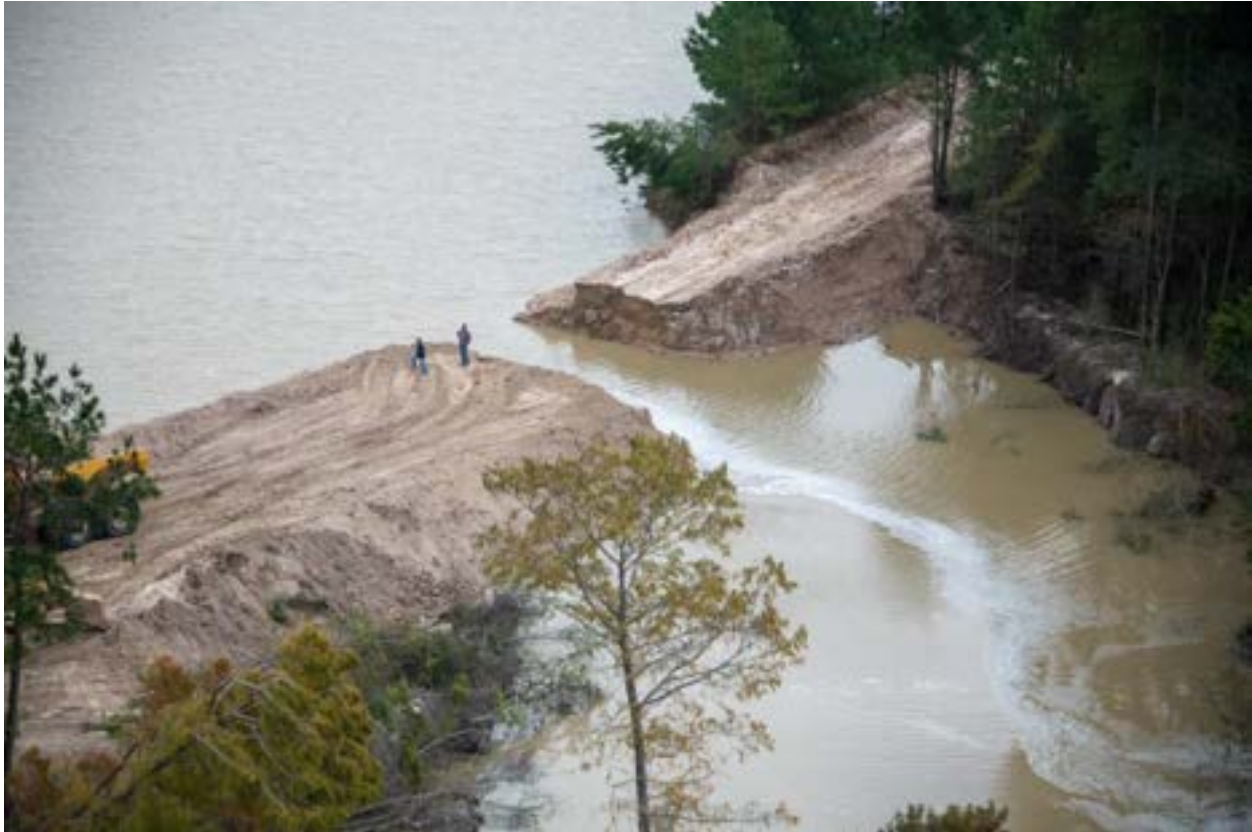
Broken dike at the Triple PG sand mine in Porter. Industrial wastewater is flowing out of the mine into White Oak Creek which joins Caney Creek and the San Jacinto East Fork before flowing into Lake Houston.

Conclusion: Mines need to be positioned farther from rivers on higher ground. Natural vegetation needs to be left in the buffer zones to slow floodwaters and reduce erosion. The measures could help solve the problems shown above and help protect the health and safety of millions of people.
