***Sediment Pollution from Sand Mining:
Impact on Flood Risk, Costs, Water Quality***

Appendix to APO BMP List Proposal

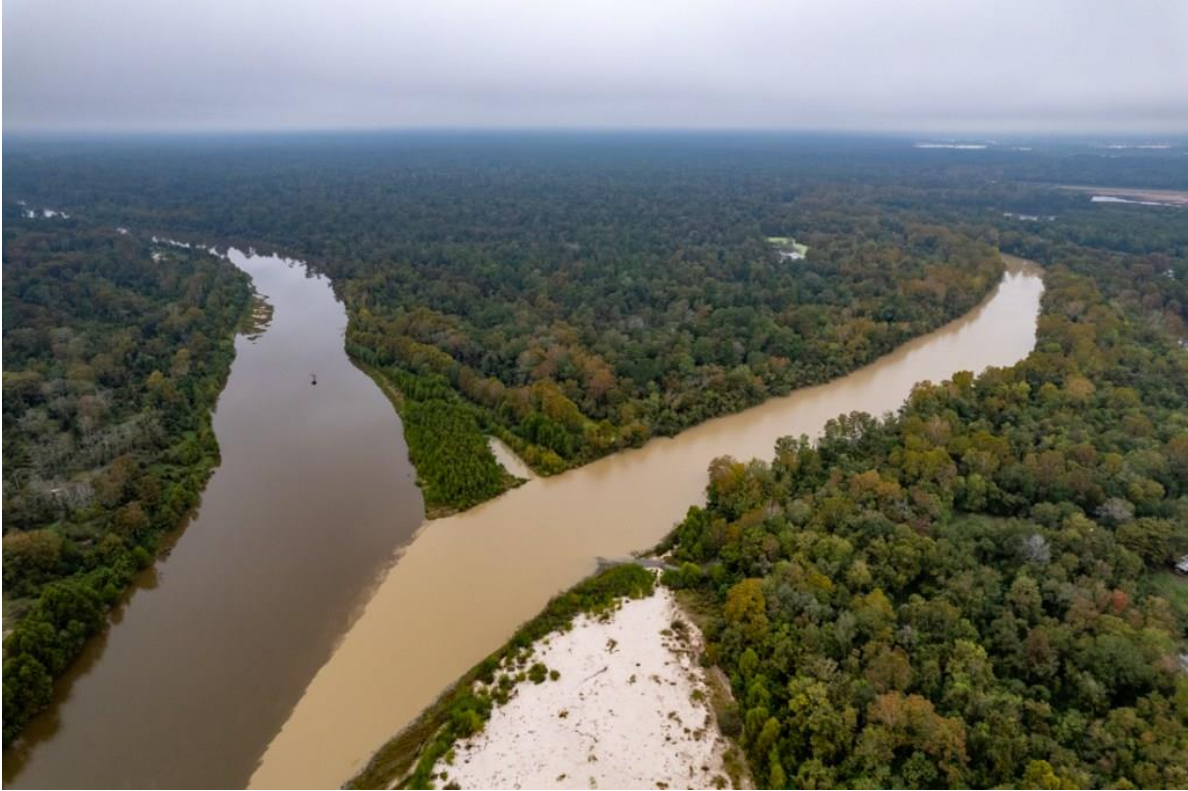
*Confluence of San Jacinto West Fork (right) and Spring Creek near US59 Bridge.
This is a frequent sight. Twenty square miles of mines are upstream on the right
in a 20-mile reach of the river.*

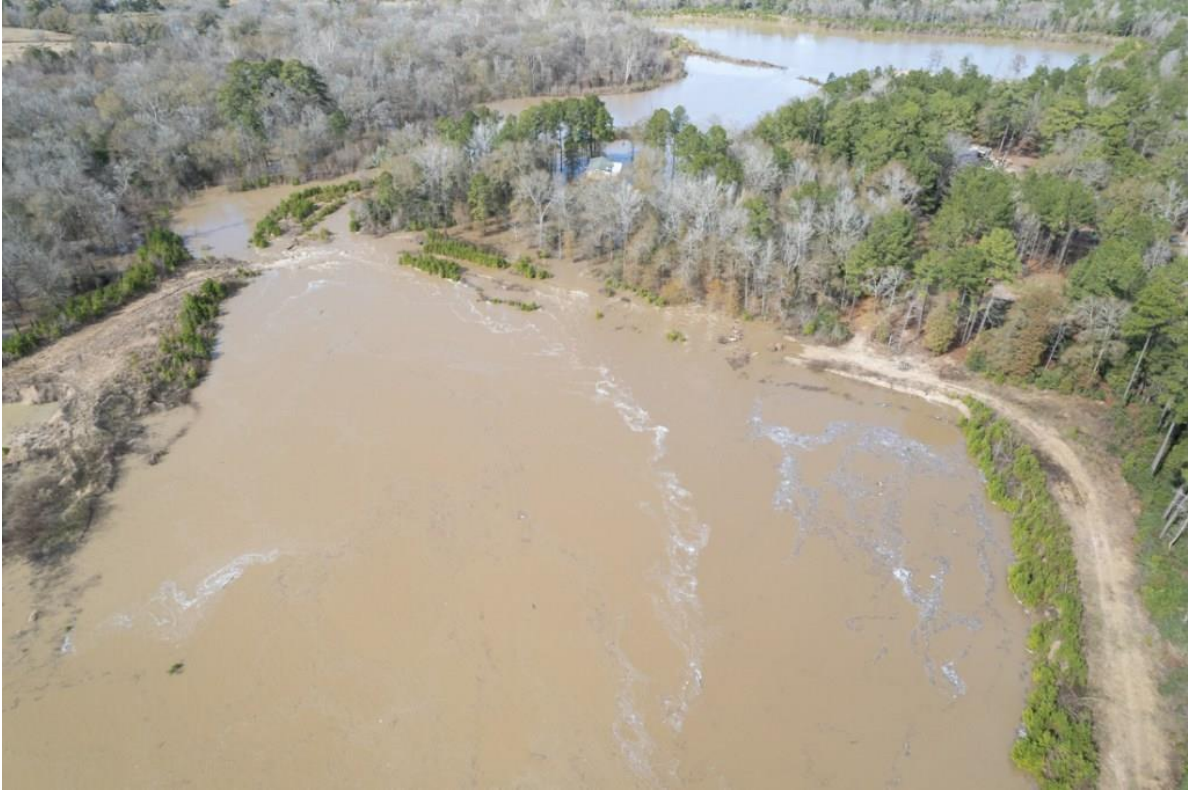
San Jacinto East Fork capturing a mine in Plum Grove.

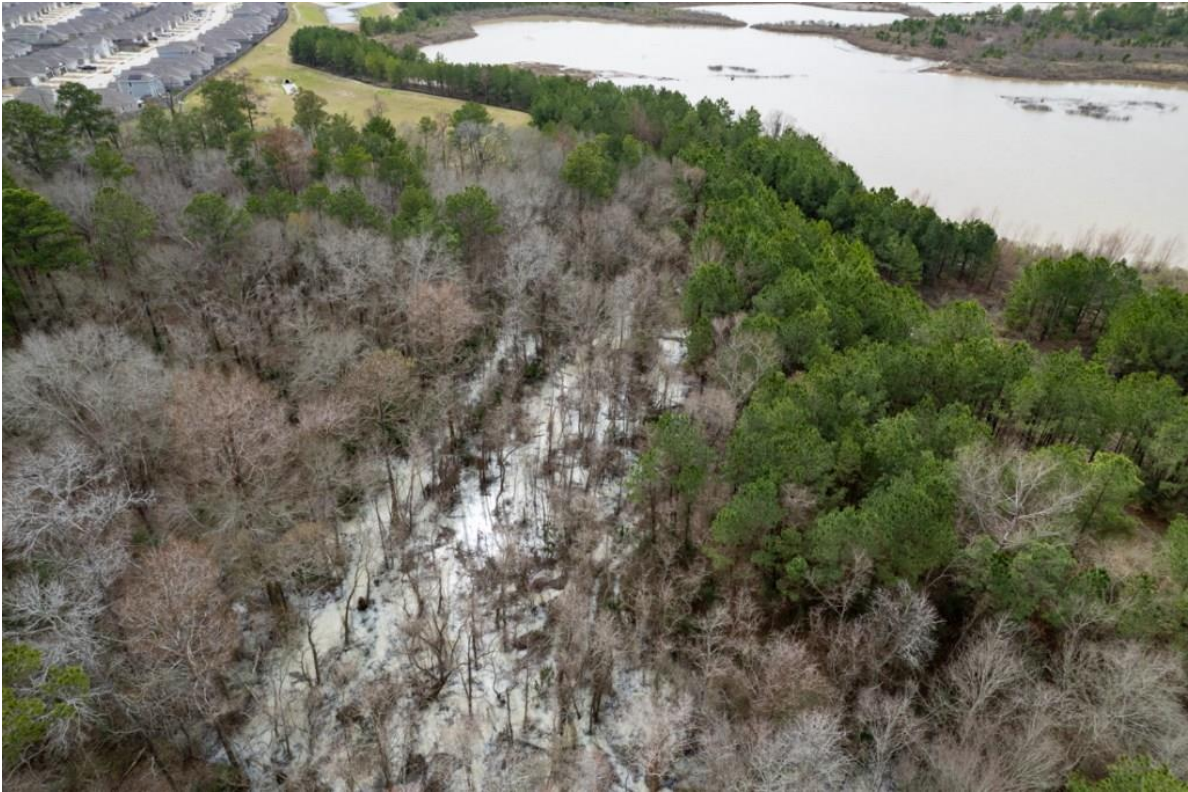
Effluent from the Hallett settling pond on San Jacinto West Fork escaping into adjacent property owned by others.

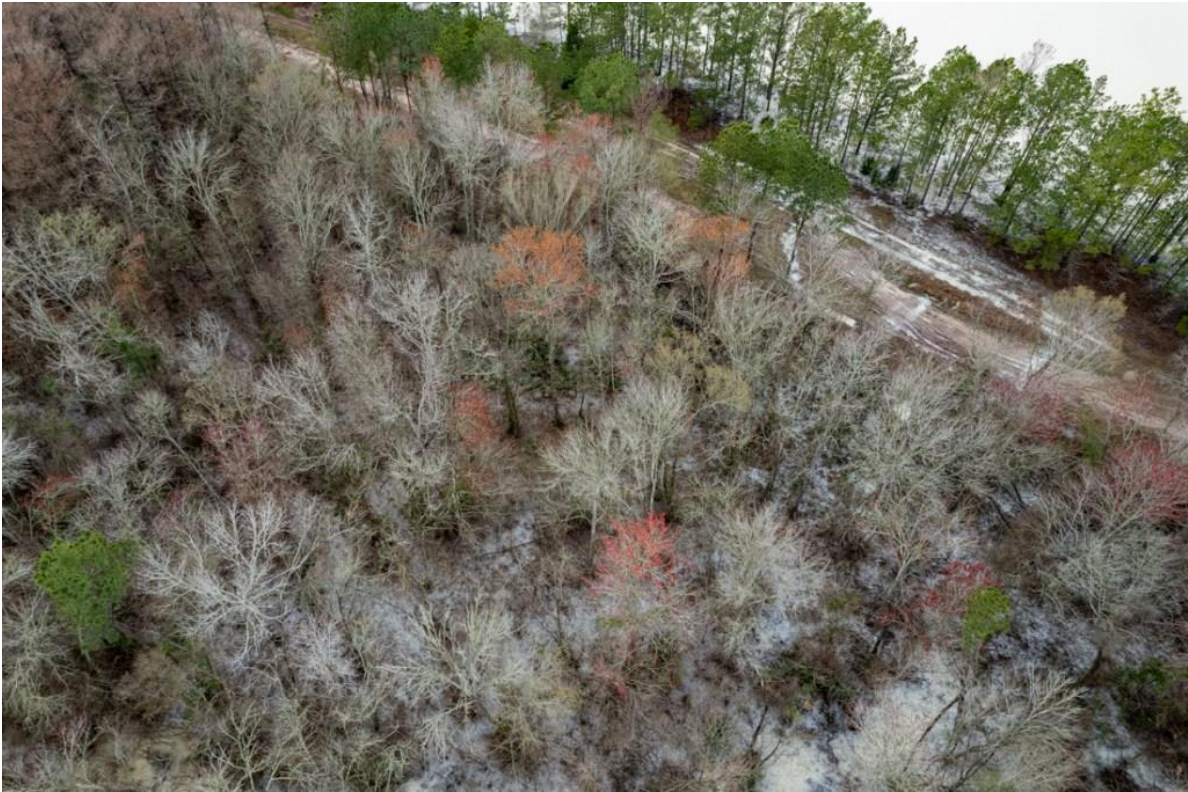
Close up of same effluent from same pond shows source of leakage.

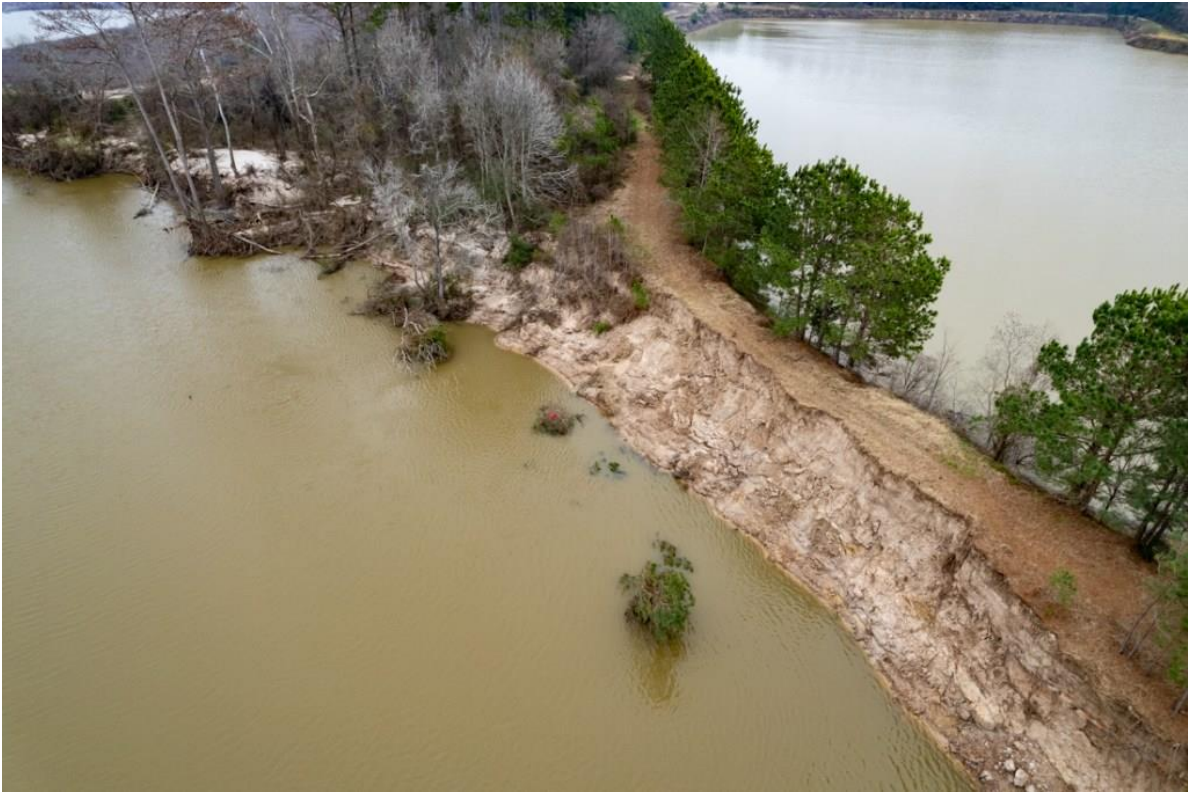
Dike of abandoned Williams Brothers Mine (upper right) eroded by the San Jacinto West Fork (lower left).

In the next flood, about three months later...

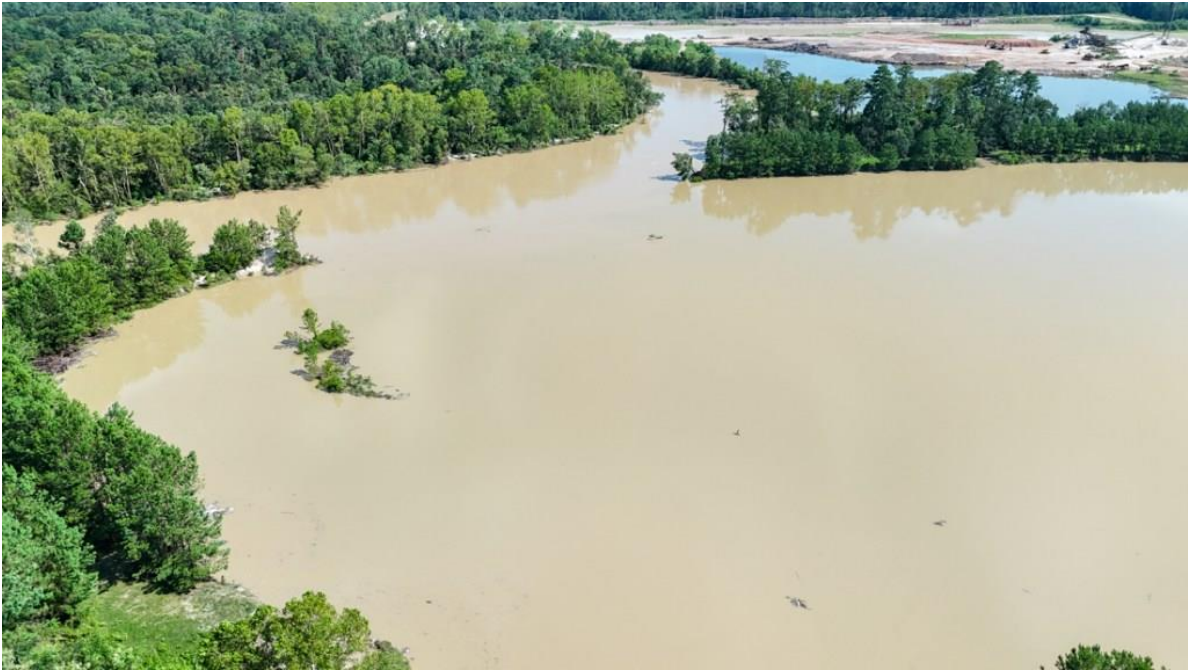
... Hurricane Beryl eroded what was left of the wall and flowed through the pit.

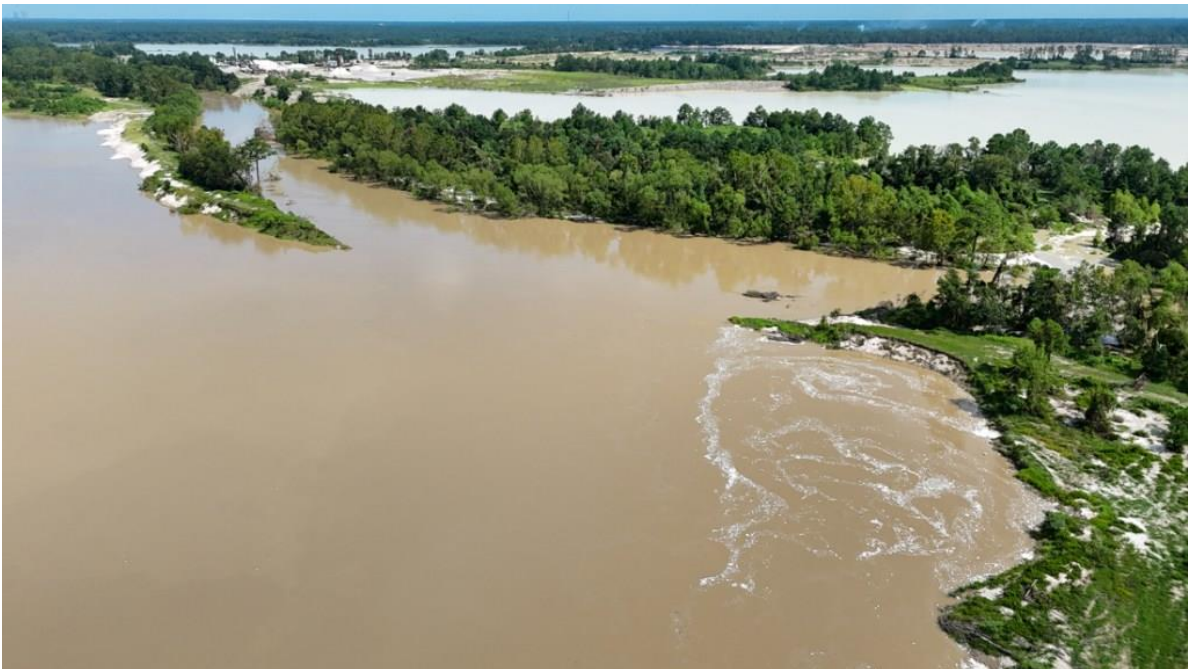
A little upstream, Hallett sold a sand pit (below left) on the San Jacinto West Fork to a real estate developer, Riverwalk Porter LLC. Within months, the river captured the pit.

The West Fork now flows into the pit at the north end...

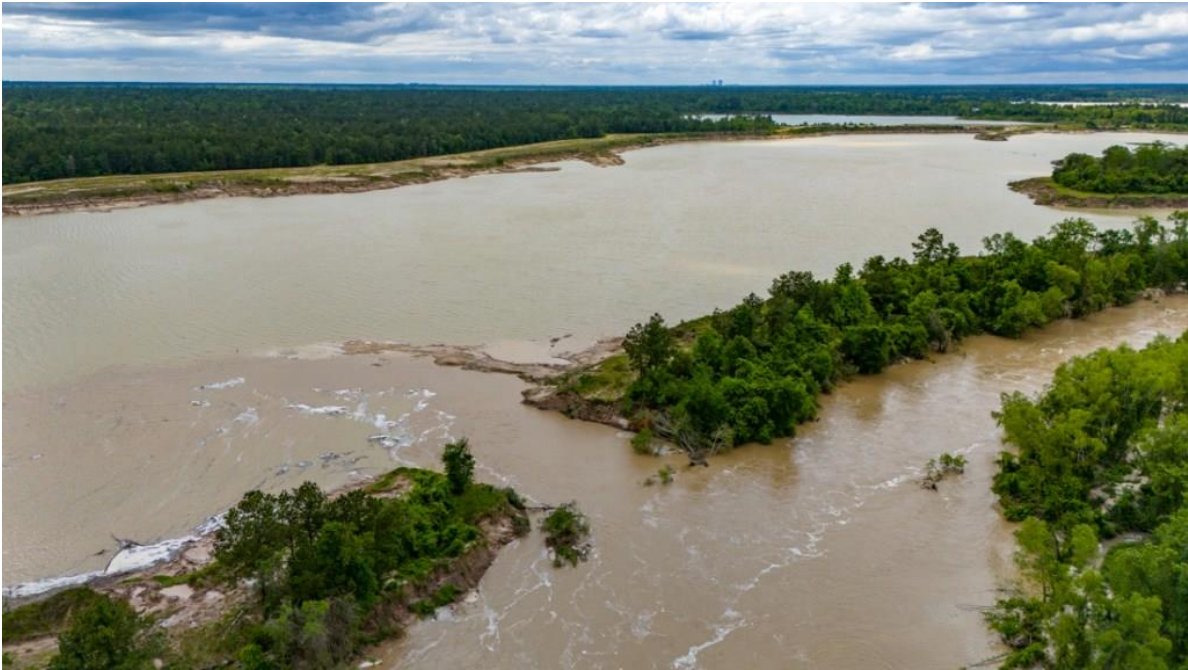
...and flows out at the south end.

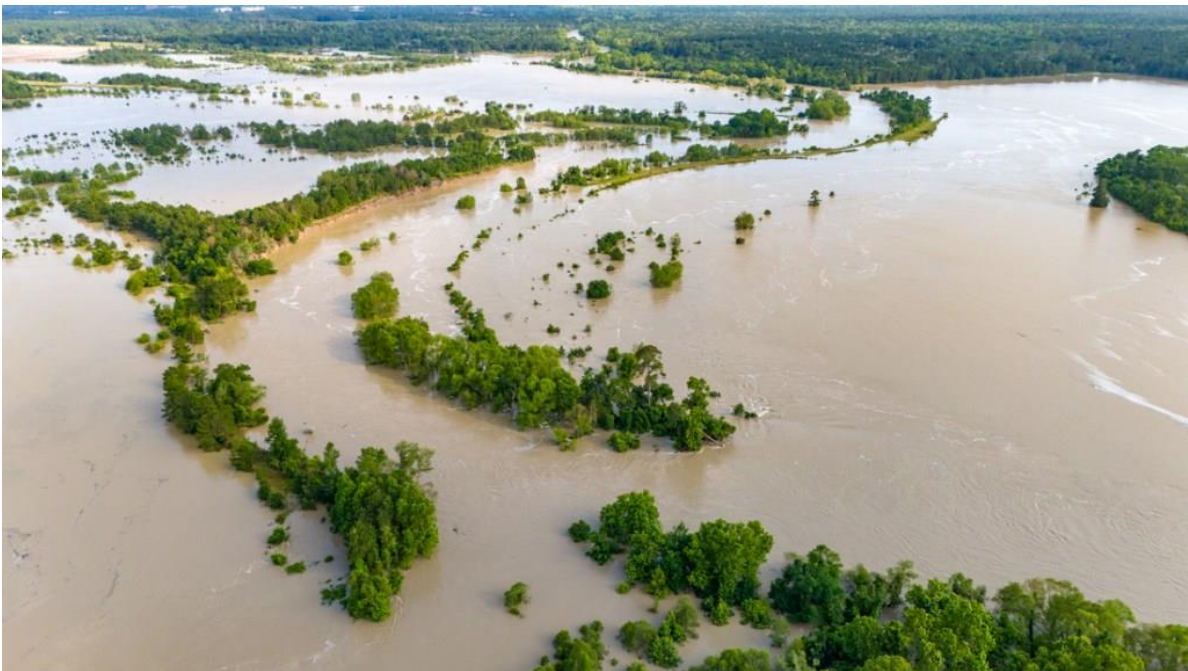
Wider shot of same pit (to the right of the S-turn) shows both the entry breach (lower right) and exit breach (upper right) in the dikes.

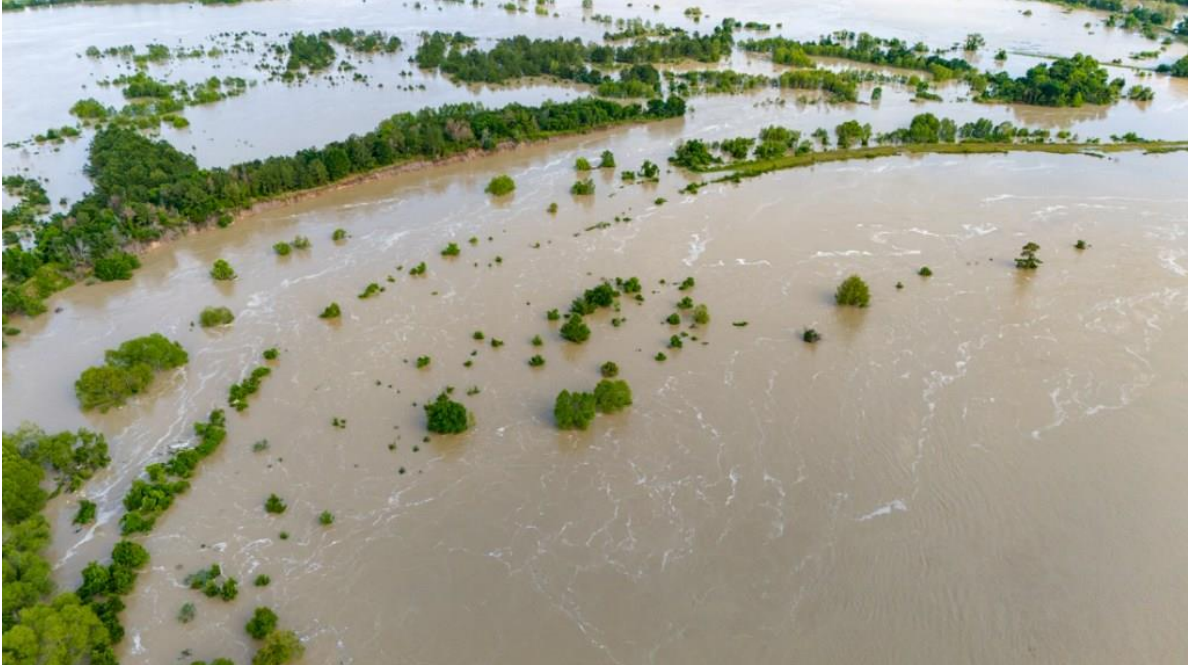
Miners claim their pits actually capture sand and keep it from floating downstream. That may be true at certain times during a flood, for instance, as it recedes. However, at the peak of the May 2024 flood, the speed of floodwater was sufficient to entrain sand in pits and carry it downstream.

A drone followed logs floating through this captured West Fork pit at 5 MPH.

[5 MPH is more than fast enough to scoop up and carry off the largest grains of sand](#) and other sediment.

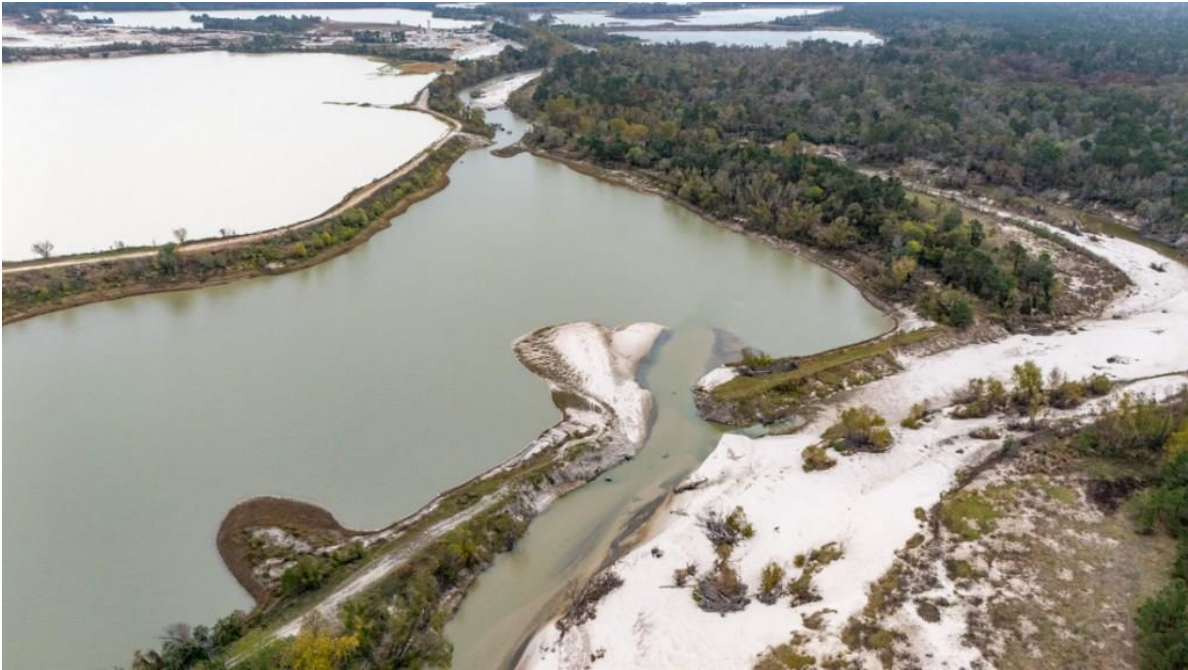
Another West Fork pit capture at the Hallett Mine after floodwaters receded. Notice how natural channel of the river has been virtually cut off.

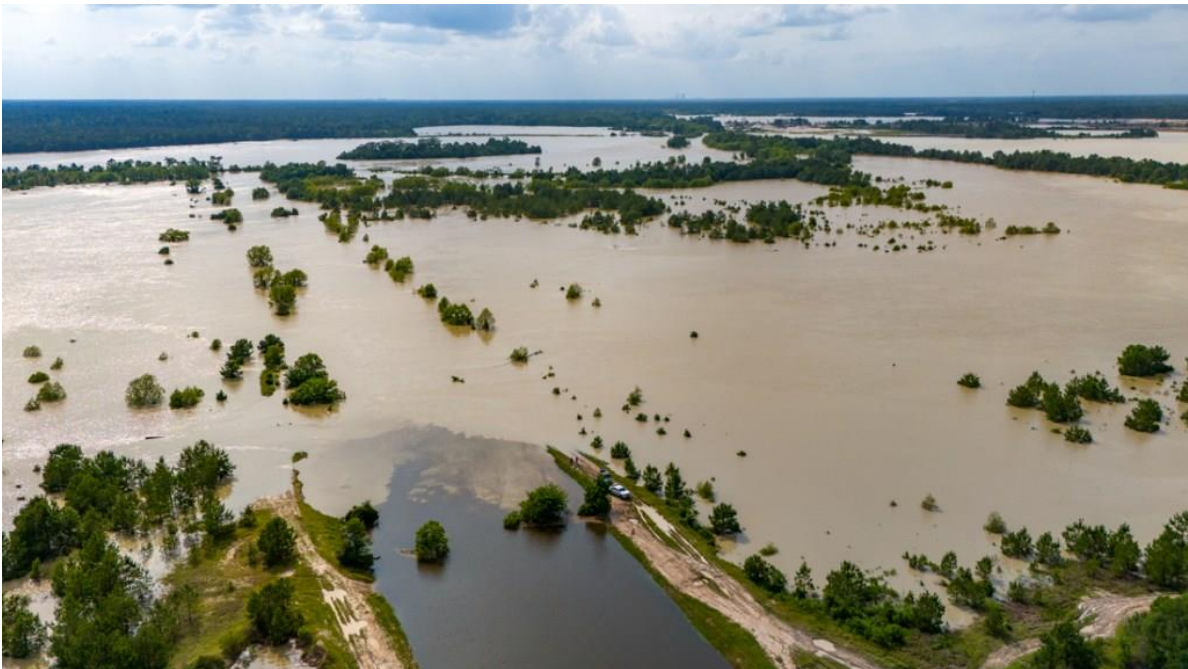
Effluent from the Hallett Mine (upstream in upper right) polluting the West Fork at the Northpark/Oakhurst Ditch (middle foreground). Water flows right to left. Facing West.

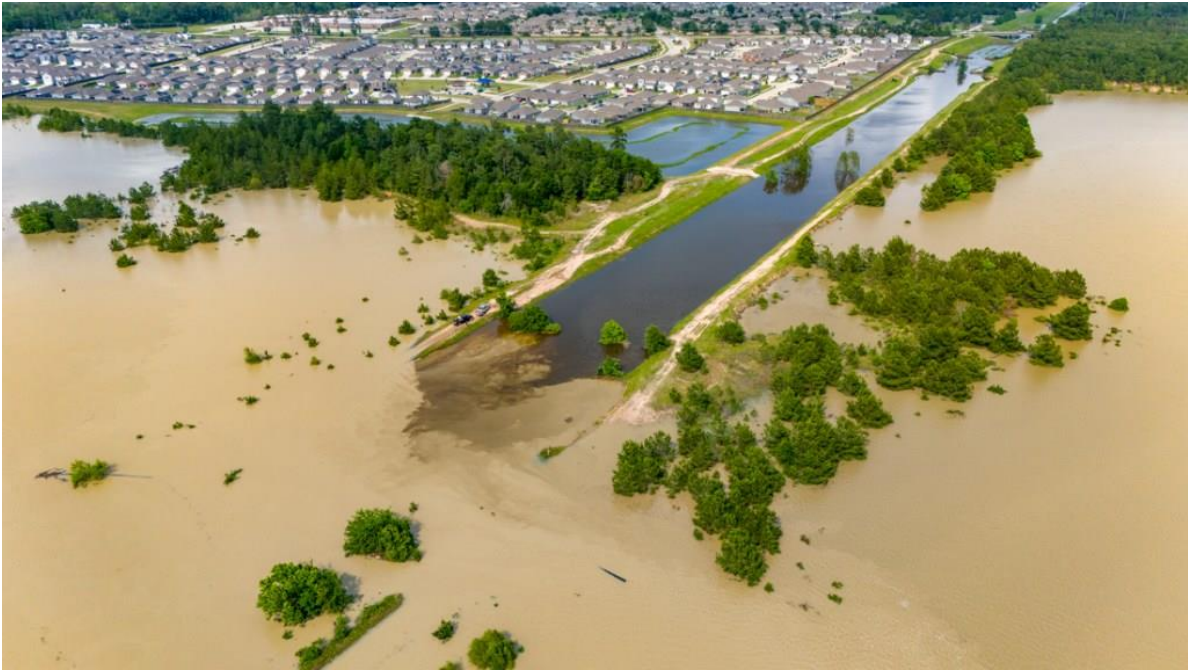
Reverse angle (facing east) shows proximity of pollution to homes in Northpark Woods subdivision. That's the Oakhurst Ditch, which empties into the West Fork behind camera position. Water flows left to right. Hallett mine is upstream on left.

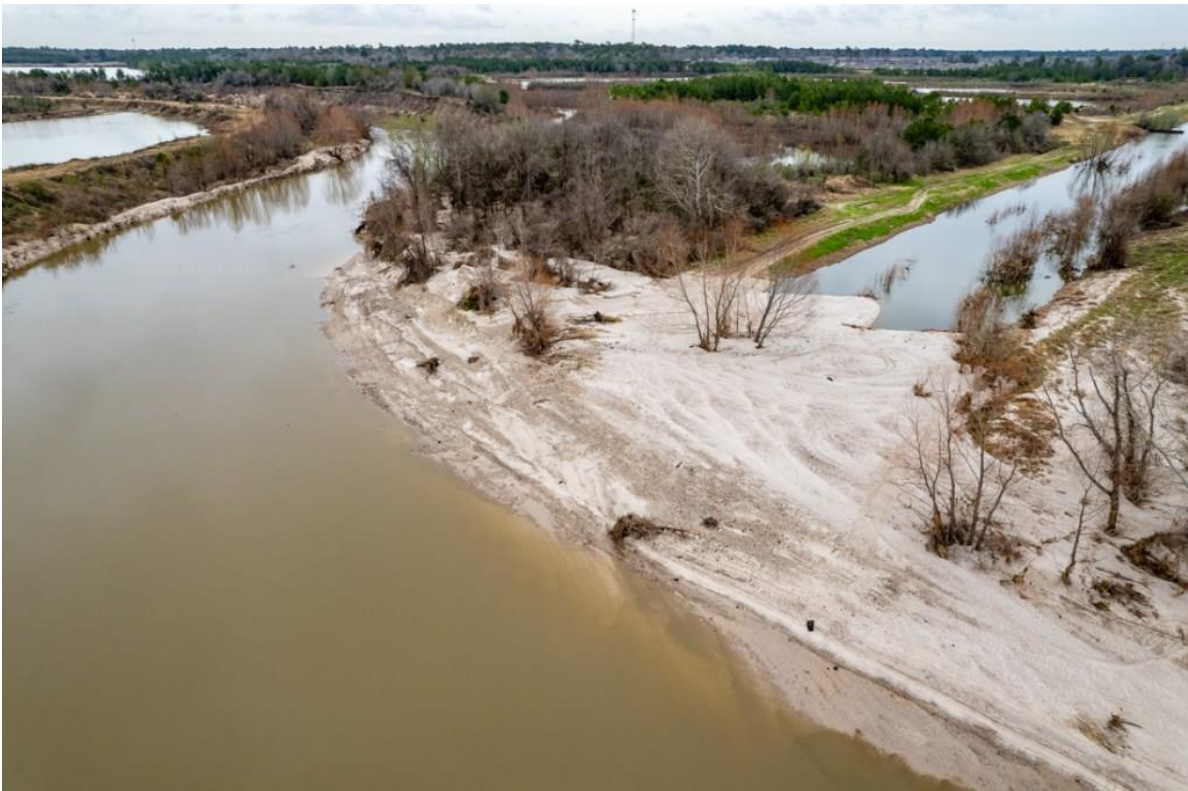
Same ditch blocked by sand increases flood risk for homes (visible in top right).

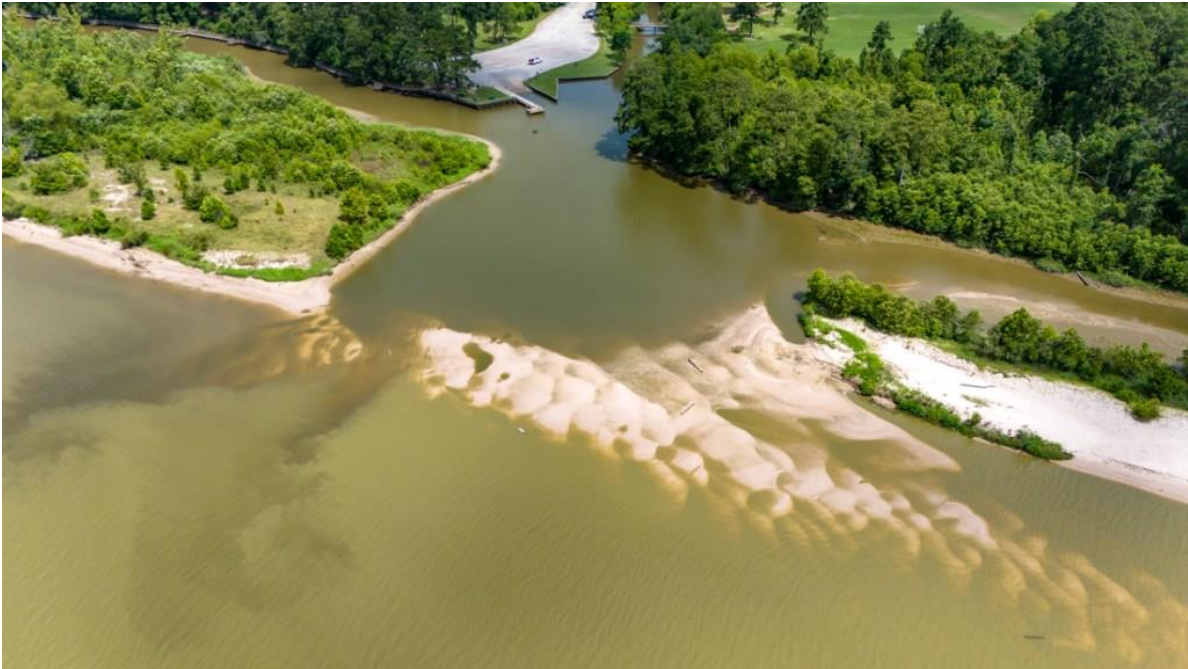
Farther downstream, the Kingwood Diversion Ditch (top middle) also became blocked by sediment. A Harris County Flood Control District study found that the [Diversion Ditch was one of the two most dangerous flooding problems](#) in Kingwood.

The entrance to this ditch had just recently been dredged by the Army Corps.

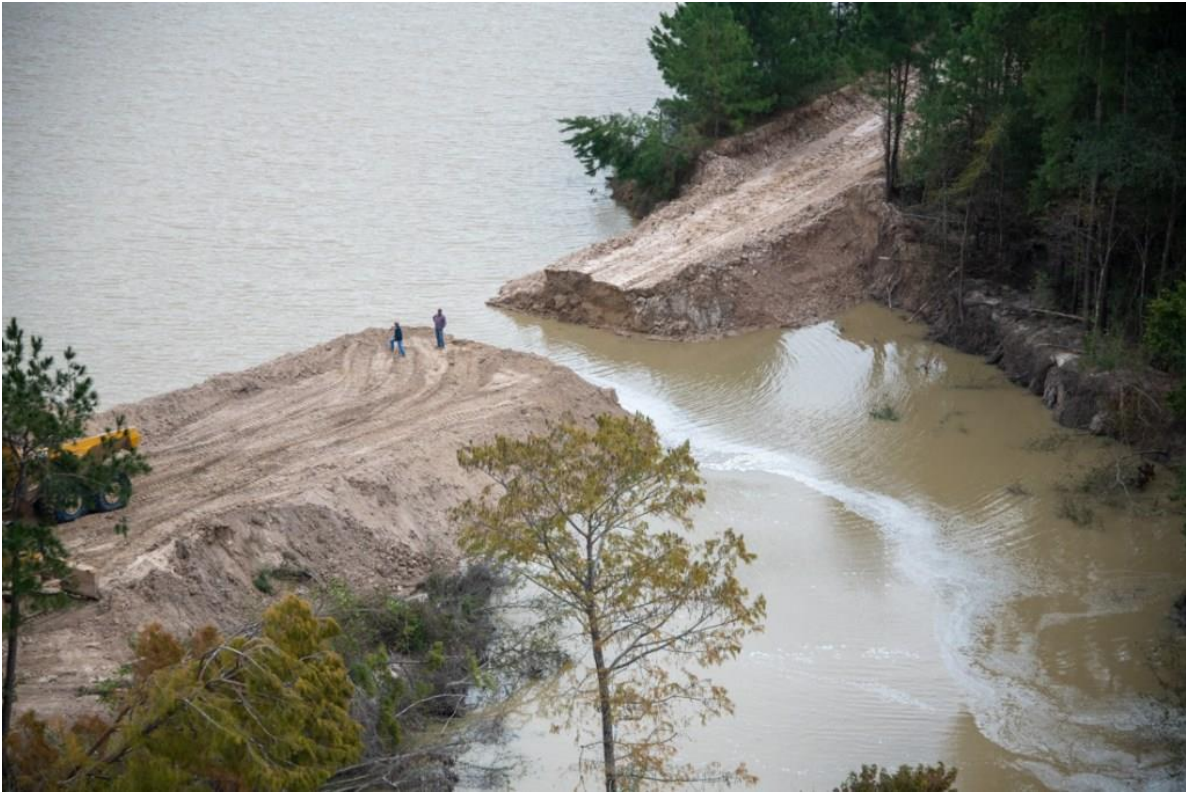
Broken dike at the Triple PG sand mine in Porter. Industrial wastewater is flowing out of the mine into White Oak Creek which joins Caney Creek and the San Jacinto East Fork before flowing into Lake Houston.

Conclusion: Mines need to be positioned farther from rivers on higher ground. Natural vegetation needs to be left in the buffer zones to slow floodwaters and reduce erosion. The measures could help solve the problems shown above and help protect the health and safety of millions of people.
