***Sediment Pollution from Sand Mining:
Impact on Flood Risk, Costs, Water Quality***

Appendix to APO BMP List Proposal

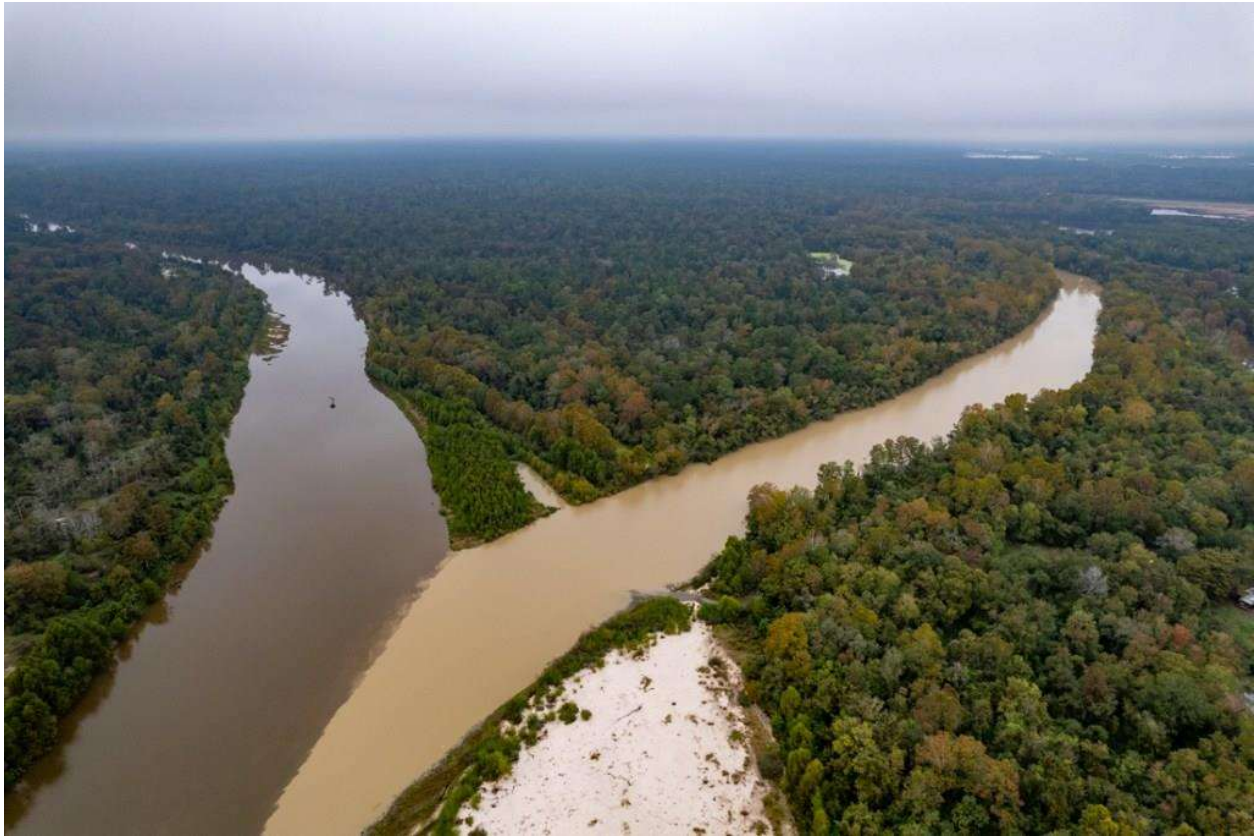
*Confluence of San Jacinto West Fork (right) and Spring Creek near US59 Bridge.
This is a frequent sight. Twenty square miles of mines are upstream on the right
in a 20-mile reach of the river.*

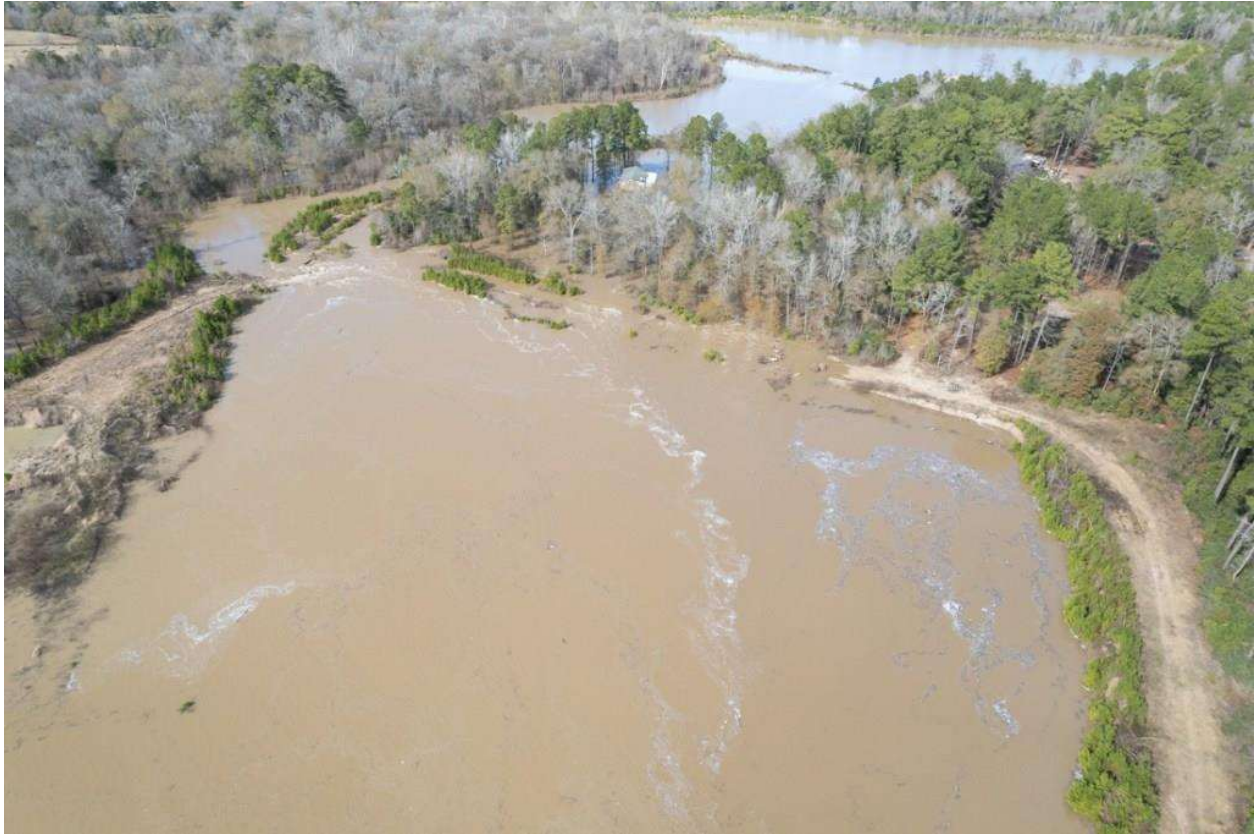
San Jacinto East Fork capturing a mine in Plum Grove.

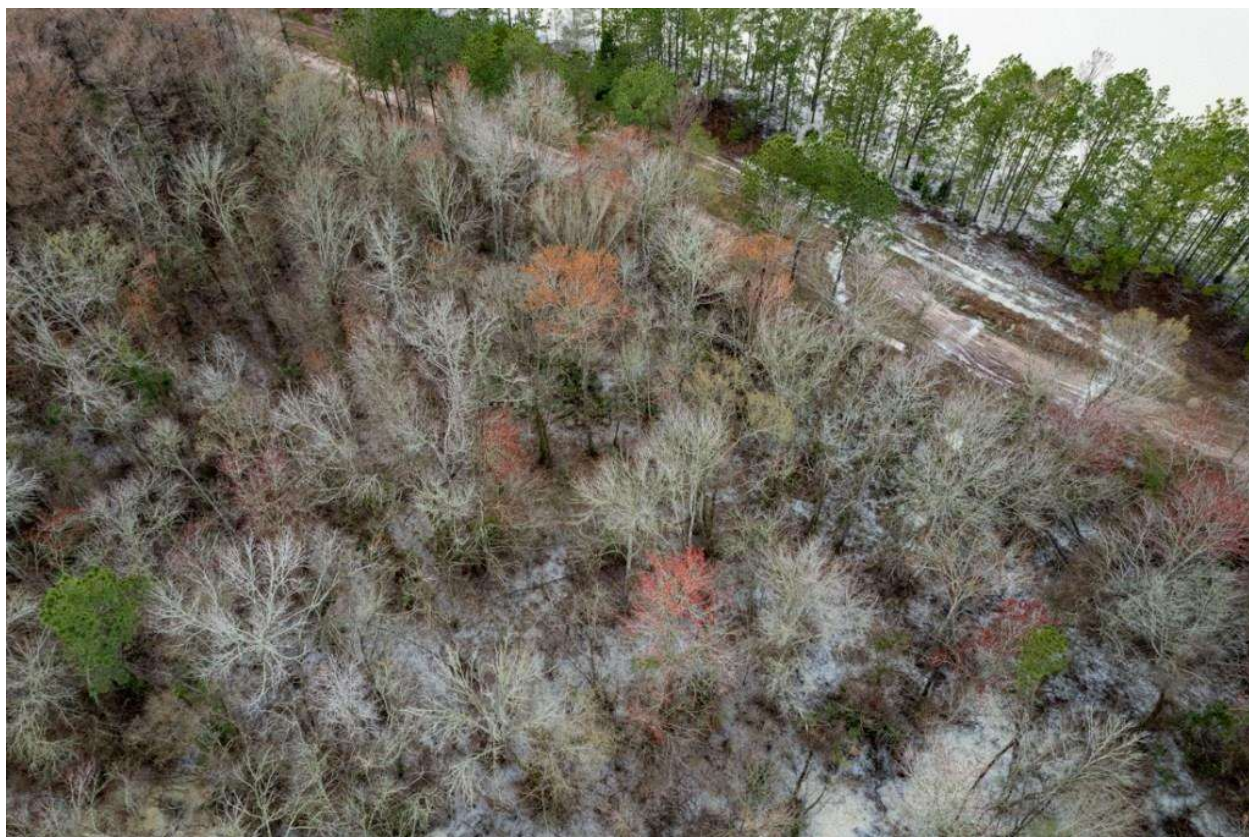
Close up of same effluent from same pond shows source of leakage.

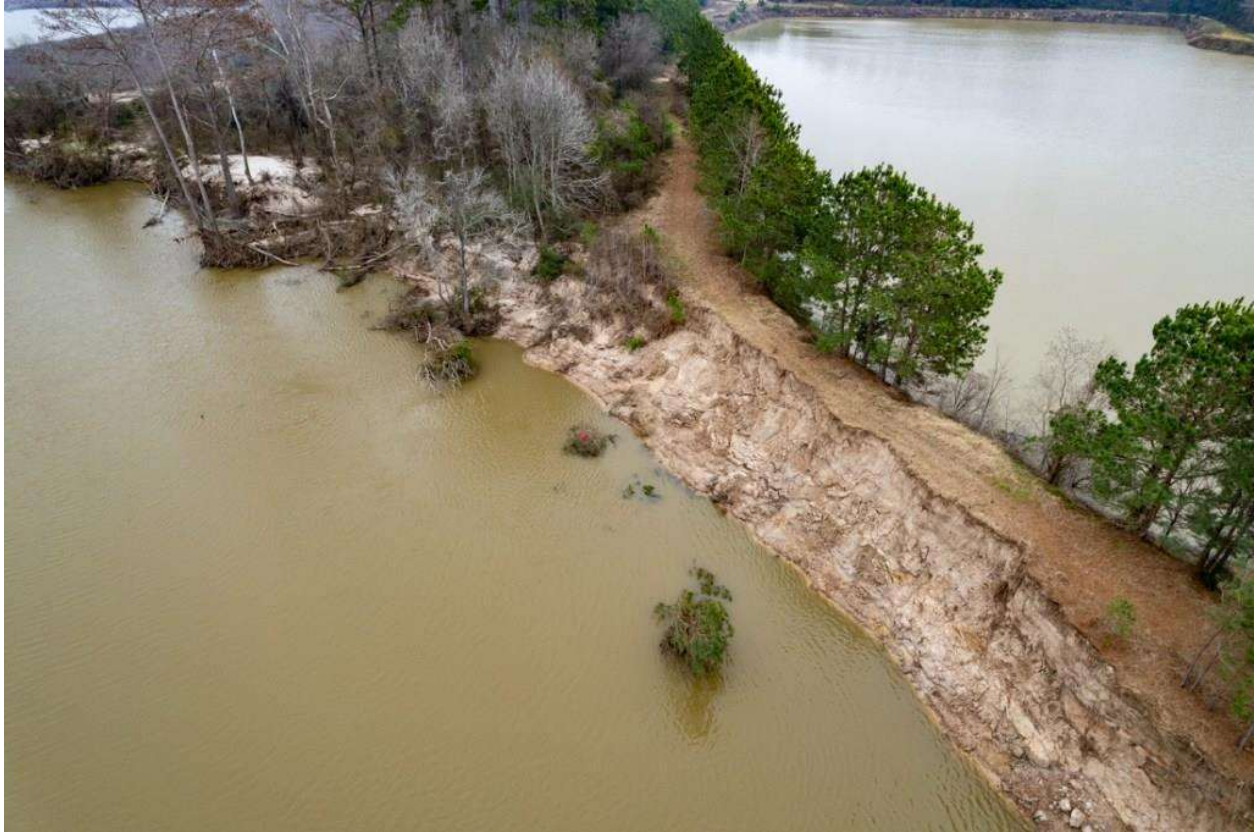
Dike of abandoned Williams Brothers Mine (upper right) eroded by the San Jacinto West Fork (lower left).

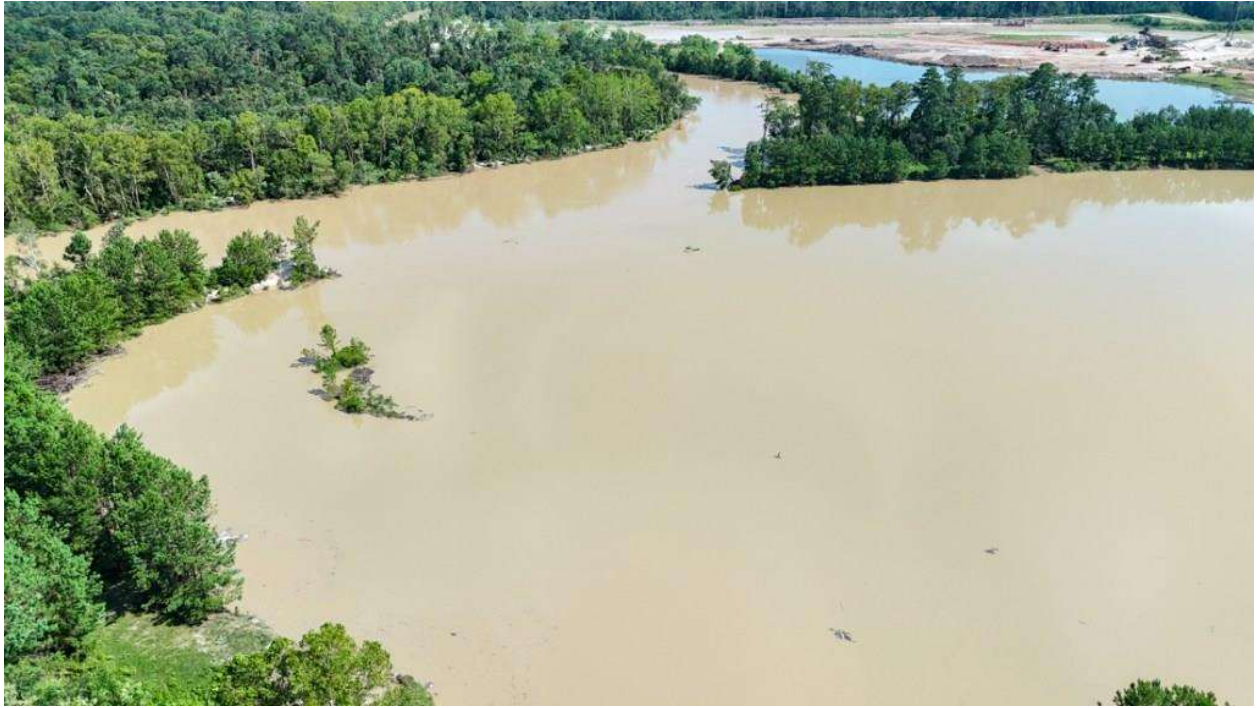
... Hurricane Beryl eroded what was left of the wall and flowed through the pit.

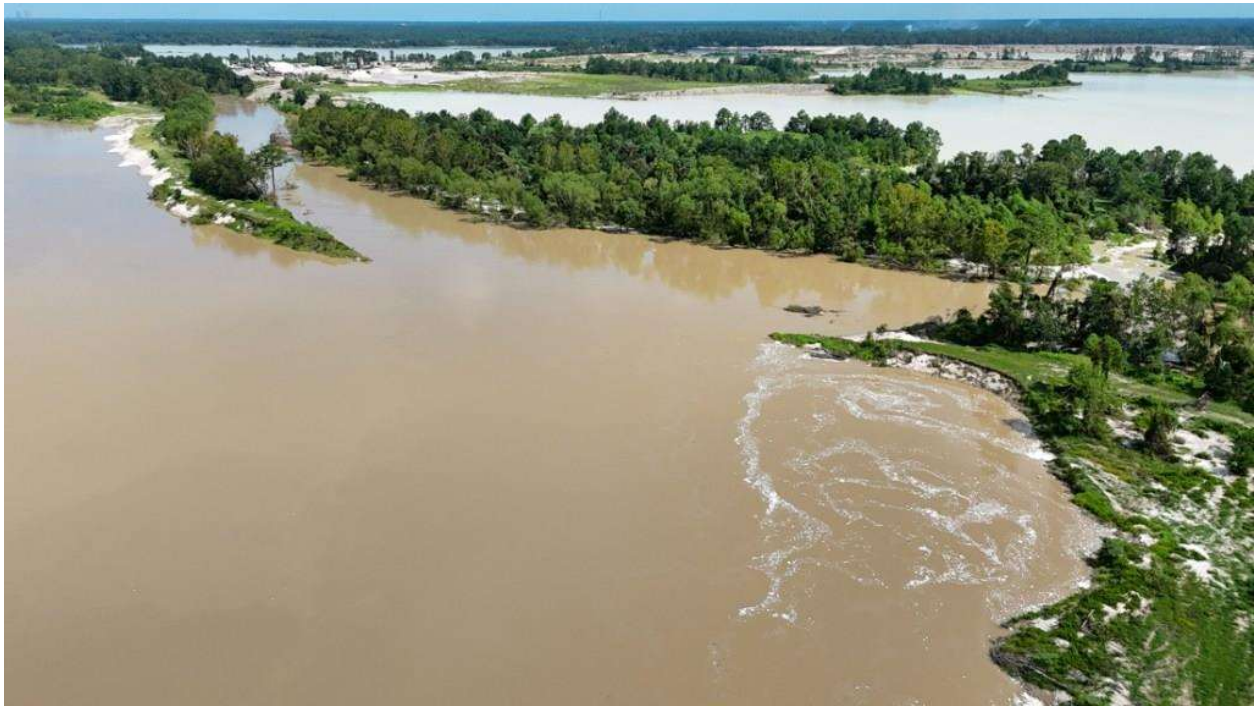
A little upstream, Hallett sold a sand pit (below left) on the San Jacinto West Fork to a real estate developer, Riverwalk Porter LLC. Within months, the river captured the pit.

The West Fork now flows into the pit at the north end...

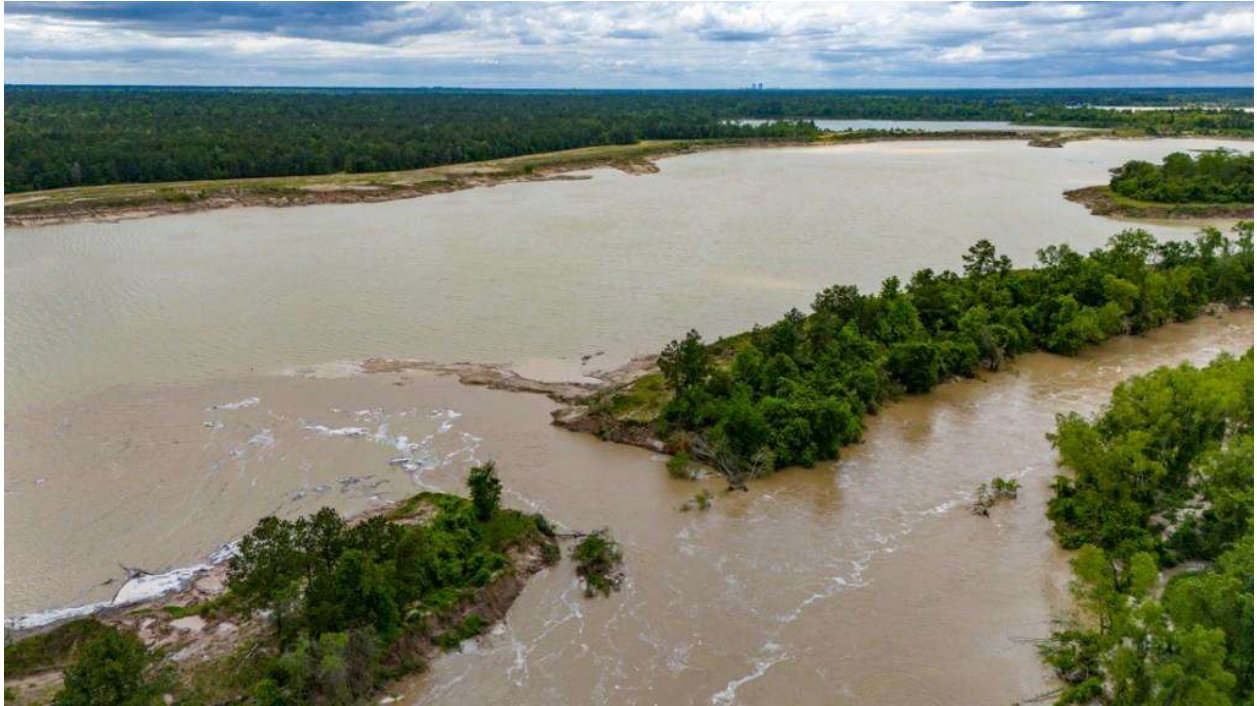
...and flows out at the south end.

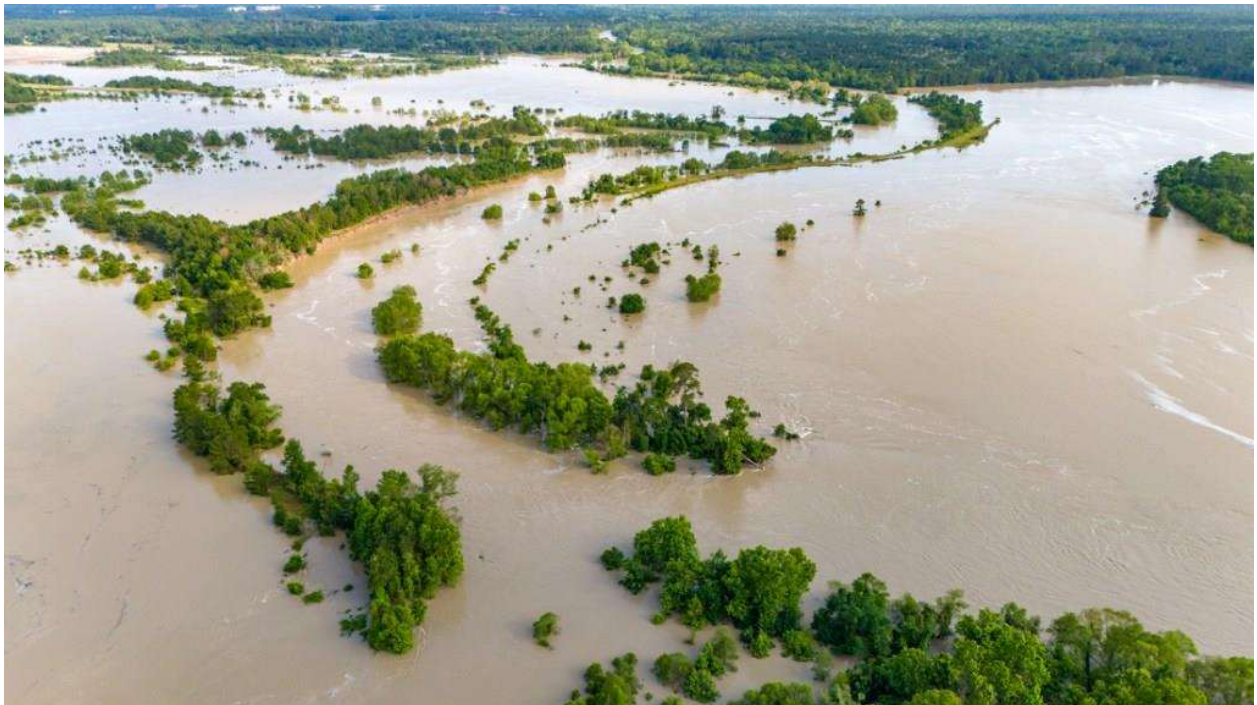
Wider shot of same pit (to the right of the S-turn) shows both the entry breach (lower right) and exit breach (upper right) in the dikes.

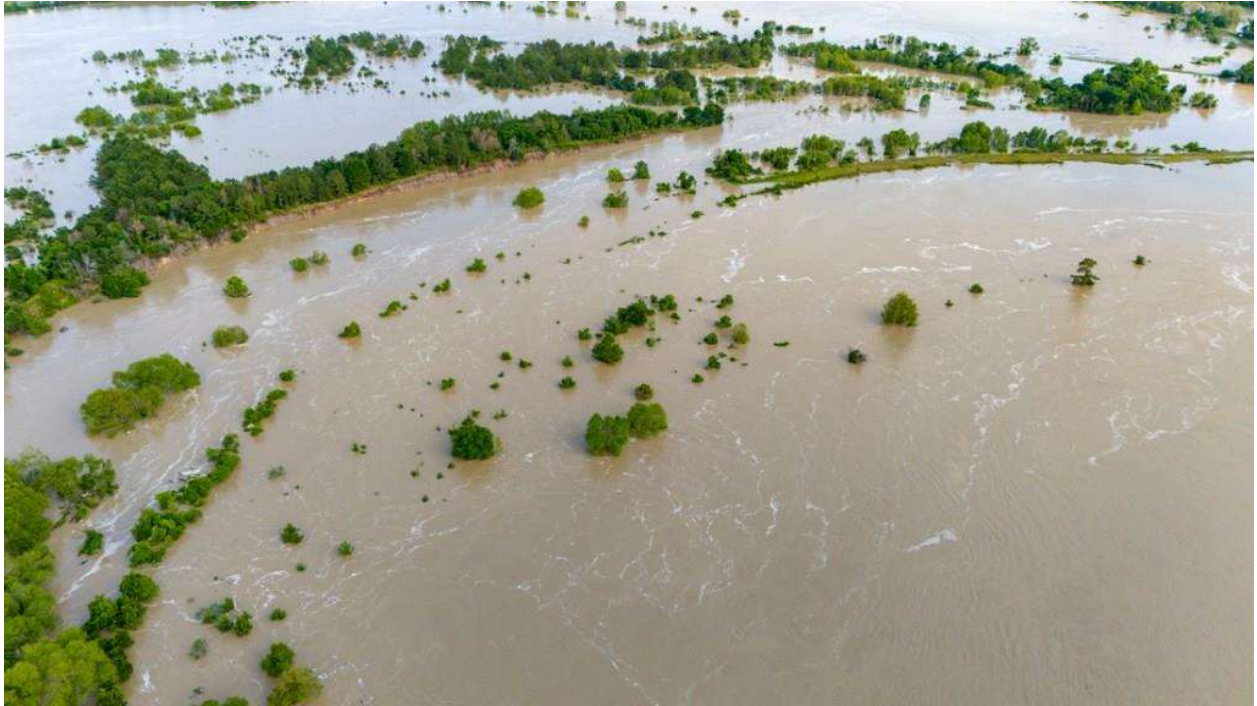
A drone followed logs floating through this captured West Fork pit at 5 MPH.

[5 MPH is more than fast enough to scoop up and carry off the largest grains of sand](#) and other sediment.

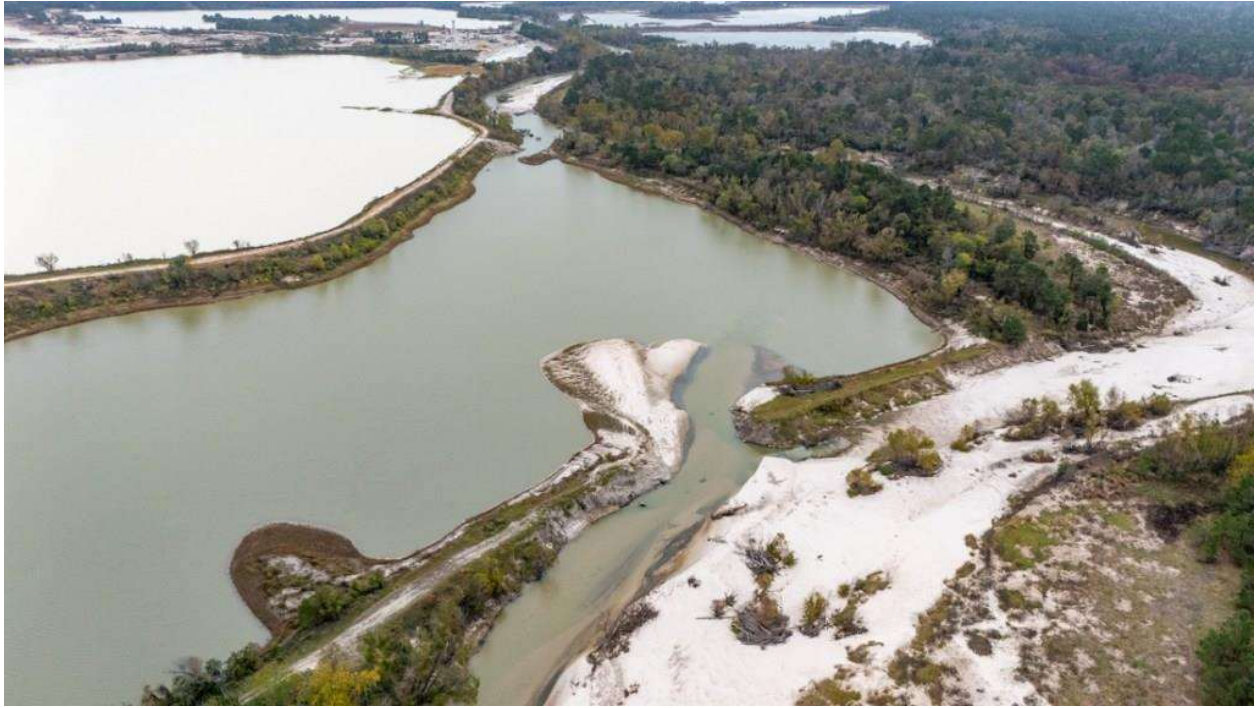
Another West Fork pit capture at the Hallett Mine after floodwaters receded. Notice how natural channel of the river has been virtually cut off.

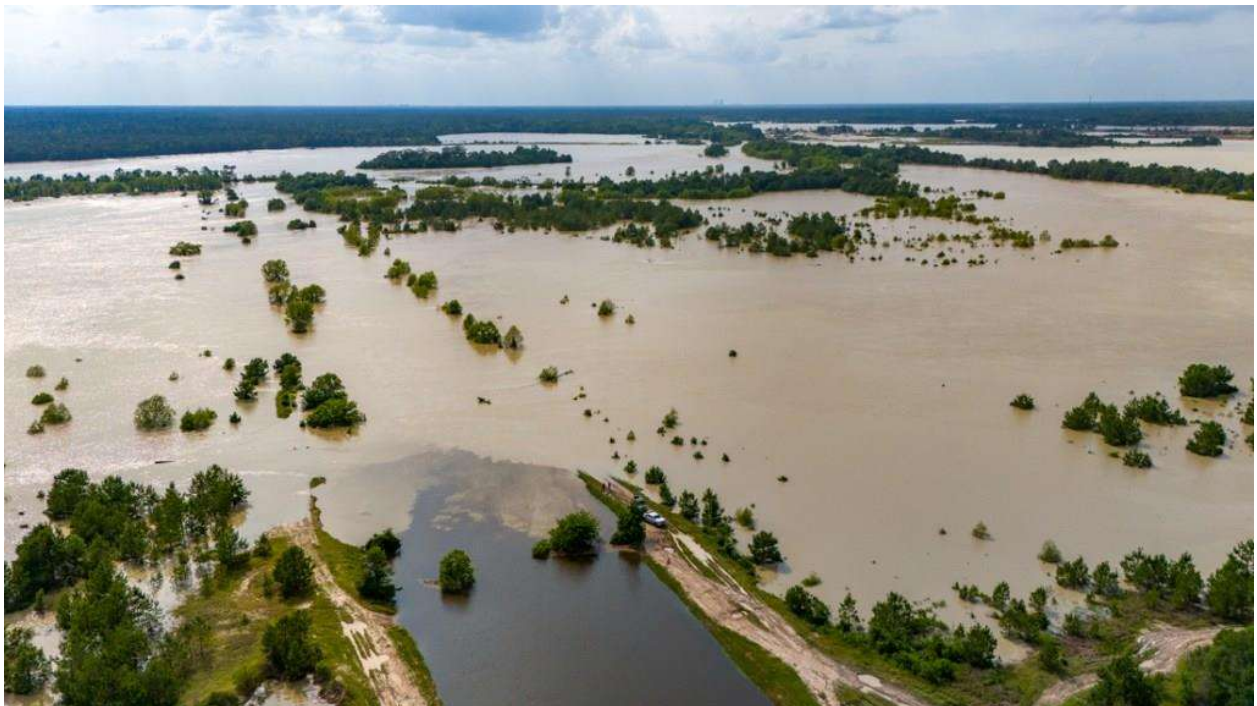
Effluent from the Hallett Mine (upstream in upper right) polluting the West Fork at the Northpark/Oakhurst Ditch (middle foreground). Water flows right to left. Facing West.

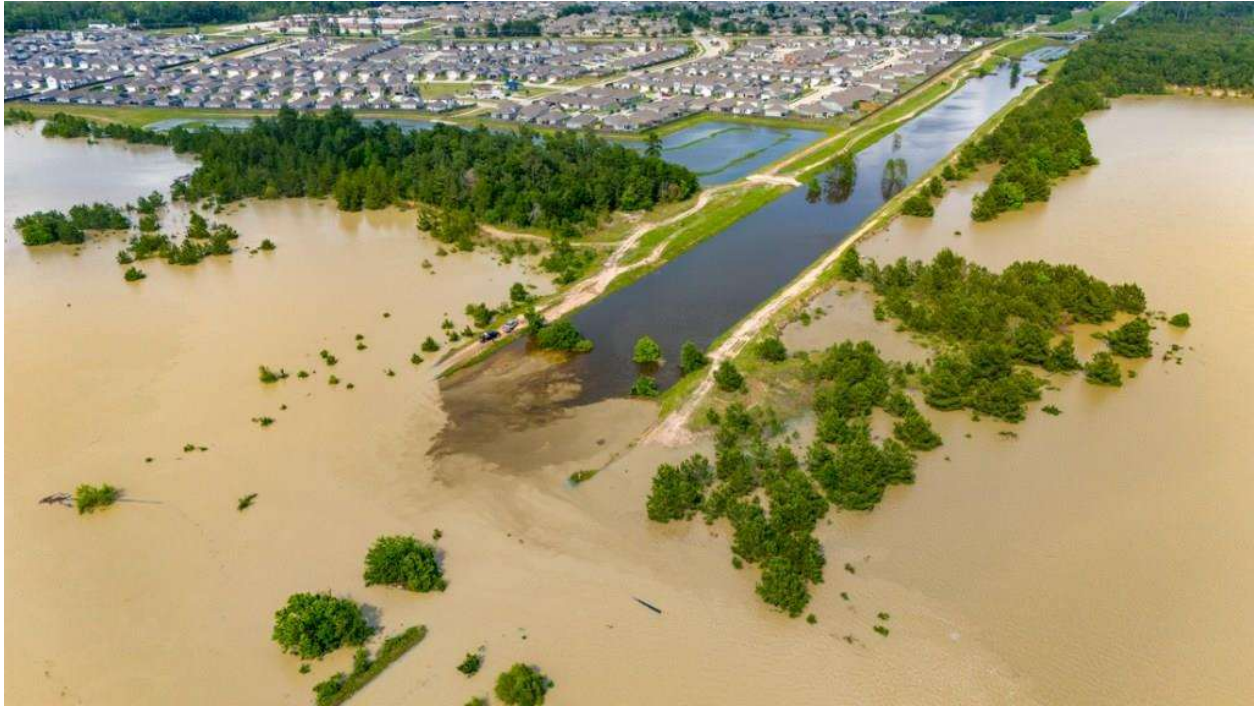
Reverse angle (facing east) shows proximity of pollution to homes in Northpark Woods subdivision. That's the Oakhurst Ditch, which empties into the West Fork behind camera position. Water flows left to right. Hallett mine is upstream on left.

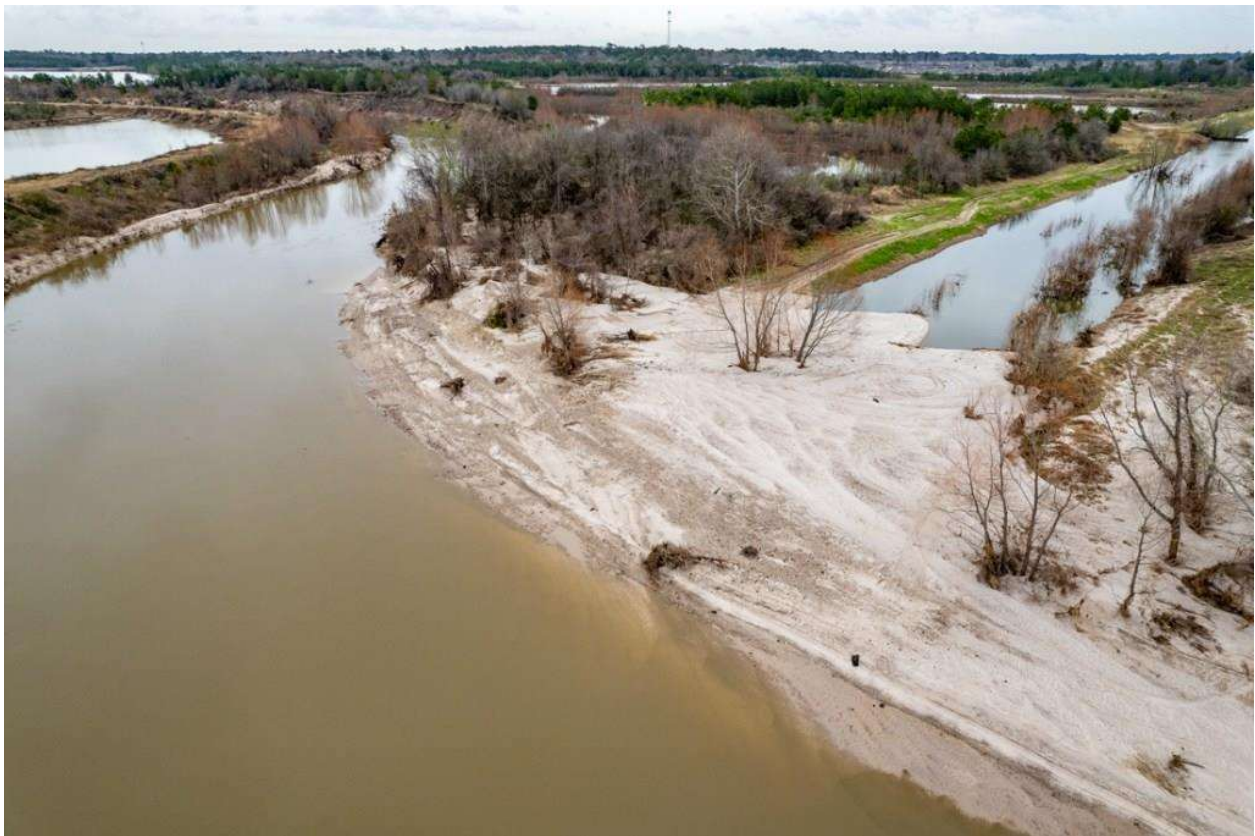
Same ditch blocked by sand increases flood risk for homes (visible in top right).

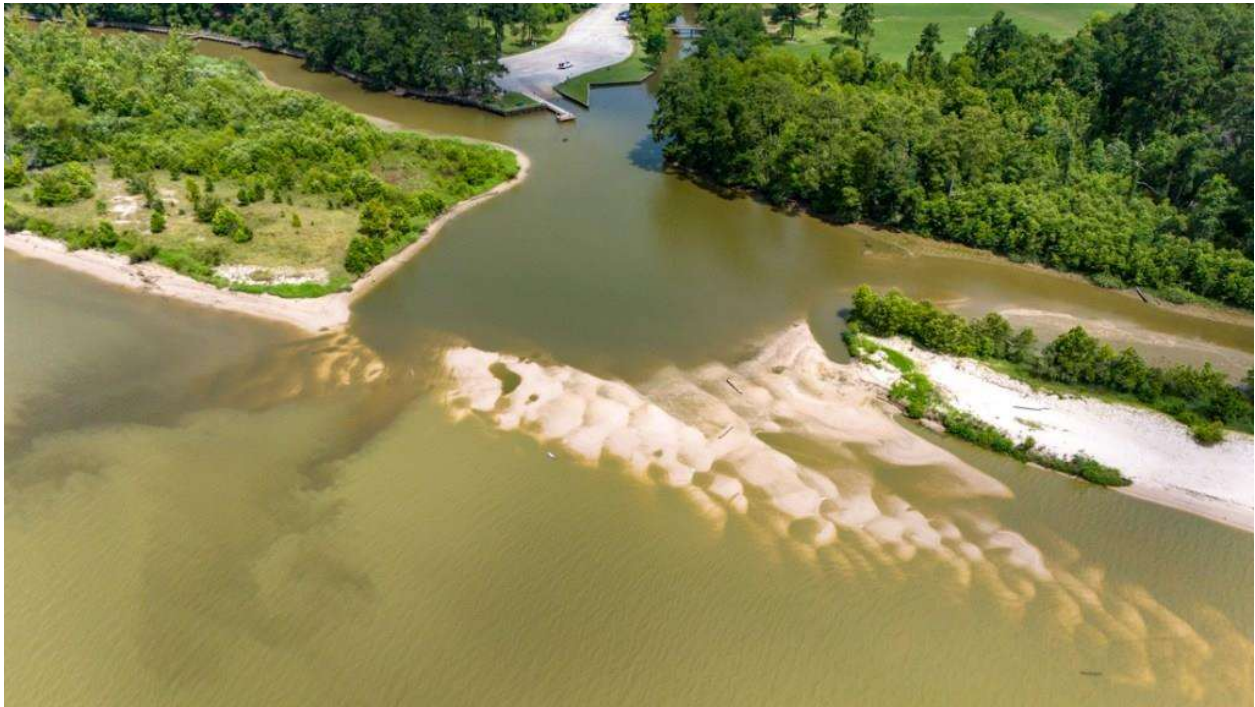
Farther downstream, the Kingwood Diversion Ditch (top middle) also became blocked by sediment. A Harris County Flood Control District study found that the [Diversion Ditch was one of the two most dangerous flooding problems](#) in Kingwood.

The entrance to this ditch had just recently been dredged by the Army Corps.

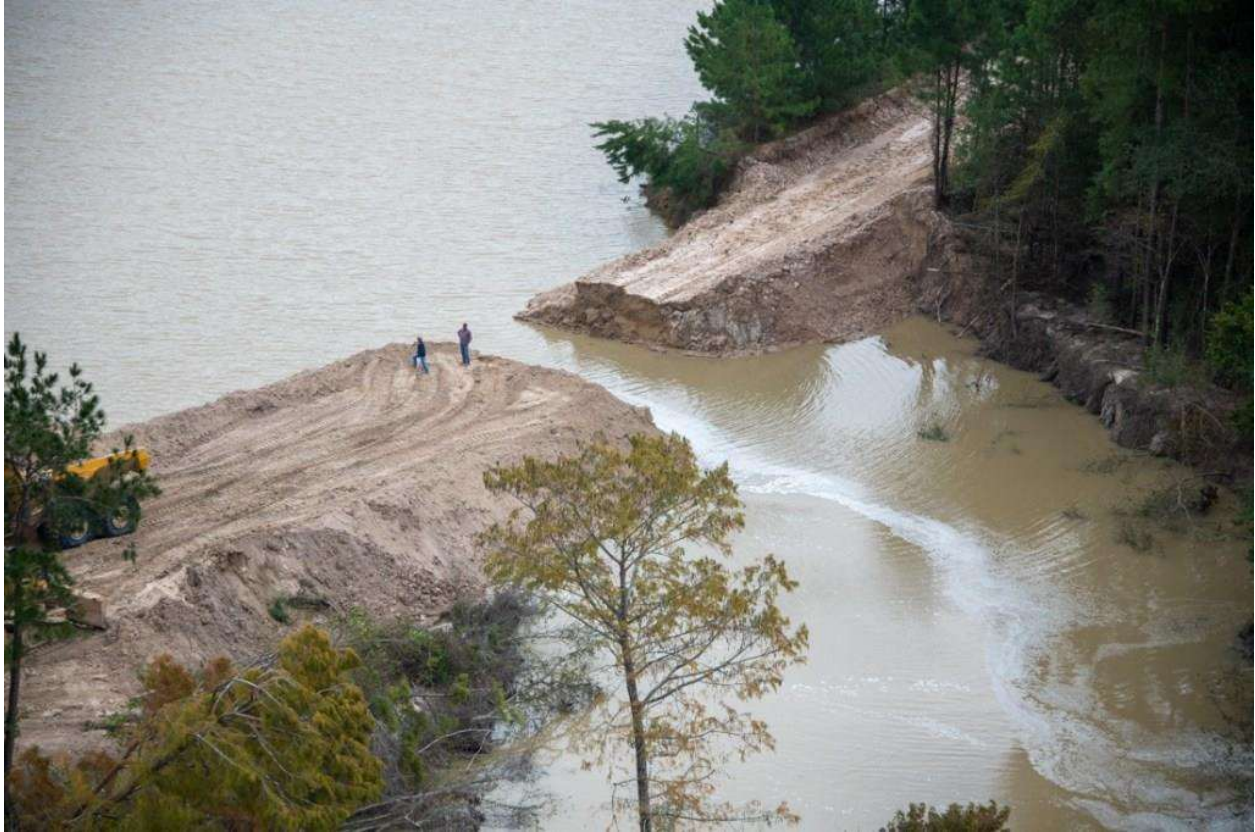
Broken dike at the Triple PG sand mine in Porter. Industrial wastewater is flowing out of the mine into White Oak Creek which joins Caney Creek and the San Jacinto East Fork before flowing into Lake Houston.

Conclusion: Mines need to be positioned farther from rivers on higher ground. Natural vegetation needs to be left in the buffer zones to slow floodwaters and reduce erosion. The measures could help solve the problems shown above and help protect the health and safety of millions of people.
