***Sediment Pollution from Sand Mining:  
Impact on Flood Risk, Costs, Water Quality***

***Appendix to APO BMP List Proposal***

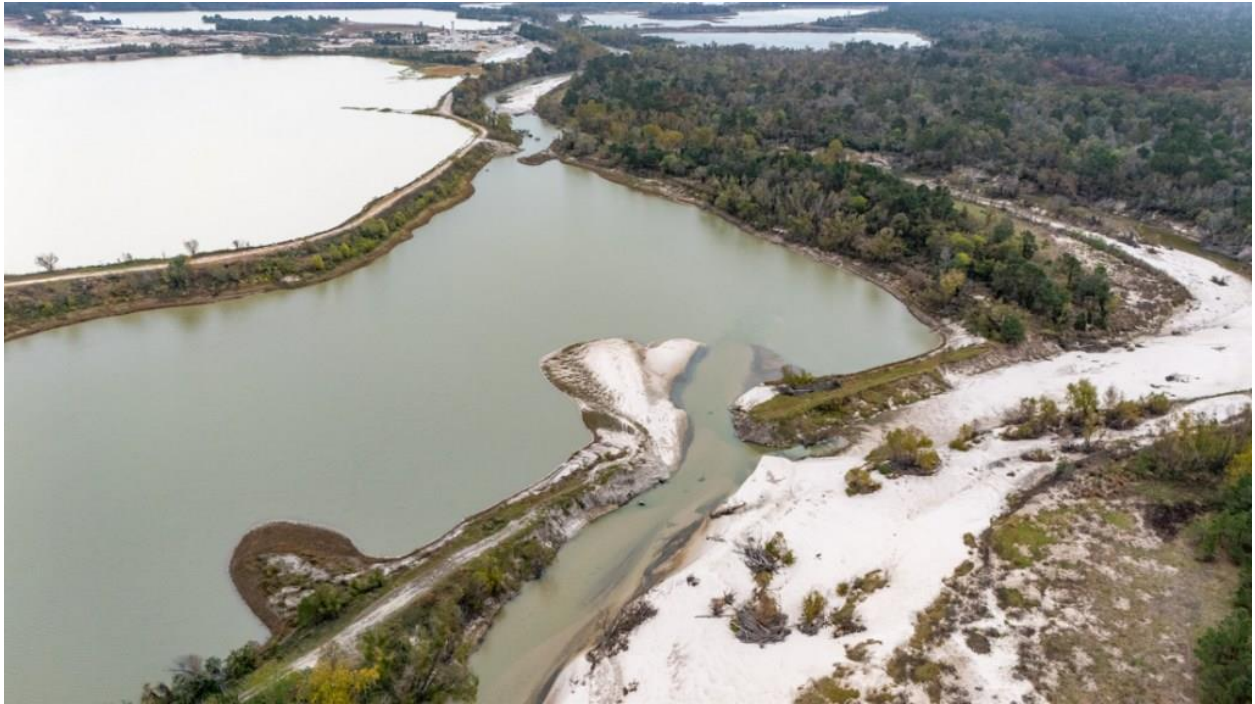
*Another West Fork pit capture at the Hallett Mine after floodwaters receded. Notice how natural channel of the river has been virtually cut off.*

**Conclusion:** Mines need to be positioned farther from rivers on higher ground. Natural vegetation needs to be left in the buffer zones to slow floodwaters and reduce erosion. The measures could help solve the problems shown above and help protect the health and safety of millions of people.

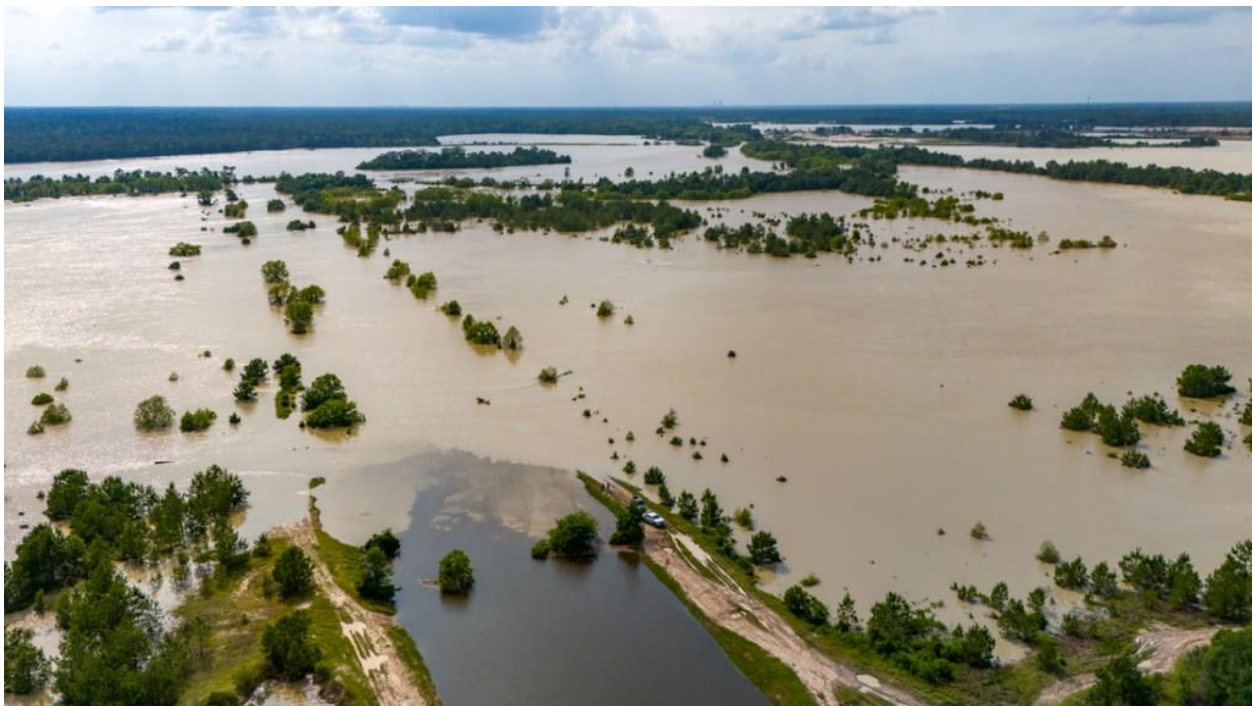
*Effluent from the Hallett Mine (upstream in upper right) polluting the West Fork at the Northpark/Oakhurst Ditch (middle foreground). Water flows right to left. Facing West.*

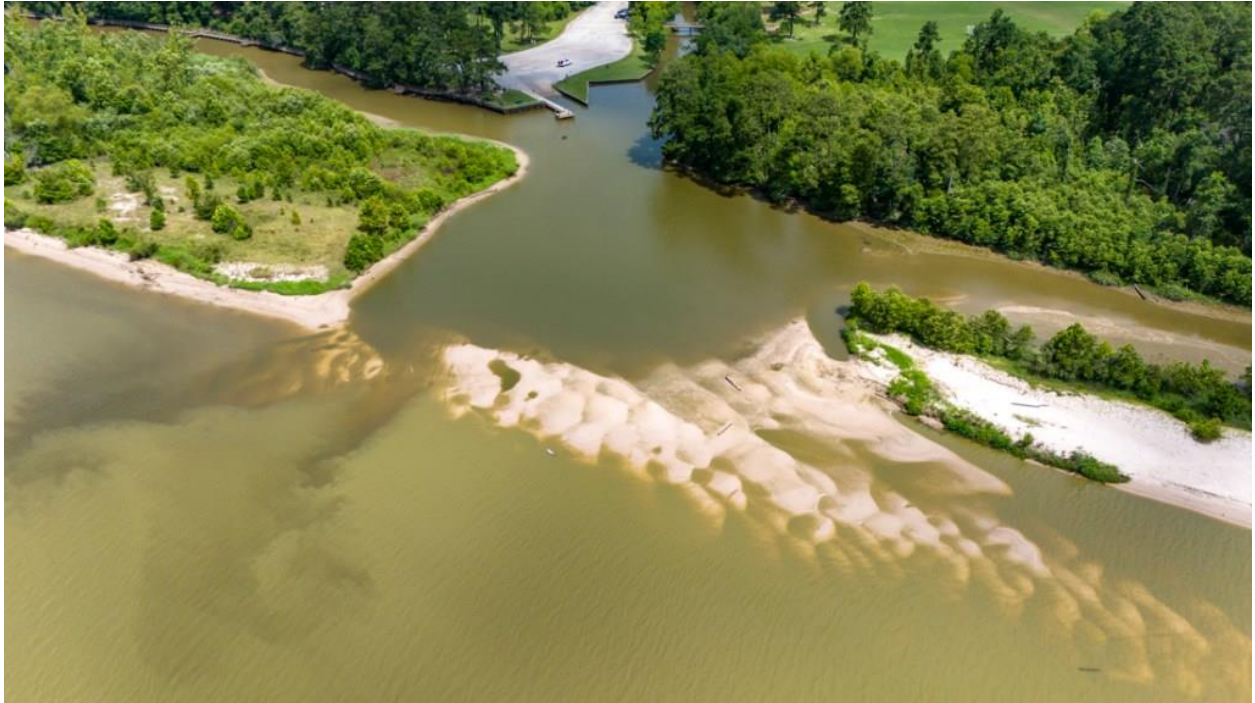
*Farther downstream, the Kingwood Diversion Ditch (top middle) also became blocked by sediment. A Harris County Flood Control District study found that the [Diversion Ditch was one of the two most dangerous flooding problems](#) in Kingwood.*

The entrance to this ditch had just recently been dredged by the Army Corps.
