Patagonia Area Resource Alliance (PARA) ♦ Arizona Mining Reform Coalition ♦
Borderlands Restoration Network ♦ Center for Biological Diversity ♦ Earthworks ♦
Friends of the Santa Cruz River ♦ Friends of Sonoita Creek ♦ Sierra Club (Grand
Canyon Chapter) ♦ Tucson Audubon

January 12, 2024

**Re: Comments and Objections to Proposed Renewal of AZPDES Permit
(AZ0026387) for South32 Hermosa, Inc.**

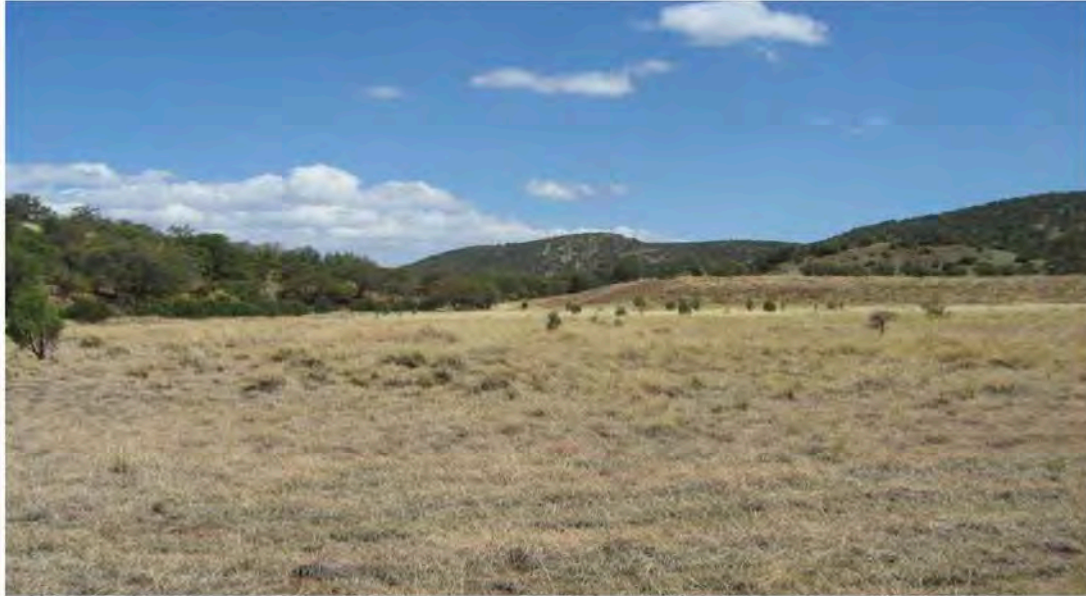
Trench Camp-site of proposed evaporation pond on tailings pile no. 4 (upper lift of tailings no. 1, site of other proposed evaporation pond, in the background).

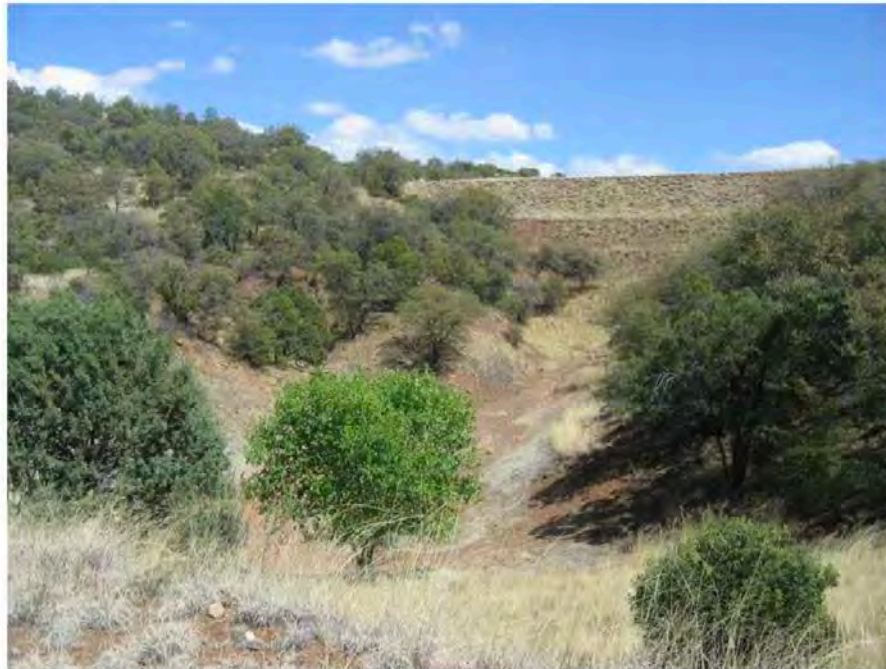
View of tailing pile no.4, looking upstream; this pile is the second and lowermost of the two piles proposed for installing the evaporation ponds. Note steep sided nature of this pile, showing the need for additional reinforcement (buttressing) to support additional weight of ponds

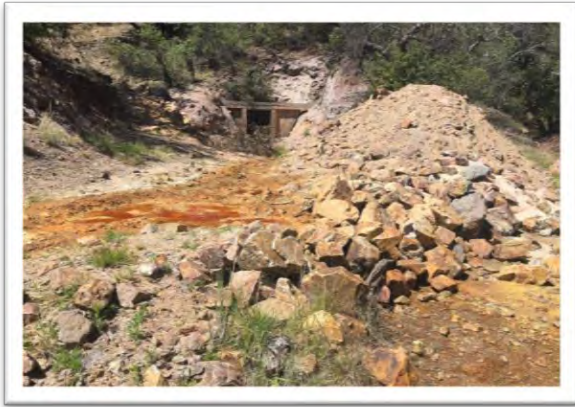
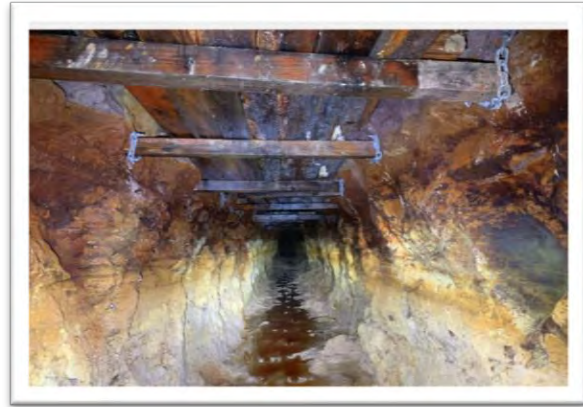
Figures 1 & 2: Adit and rock storage before construction (left) Inside adit before construction (right)

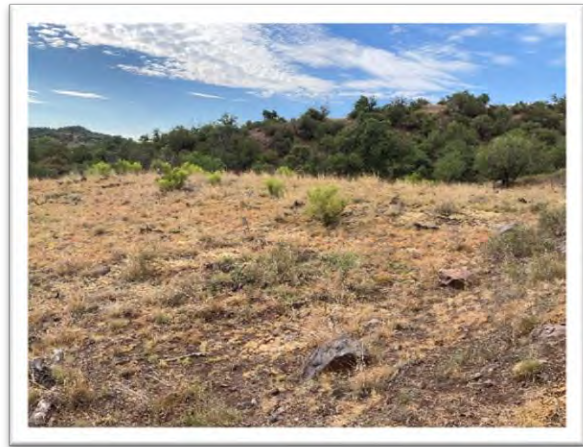
The waste repository constructed in 2015 appears to be stable with grasses and shrubs growing on this area.

Figures 9 & 10: Views of the repository

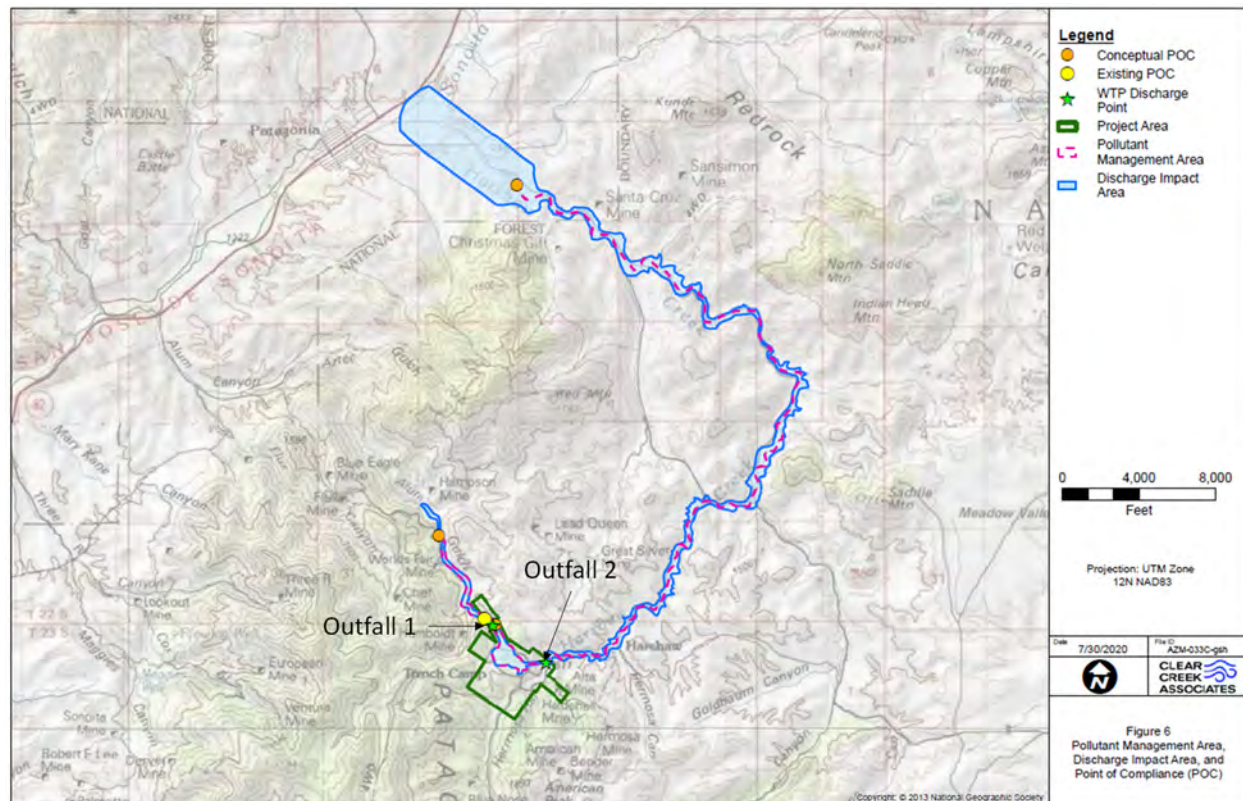
Figure 15. AMI's delineated Discharge Impact Area and Pollutant Management Area for the Hermosa Project (Clear Creek Associates, 2020).

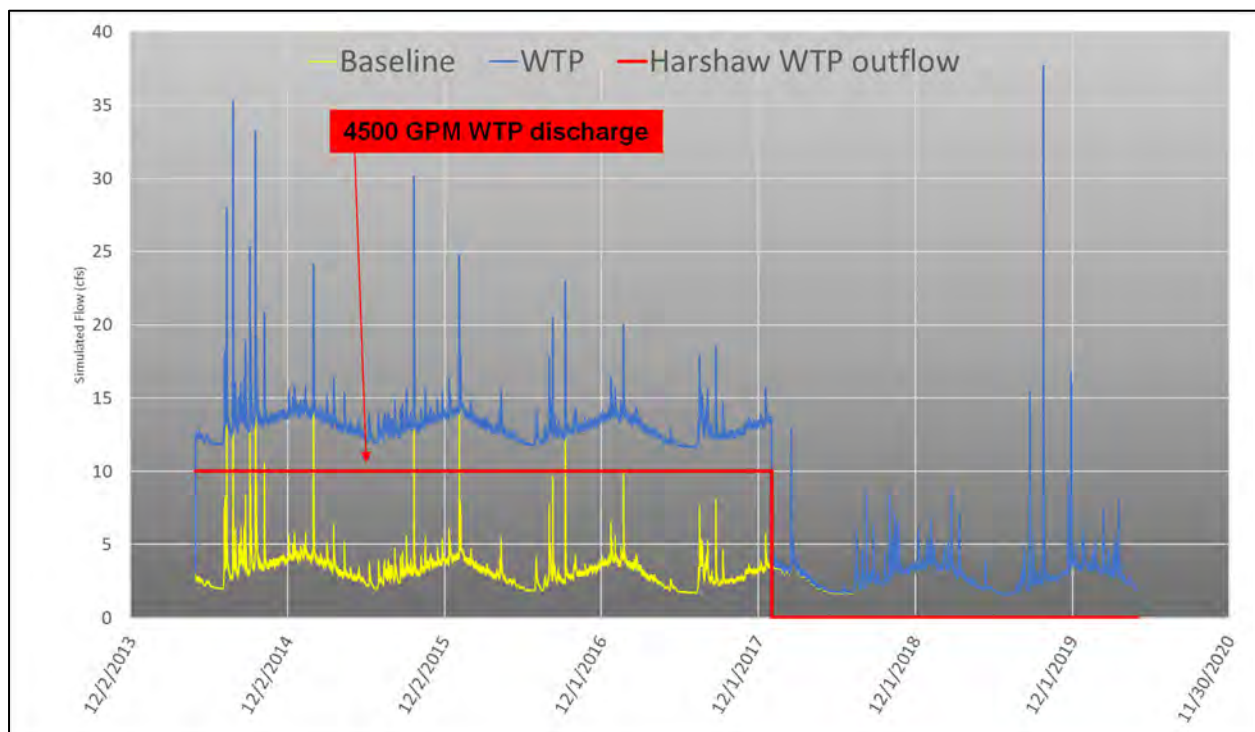
Figure 20. Simulated discharge at the TNC Patagonia-Sonoita Creek Preserve with and without 4 years of 4500 gpm discharge at WTP2.

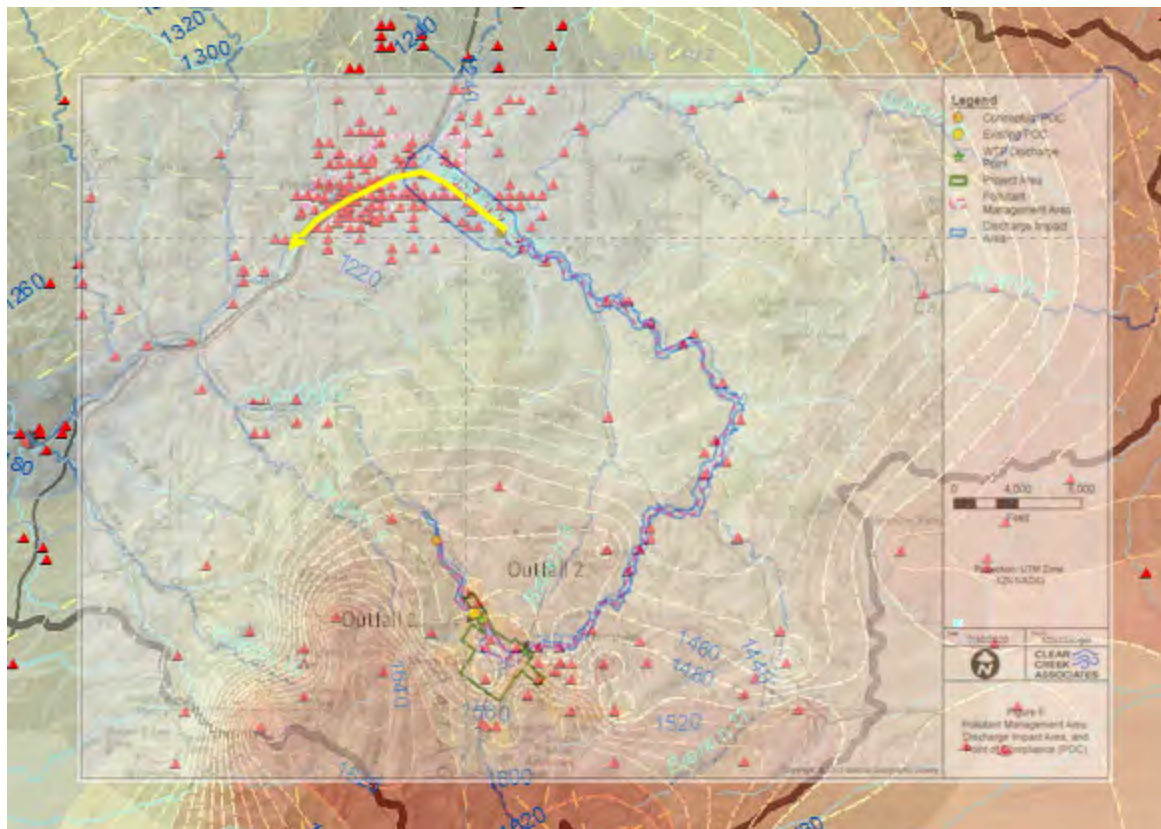
Figure 22. Overlay of AMI's "Discharge Impact Area" (Clear Creek Associates, 2020) on map of groundwater wells (red triangles) and groundwater elevations (Lacher & Prucha, 2020). Yellow arrow shows flow path into and down Sonoita Creek toward the TNC Preserve.
