Patagonia Area Resource Alliance

January 12, 2024

**Re: Comments and Objections to Proposed Renewal of AZPDES Permit
(AZ0026387) for South32 Hermosa, Inc.**

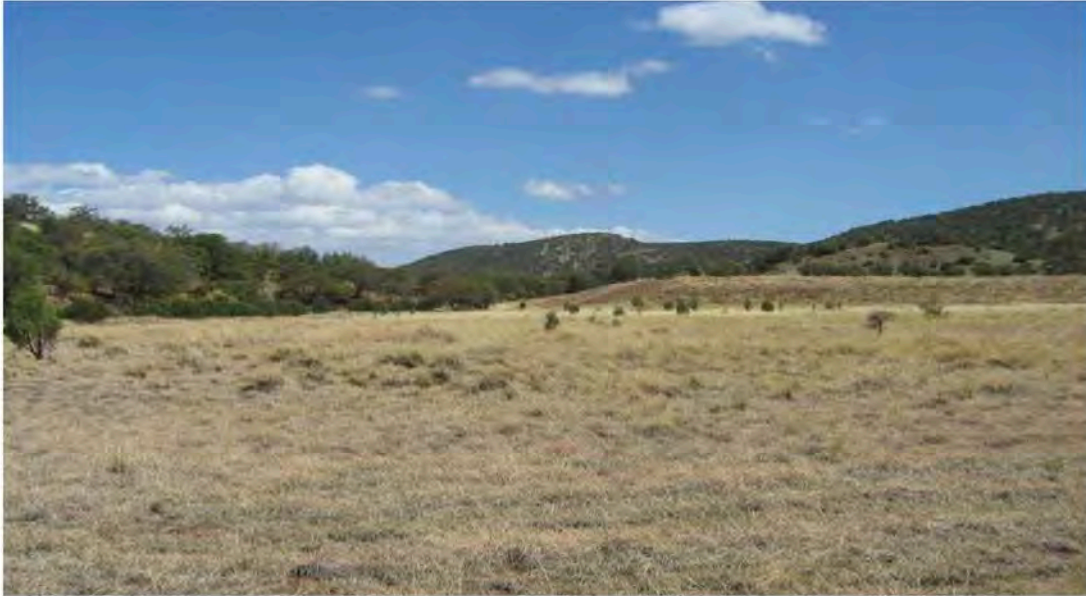
Trench Camp and Passive Treatment System for the January Adit

Trench Camp-site of proposed evaporation pond on tailings pile no. 4 (upper lift of tailings no. 1, site of other proposed evaporation pond, in the background).

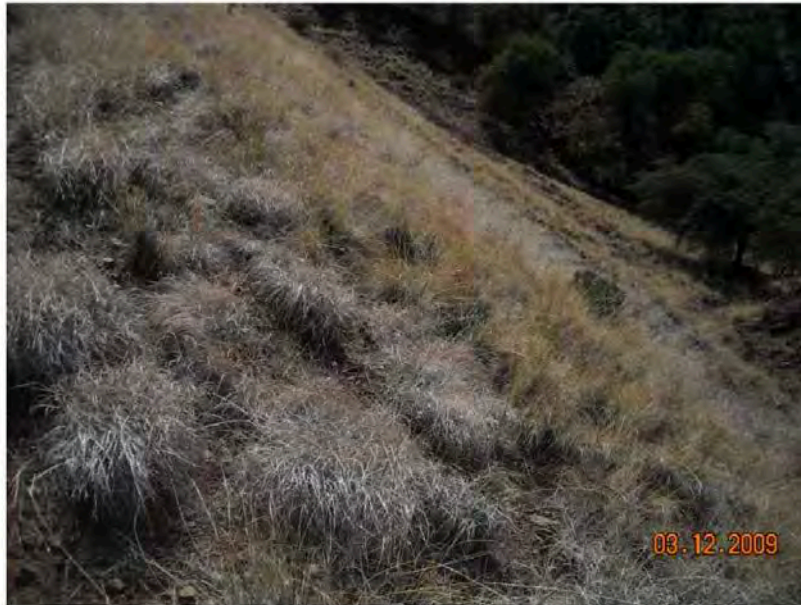
View of tailing pile no.4, looking upstream; this pile is the second and lowermost of the two piles proposed for installing the evaporation ponds. Note steep sided nature of this pile, showing the need for additional reinforcement (buttressing) to support additional weight of ponds

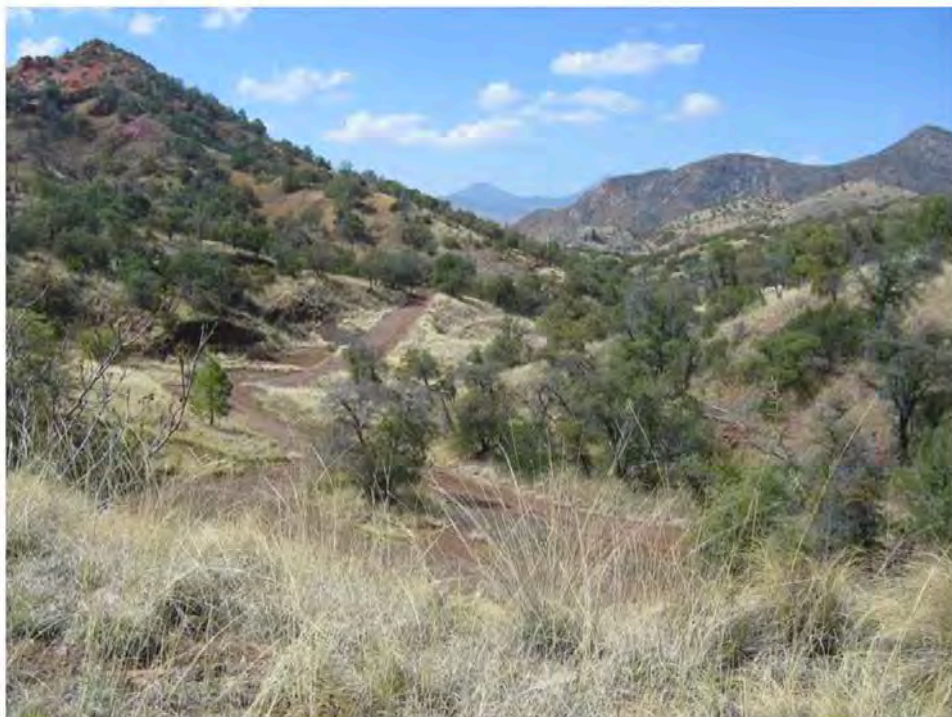
Close-up of side slope of tailings pile no. 4 showing the steep-sided nature of the tailings impoundments' slopes

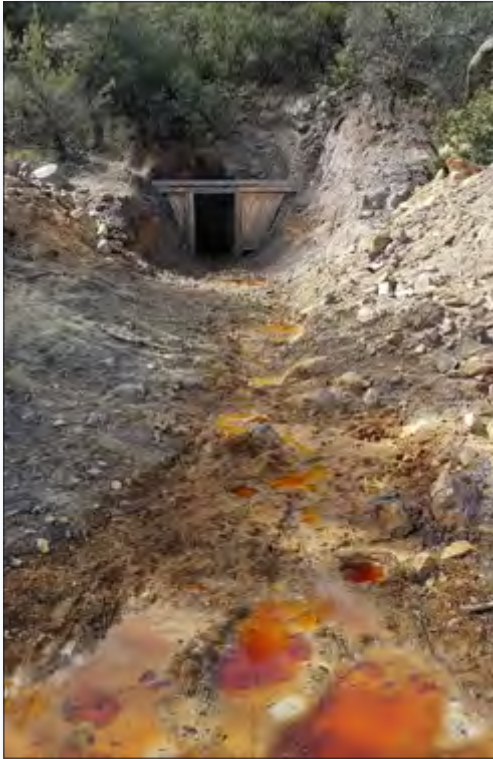
Figure 2. The adit at Lead Queen Mine, before remediation.

In 2016, USFS remediated the waste rock piles and addressed several adits and shafts at the site (Table 1). (An adit is a horizontal entrance to an underground mine primarily used for de-watering and extraction of minerals during operations.) The cleanup included the excavation and hauling of waste rock material to a single below-ground consolidation cell, which was covered with 2–4 feet of native soil and revegetated.

Entry to the open shafts were closed with bat-friendly gates, while others were sealed using polyurethane foam. A total of 11 zeolite gabion basket structures were installed in the stream channel at various locations downstream of the main adit in order to mitigate stormwater contact. However, the remedy at the main adit began to fail, allowing discharge of pollutants. USFS investigations discovered that the foam plug was intact, but that fractures and faults near the opening were seeping tunnel discharge that was then flowing downstream. USFS built a retention basin to contain and treat the small seep and flow. In 2019, USFS installed a hydraulic plug—a more long-term solution—to cease the discharge. Subsequent site visits confirmed no new seepage coming from the former adit opening.

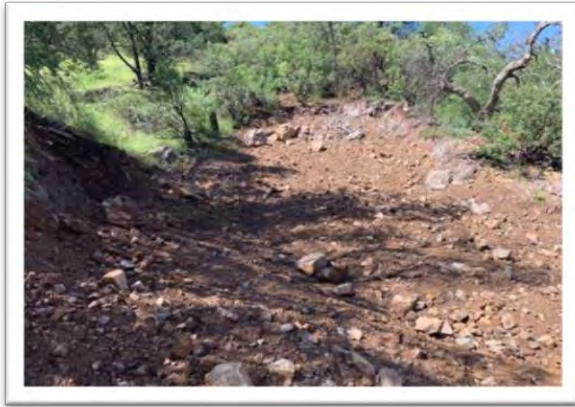
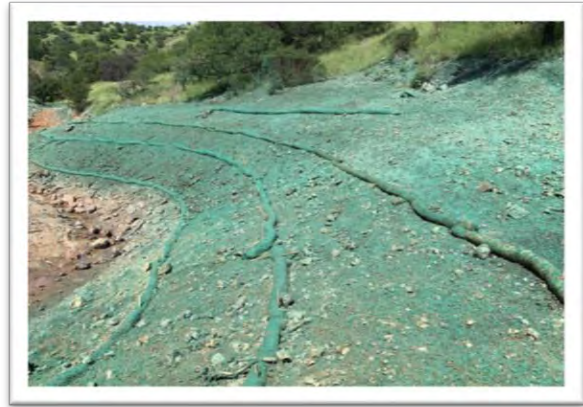
Figures 3 & 4: Outside adit after construction (left) Stabilized slope after construction (right)

The contractor re-mobilized to the site on August 26th, 2019, to finish work at the site. The contractor grouted the concrete plug to fill voids left behind from the curing process. The contractor then removed five of the remaining gabions and began backfilling the portal entrance with clean material. The spur road to the site was obliterated and seeded. Work was completed on September 5, 2019.

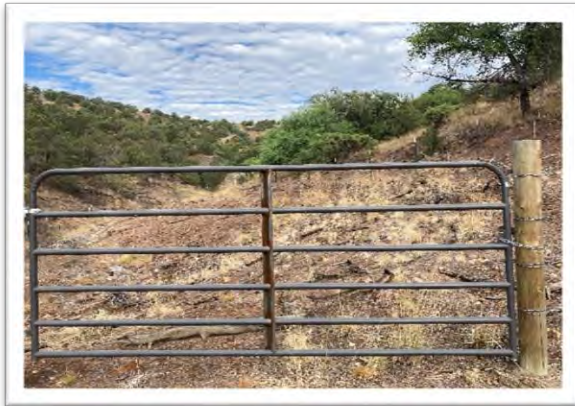
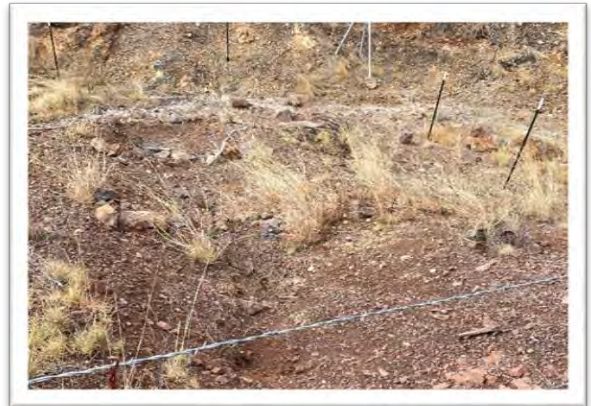
Figures 5 & 6: Views of the gate and inside the stabilized slope area.

On July 11, 2023, Hailey Stock, Assistant Regional Environmental Engineer, and Ernesto Maldonado, Arizona OSC, visited the former Lead Queen Mine for a monitoring inspection. Access was possible with a high-clearance, 4WD vehicle to the turn-around area on the unnamed access road. The fence and gate around the stabilized area are intact and appear to be effective in keeping out livestock. The slope in this area appears to be stable, with some vegetation growing on the surface and no obvious signs of erosion.

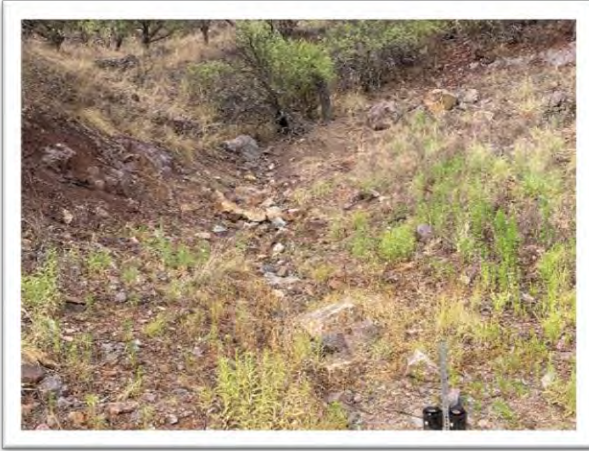
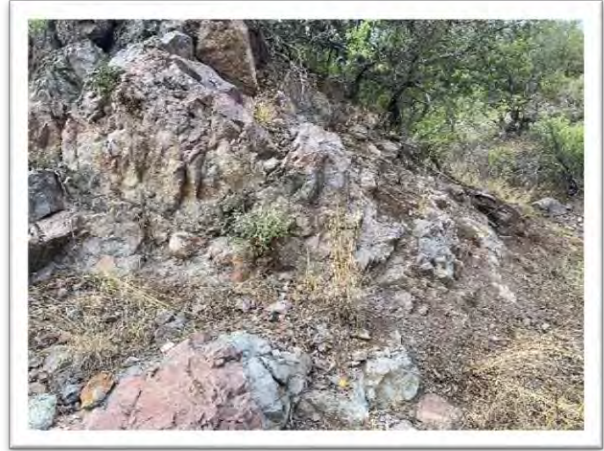
What appears to be an autosampler was installed outside of the adit by ADEQ. It had rained the night before, but no surface water was observed originating from the adit or the drainage upstream. The hard rock face outside of the adit also did not appear to be percolating water. Vegetation on the backfilled adit portal appeared to be stable. Numerous insects and birds were observed around the site.

Figures 7 & 8: View of the backfilled adit with autosampler (left) View of the adjacent rock face (right)

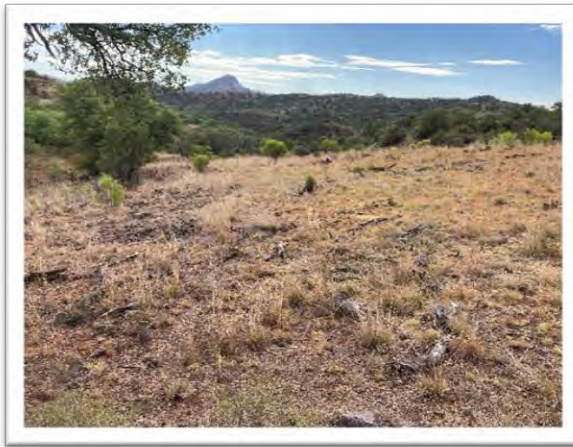
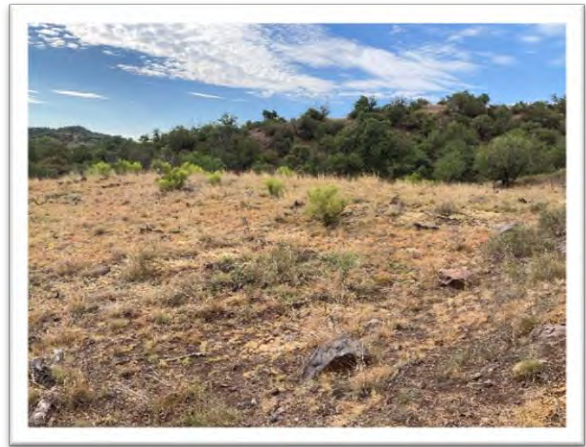
The waste repository constructed in 2015 appears to be stable with grasses and shrubs growing on this area.

Figures 9 & 10: Views of the repository

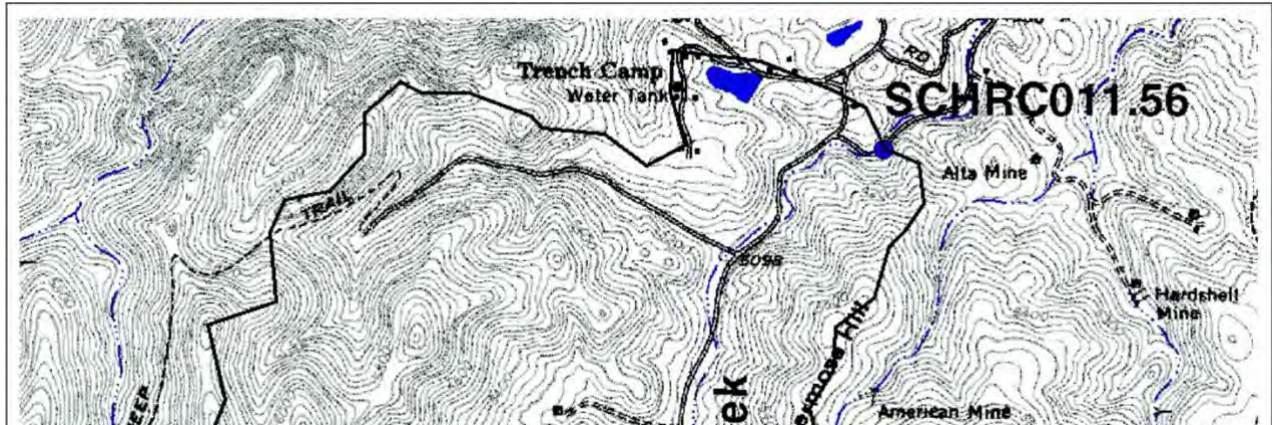
The map excerpt below (from 2003 Upper Harshaw Creek TMDL at [p.10](#)) also shows the bottom portion of the listed reach extending past Trench Camp Mine, and beyond ADEQ Sample Point No. SCHRC011.56. Note that this map (based on USGS Quadrangle Map and to scale) does NOT show the spring. Taken together with the description and map above, this demonstrates that the spring (and beyond it, the end of listed Upper Harshaw Creek) lies further north beyond the area.

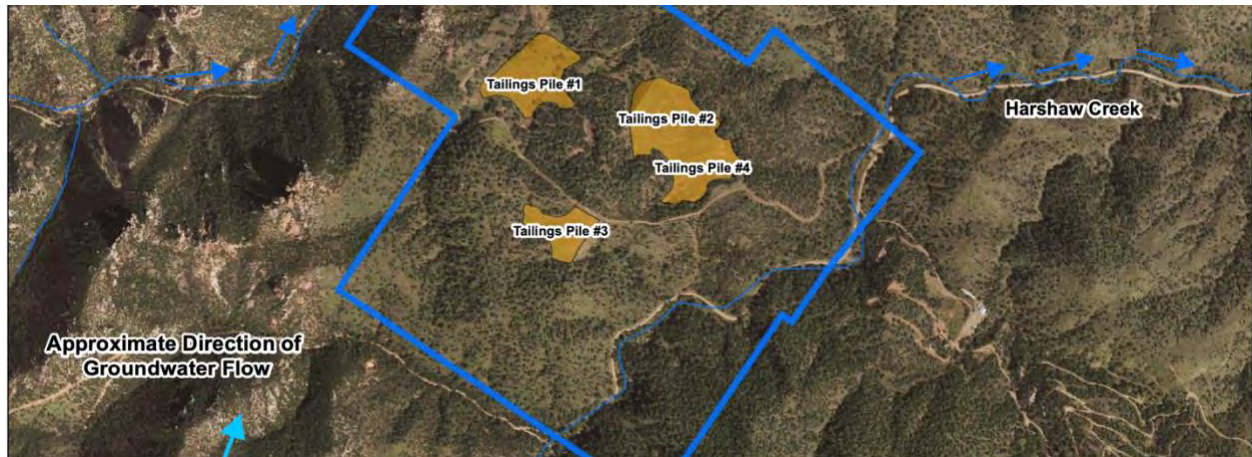
See also below, excerpt of Drawing No. A010 (p. 71) from Tailings and Potentially Acid Generating (PAG) Material Remediation, Placement and Storage Voluntary Remediation Program Design dated April 2017 (annotations and spring identifiers added).
